October 26, 2022

Re: APRMS Auditorium Framing Analysis for Photovoltaic Panels  
Amherst Pelham Regional Middle School  
170 Chestnut Street, Amherst, MA  
Gale JN 839820

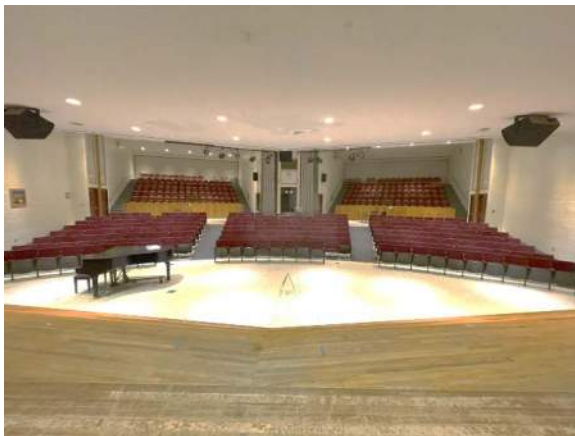
**Photo 1:** Overall view of auditorium seating with acoustic ceiling.

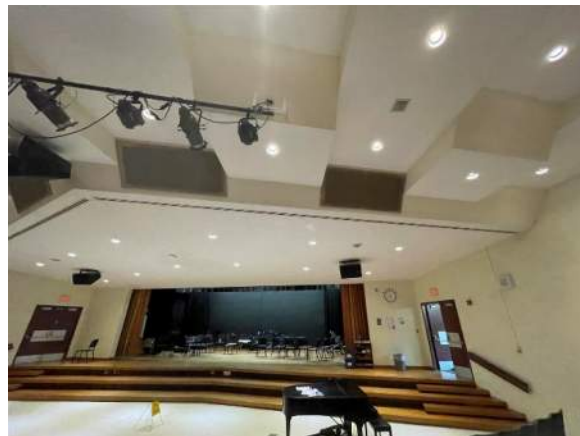
**Photo 2:** Overall view of Auditorium stage.

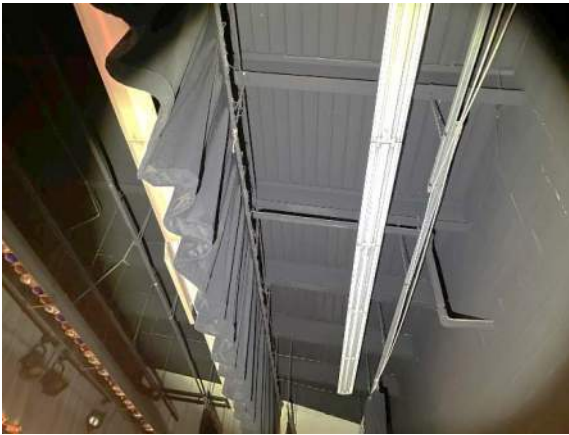
**Photo 3:** Overall view of 14-inch deep steel roof beams located above the Auditorium stage.

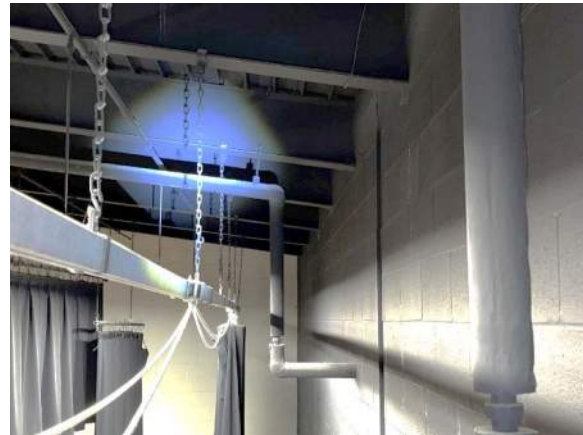
**Photo 4:** Overall view of equipment and utilities suspended directly from the underside of 14-inch deep steel beams located above the Auditorium stage, looking north along Column Line E.

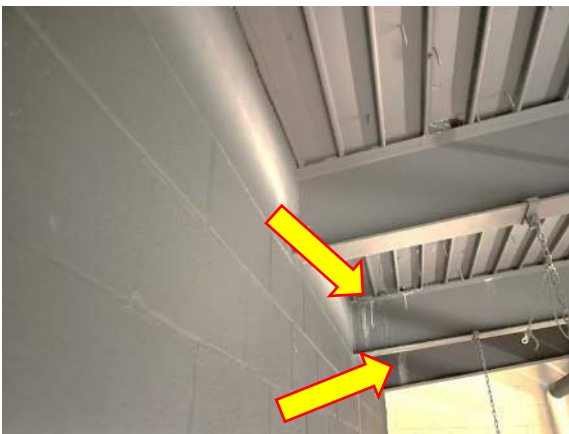
2. In general, the accessible steel roof framing observed at the time of the inspection appeared to be in good condition without areas of extensive damage or severe corrosion. Isolated areas of efflorescence staining were observed in some locations, as depicted in Photo 5, indicating signs of potential water infiltration. The extent of observed efflorescence appears to be localized and does not appear to have compromised the structural integrity of the observed members.

**Photo 5:** View of efflorescence staining on 14-inch deep steel beam located above Auditorium stage, looking south along Column Line E.

Furthermore, the existence of efflorescence below the roof deck indicates past water infiltration originating from the roof level. It is Gale's opinion that the roof system be repaired, partially replaced, or fully replaced to reduce future water infiltration and to extend the service life of the structure.

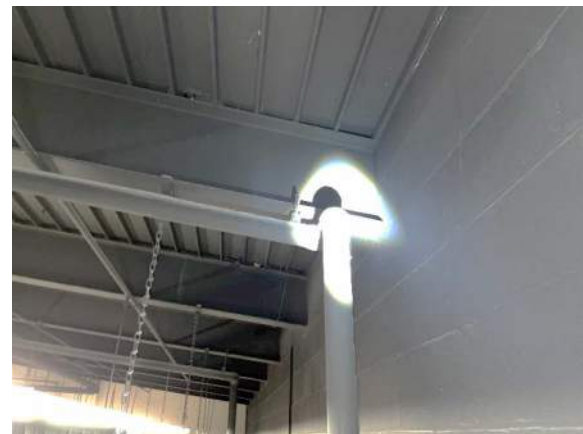
**Photo 6:** View of 14-inch deep steel beams in good condition.

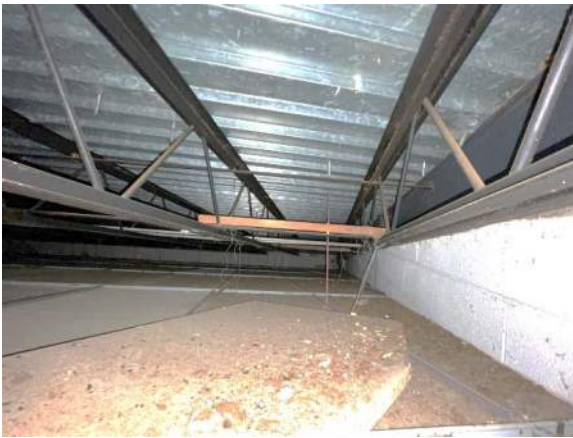
**Photo 7:** Overall view of 16-inch deep steel joists with top chord horizontal bridging located above the Chorus room, looking east along Column Line 39.

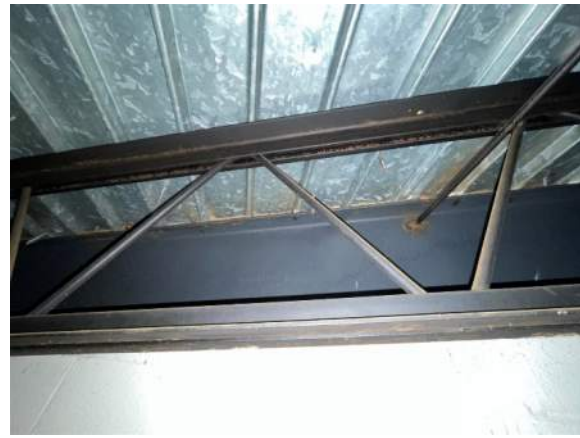
**Photo 8:** View of typical 16-inch deep steel joists and 14-inch deep steel beam beyond.

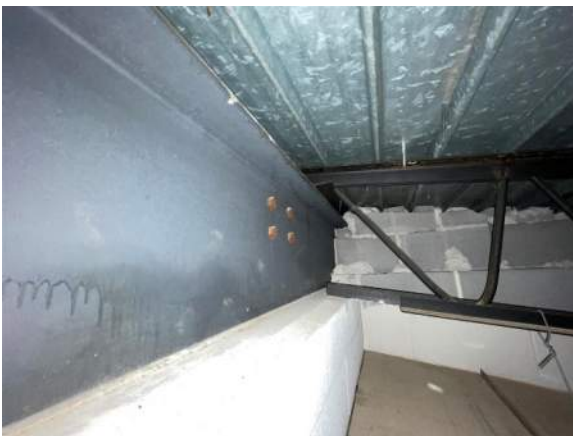
**Photo 9:** Typical view of a steel joist connection to a 14-inch deep steel beam, looking north along Column Line E.

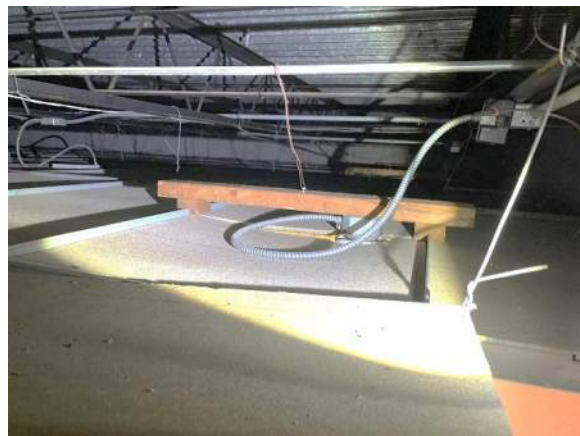
**Photo 10:** View of ceiling tiles and utilities suspended from steel joists, located above the Band room.

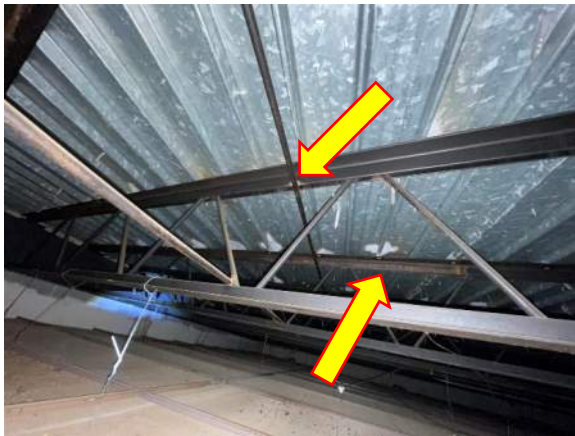
2. In general, the steel roof framing observed in the accessible locations at the time of the inspection at the east end of the building appeared to be in good condition. Isolated areas of minor corrosion were observed above the Band Room as shown in Photo 11. Miscellaneous breaches in the metal roof deck were observed above the Chorus Room as shown in Photo 12.

**Photo 11:** View of minor corrosion at a steel joist located above the Chorus Room.

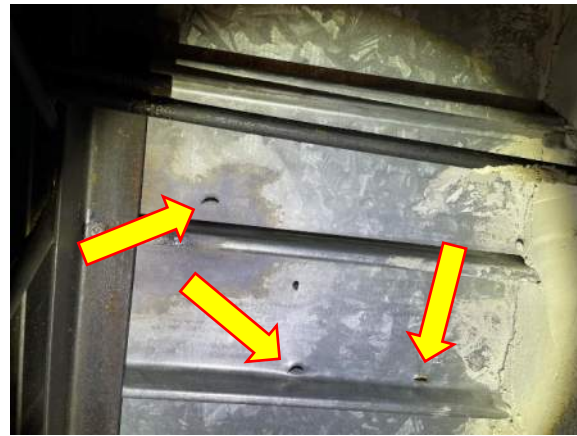
**Photo 12:** Typical view of scattered breaches in the metal roof deck above Band Room.

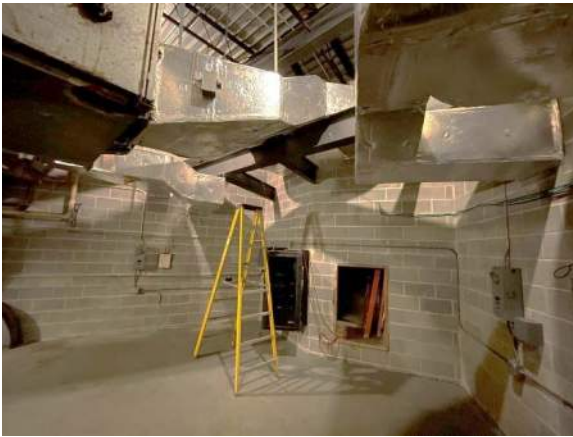
**Photo 13:** Overall view of mechanical room and crawl space entrance.

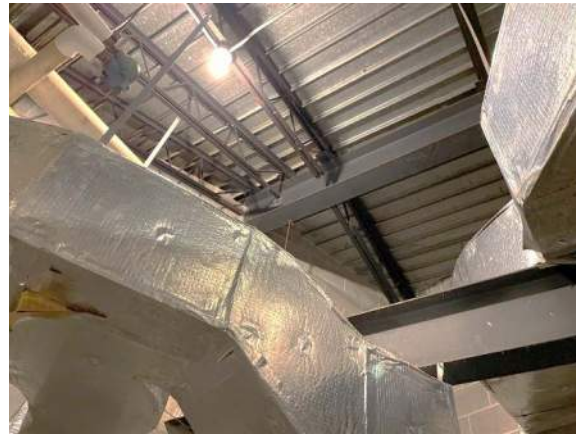
**Photo 14:** View of accessible steel roof framing in the mechanical room.

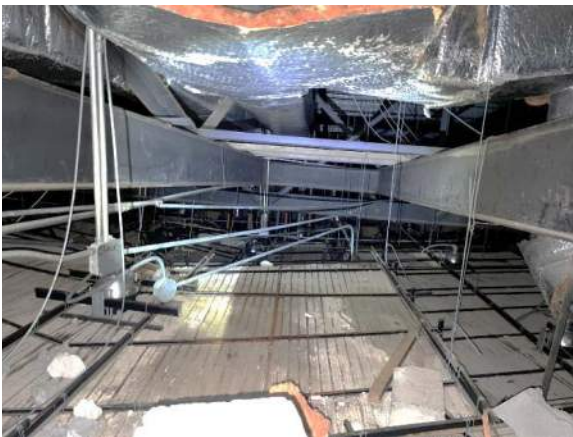
**Photo 15:** Overall view of crawl space.

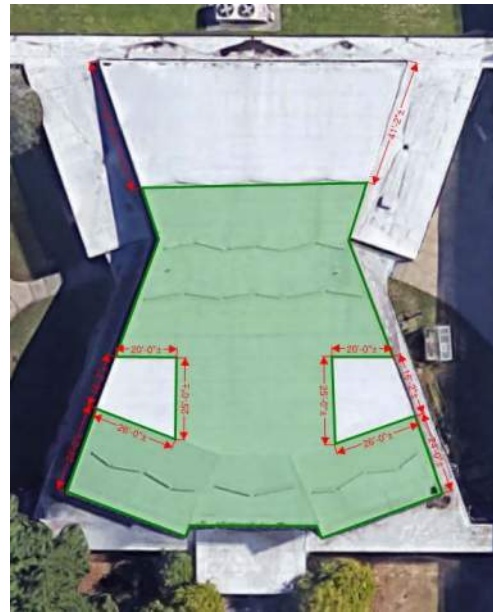
**Figure 2:** Aerial view with allowable PV Array areas in green
