July 1, 2022

Re: Amherst-Pelham Regional Middle School Auditorium Roof Evaluation  
170 Chestnut Street  
Amherst, MA 01002  
Gale JN 839810

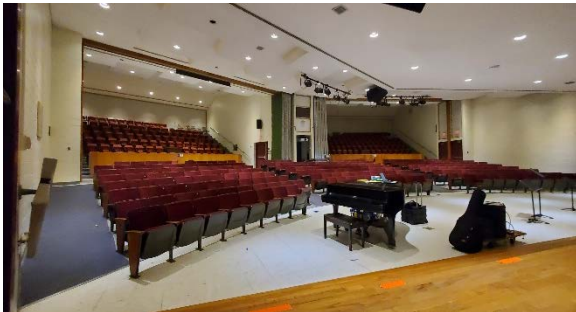
Based on discussions with APRMS facilities staff, it is Gale's understanding that the building has experienced moisture infiltration at isolated locations in the auditorium. Past and current reported leak locations exist below Roof Area A (the auditorium roof). APRMS noted that there is one (1) current active leak that occurs every time it rains. APRMS also noted that there were four (4) other recent leak locations that are not as active which may have been addressed by maintenance repairs. Miscellaneous water-stains were also observed in the auditorium and corridors, however, APRMS indicated that these are not known to be active leaks. The reported leak and water stain locations have been projected onto a roof plan (Appendix B), many of which appear to be in the vicinity below the snowguards (refer to the Exterior Observations Section for additional information).

Figure 2: View of the auditorium below Roof Area A.

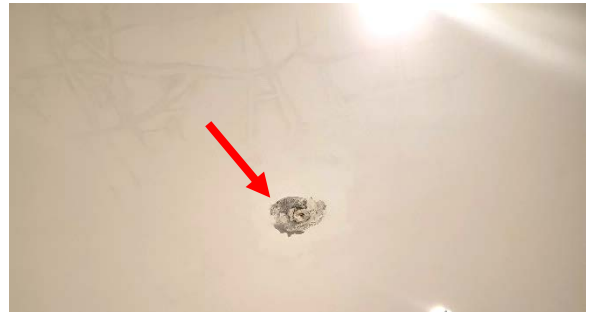
Figure 3: View of the stained/damaged ceiling at Leak Location #1 in the auditorium.

- 1. Addressing Reported Water Leakage: The reported water leakage source is unknown at this time. On low-and-moderately sloped roofs, the leak source may exist directly above the interior leak/staining, however, roof leak sources are often located some distance away. For example, defects in low slope roofs that allow water into the roof assembly may result in the water travelling a fair distance along the coverboard, insulation, and deck materials before finding the path to the interior. The same is true for steep slope roofs, however, the leakage source is usually more directly upslope of the interior leak/stain whereas leakage source for low-slope roofs can come from any direction.

Water testing studies must be performed to identify the leak sources so that the appropriate repairs can be applied. This can often result in numerous repair attempts if multiple water leakage sources exist for a given interior leak/water stain location. Any repair should be water tested to confirm the effectiveness of the repair, and the interior area should continue to be monitored during future rain events. Gale can perform water testing and design repairs, if requested.

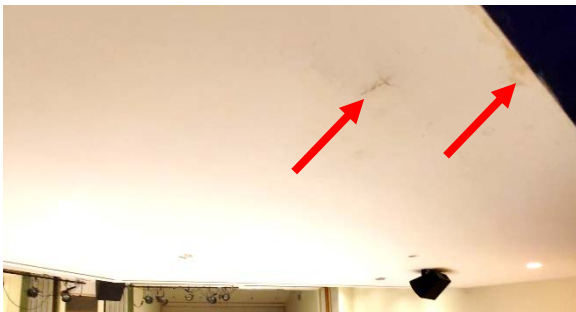
Figure 4: View of the stained/damaged ceiling at Leak Location #5 in the auditorium.

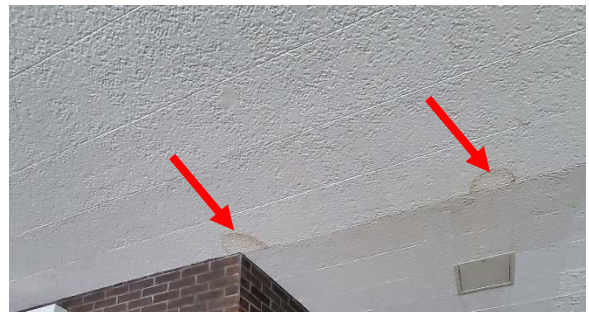
Figure 5: View of the stained ceiling tiles at Water Stain #3; APRMS indicated that this is not known to be an active leak.

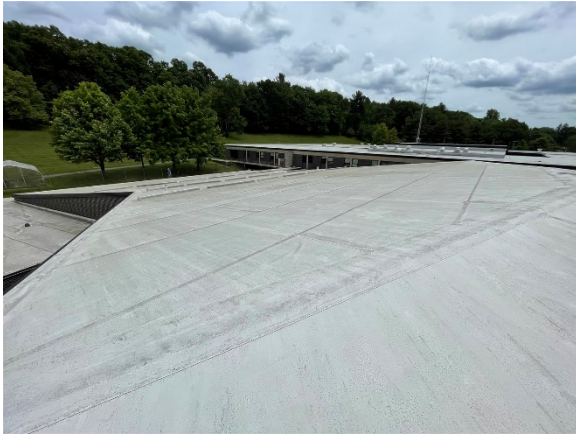
1. A thermoplastic roof system (totaling approximately 17,250 square feet) exists on five (5) roof areas (Roof Areas A through E). The 60-mil thermoplastic membrane is approximately twenty (20) years old and appears to be in fair condition given its age.

Figure 7: Partial view of Roof Area A.

Remove the existing adhered thermoplastic roof membrane, insulation, loose-laid vapor retarder (where present), and associated components down to the existing roof deck, and install an adhered thermoplastic roof membrane, adhered high density coverboard, mechanically attached polyisocyanurate insulation, vapor retarder, and baseboard. The thickness of the proposed new roof assembly is anticipated to increase approximately 3-inches to meet the minimum R-Value (R-30) requirements set by the 9th Edition of the Massachusetts State Building Code (MSBC).

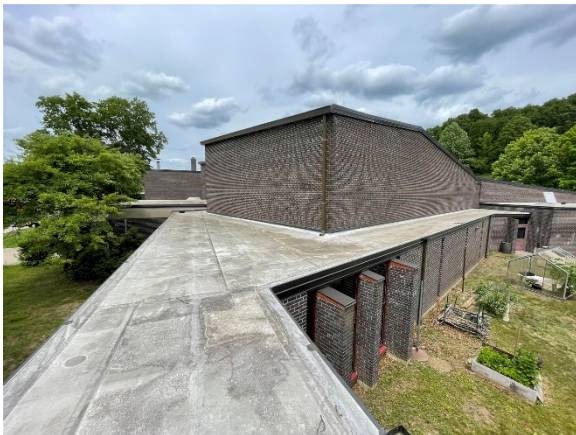
Figure 9: Partial view of Roof Area C.

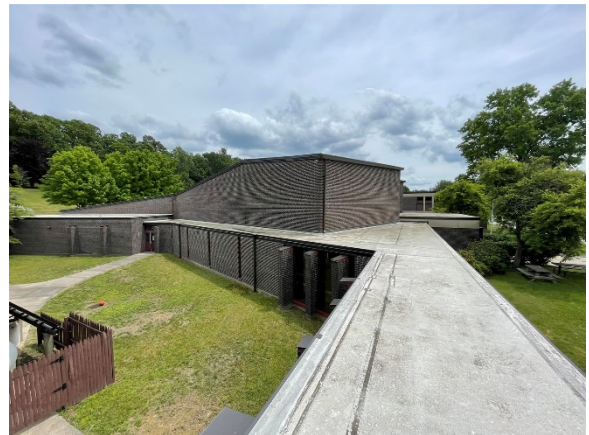
Figure 10: Partial view of Roof Area E.

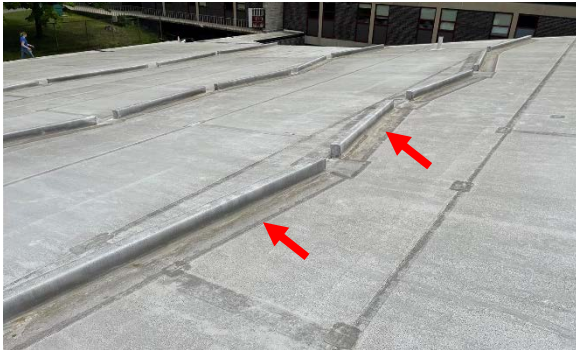
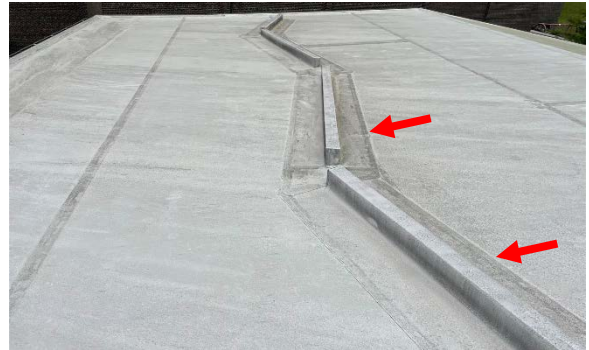
2. There are several wood blocking snow guards that span across Roof Area A in four (4) rows. The wood blocking is secured to the steel framing below and is wrapped in the thermoplastic flashing membrane. The upslope flashing membrane at the snow guards is reversed lapped. The construction of the snow guards is described in more detail in the Roof Destructive Test Cut Observations Section.

Figure 11: Partial view of the snowguards on Roof Area A; note the flashing reverse lap upslope of the snowguards.

Figure 12: Partial view of the snowguards on Roof Area A; note the flashing reverse lap upslope of the snowguards.

- J. Snow Guards: Modify snow guards as required to accommodate the increased thickness of the new roof system.
3. New Roof System Warranty: Some roof membrane manufacturers, like Sarnafil, have additional warranty stipulations if PV arrays are installed on a newer roof. Depending on the roof membrane manufacturer, some stipulations may include additional manufacturer inspections, specific roof membrane product enhancements (e.g., thicker membrane), installation of an approved coverboard, having the PV arrays installed within five (5) years of the new roof installation, etc. These warranty stipulations should be determined at the beginning stages of a roof replacement design.

Since Gale has not performed any water testing at this time, Gale can only provide assumptions on repairs that may or may not address the reported water leakage. By superimposing the APRMS-reported water leakage locations on the roof plan, the interior leaks generally appear to align with the snowguards. Per discussions with APRMS, significant snowdrifts occur at the snow guards. Since the flashing at these locations contain an upslope reverse lap, it is possible that the leading edge of the flashing contains defects, allowing water from the snowdrifts to leak into the roof system. It is Gale's opinion that adding additional flashing/protection measures at these snowguard locations is a good start to a trial and error repair approach.

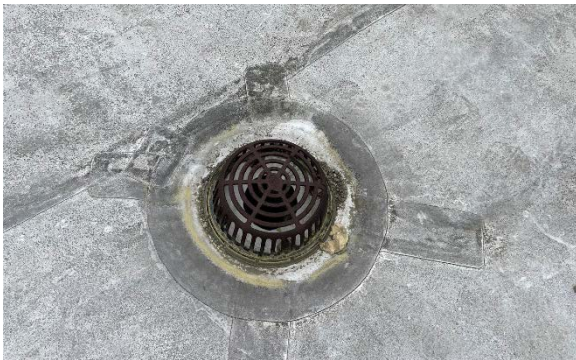
3. Roof Area A drains into gutters/downspouts that discharge onto the lower roofs. Roof Areas C and E drain into scuppers/downspouts that discharge onto grade. Roof Areas B and D have internal cast iron roof drains however, there are scuppers/downspouts on the east end of Roof Area B that discharge onto grade. Gale did not evaluate the plumbing for the roof drains.

Figure 13: View of a typical roof drain.

- E. Roof Drains: Remove existing roof drains and install new bowls with extendable collars, clamps, and cast-iron strainers.
- F. Gutters, Scuppers, and Downspouts: Remove and replace existing gutters, scuppers, and downspouts. Provide roof crickets between these drainage components to promote drainage and manage water.

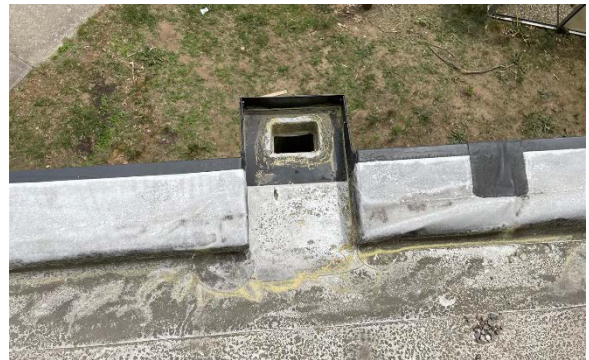
Figure 14: View of a typical scupper and downspout.

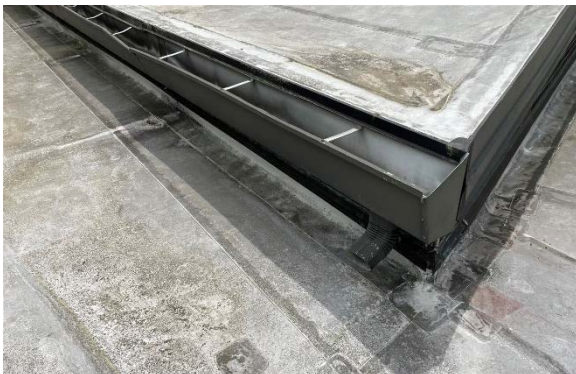
Figure 15: Partial view of the gutter on Roof Area A.

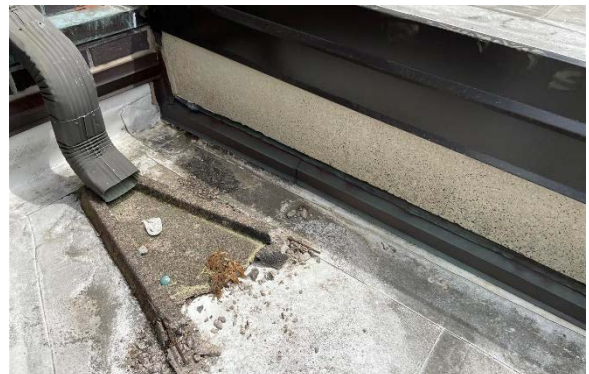
Figure 16: View of a broken concrete splash block at the base of an isolated downspout.

- D. Splash Block: Remove and replace the deteriorated splash block on Roof Area E, place new splash block on a walkway pad or protection layer.
- E. Roof Access: Remove and replace the existing interior access ladder located at the Roof Area B roof hatch.

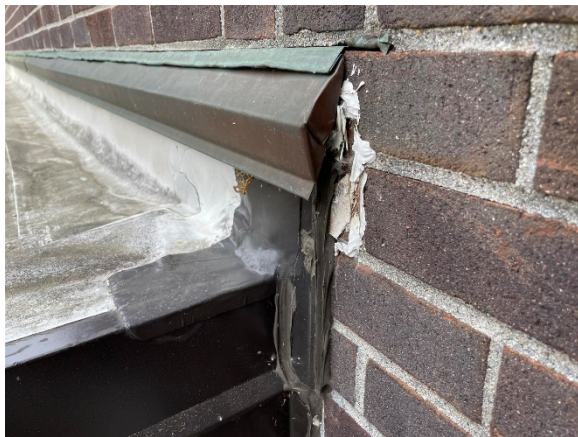
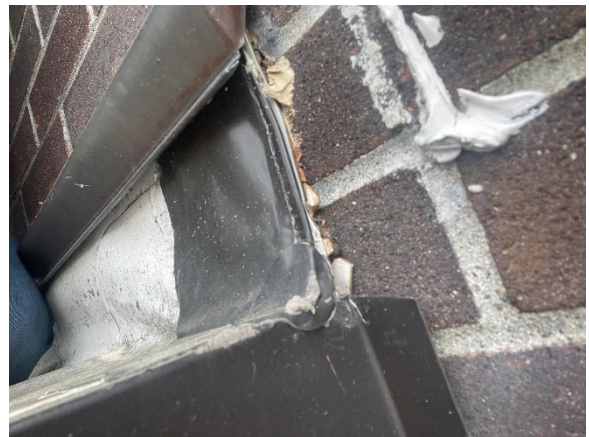
4. There are throughwall and reglet flashings at the roof to brick masonry rising wall transitions that vary from four to eleven inches (4"-11") above the existing roof system. Mortar weeps at the throughwall flashing vary between three to six feet (3'-6') on center. Some wall sections do not appear to have weeps. The throughwall flashings appear to be similarly constructed as shown in the original construction drawings. It appears that newer counterflashing has been utilized to clip onto the apparently original throughwall flashing. The sealant at the reglet flashings is debonded. The limits of the throughwall flashing typically stops flush with the roof edge and does not contain a reliable termination. Gale observed locations where the membrane was peeling away from the brick masonry wall.

*Figure 17: View of the limits of the throughwall flashing; note that the throughwall flashing stops at the roof edge and the membrane is unadhered in isolated section.*

*Figure 18: View of the limits of the throughwall flashing; note that the throughwall flashing stops at the roof edge and the membrane is unadhered in isolated section.*

- B. Masonry Repairs: Rebuild step-cracked brick masonry observed on the rising wall transitions between Roof Areas C/E and B.
- C. Throughwall/Reglet Flashing Terminations: Terminate roof membrane and/or sheet metal with a blind nailer beyond the roof edge and at rising wall inside corners to reduce the potential for water infiltration on this vertical edge.

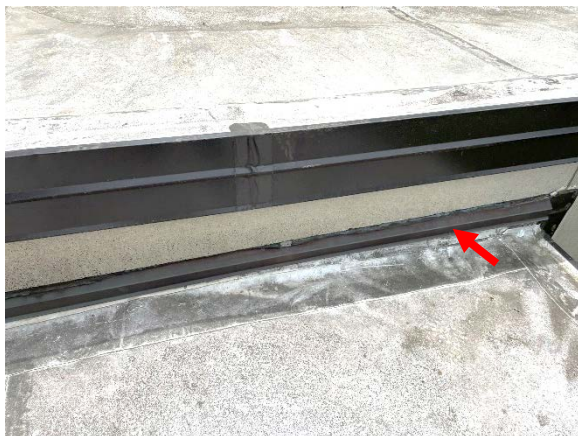
*Figure 19: View of the throughwall flashing at the precast concrete rising wall from Roof Area E to Roof Area D.*

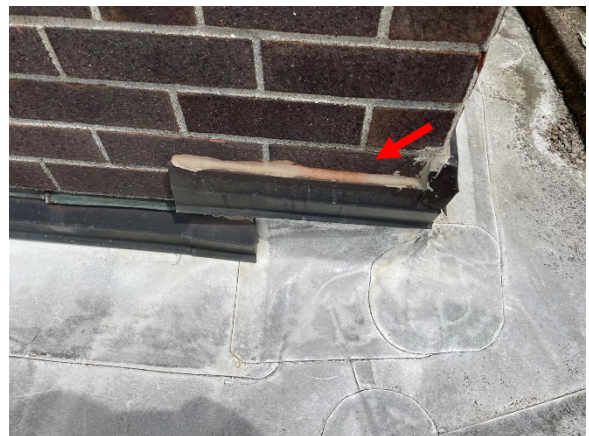
*Figure 20: View of a location where the throughwall flashing steps up; note that the upper throughwall flashing is sealed and there does not appear to be weeps or end dams.*

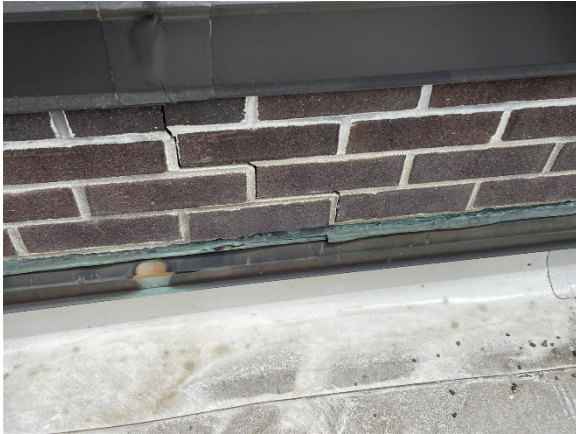
*Figure 21: View of step cracked masonry between Roof Area B and Roof Area C.*

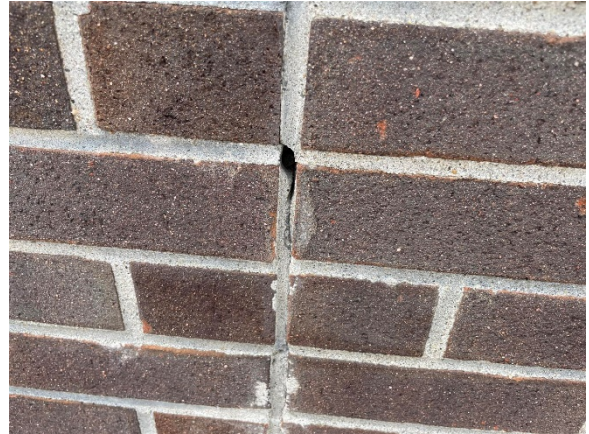
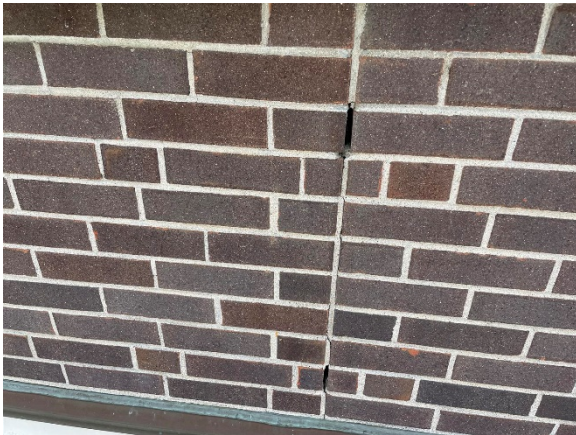
5. Brick masonry rising walls exist between the various roof areas. The brick masonry in these locations generally appear to be in good condition with isolated areas of deteriorated mortar and step cracked masonry. The masonry control joints generally appear to be filled with mortar instead of a flexible material (e.g., sealant); the mortar at these locations is typically deteriorated.

*Figure 22: View of deteriorated/missing mortar at a rising wall control joint.*

*Figure 23: View of deteriorated/missing mortar at a rising wall control joint.*

- A. Masonry Rising Wall Control Joints : As discussed in the Roof Replacement Option above, the brick masonry vertical control joints located on Roof Areas B, C, and E appear to have missing or have failed mortar joints. It is Gale's opinion that the mortar in these control joints is replaced with an elastomeric sealant under the scope of a repair project to improve the movement capability of the brick masonry and to improve moisture infiltration resistance of the wall assembly. Louvers also exist on some of the rising walls; perimeter sealant at louvers should be removed and replaced.

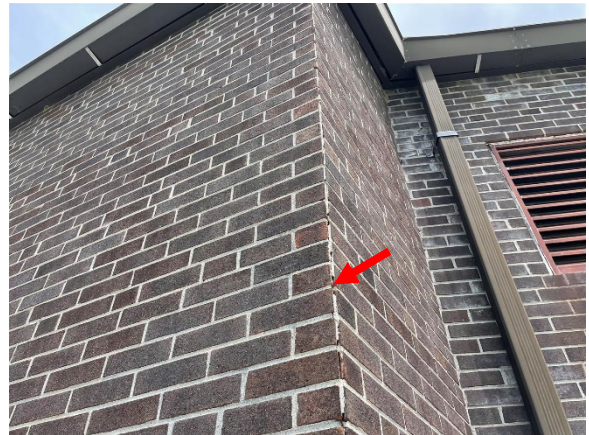
*Figure 24: View of a deteriorated mortar joint.*

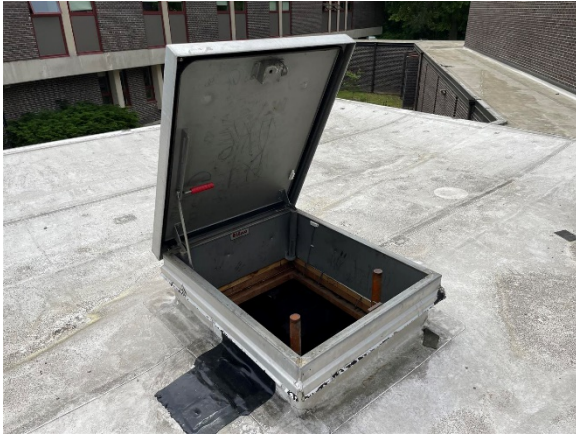
6. Gale was provided access to the roof through the Roof Area B hatch. The roof access ladder is fastened into the CMU wall and into the wood blocking. Gale observed a missing fastener at the upper bracket.

Figure 25: View of the roof access hatch on Roof Area B.

- C. Roof Access: Remove and replace the existing roof access hatch and interior access ladder located on Roof Area B.
- D. Masonry Rising Wall Control Joints: The brick masonry vertical control joints located on Roof Areas B, C, and E have missing or failed mortar joints. It is Gale's opinion that the mortar in these control joints is replaced with an elastomeric sealant under the scope of a roof replacement project to improve the movement capability of the brick masonry and to improve moisture infiltration resistance of the wall assembly. Louvers also exist on some of the rising walls; perimeter sealant at louvers should be removed and replaced.

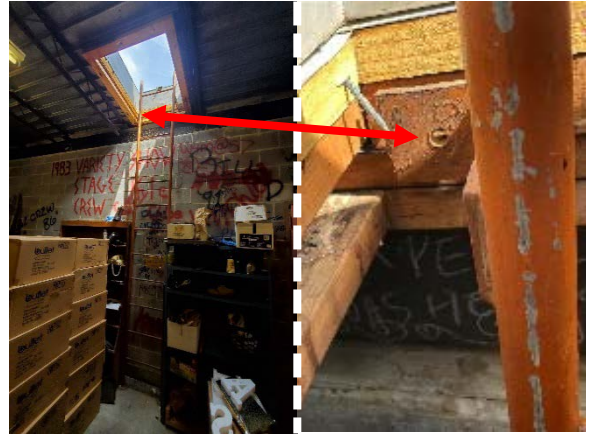
Figure 26: View of the interior roof access ladder; note that there was a missing fastener at the upper bracket.

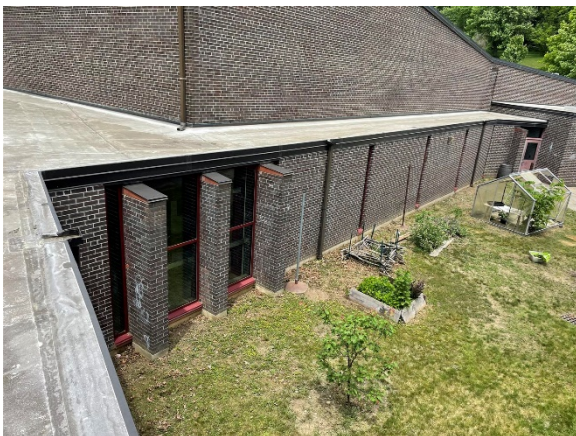
7. Gale observed isolated brick piers below the roof edge of Roof Areas C and E that were covered with sheet metal that tucked under the roof edge fascia.

Figure 27: View of the masonry piers below Roof Area C.

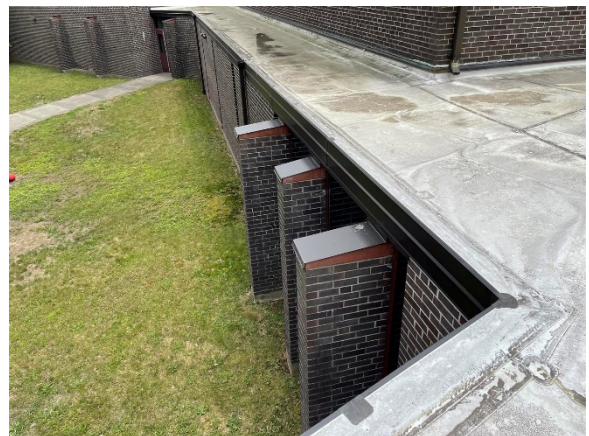
Figure 28: View of the masonry piers below Roof Area E.

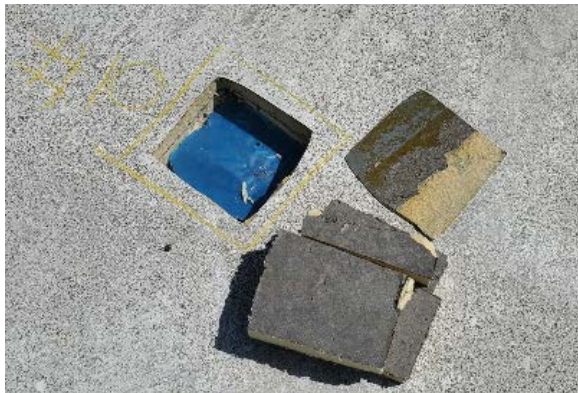
- o Mechanically fastened 3" to 7" thick polyisocyanurate rigid insulation. Tapered insulation was observed on Roof Areas A, B, C, and D.
  - o Adhered 60 mil thermoplastic membrane. Gale did not observe any wet materials in the roof test cuts.

Figure 29: View of Test Cut #10 in the field of Roof Area D.

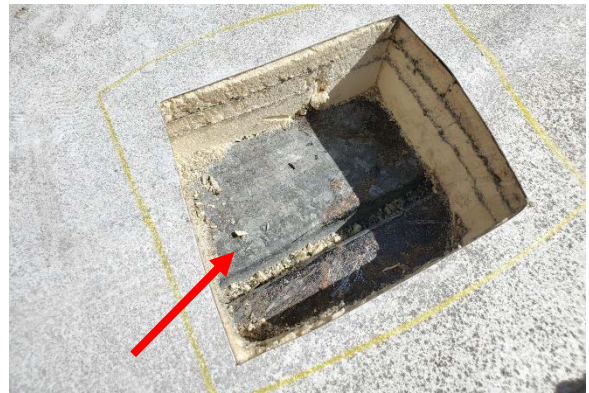
Figure 30: View of Test Cut #2 in the field of Roof Area B; note that there was no vapor retarder observed.

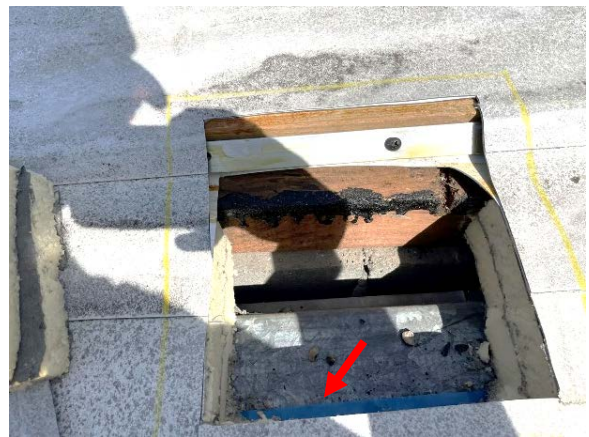
Figure 32: View of a typical roof edge detail; note the vapor retarder stopping short of the wood blocking.

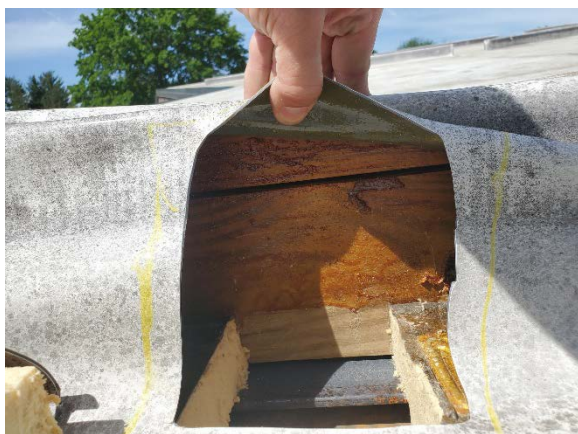
Figure 33: View of Test Cut #18 at a snowguard on Roof Area A.

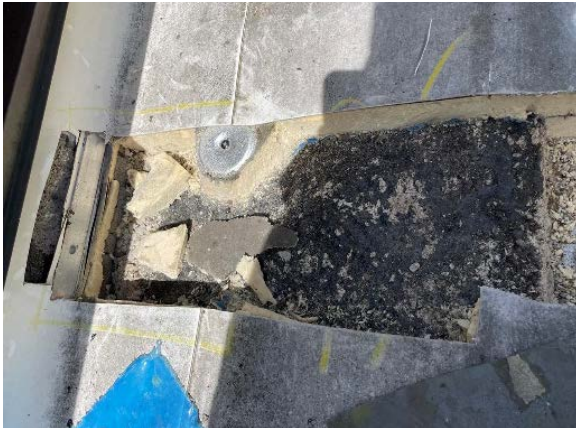
Figure 35: View of Test Cut #12 at the transition between Roof Area B to Roof Area A.

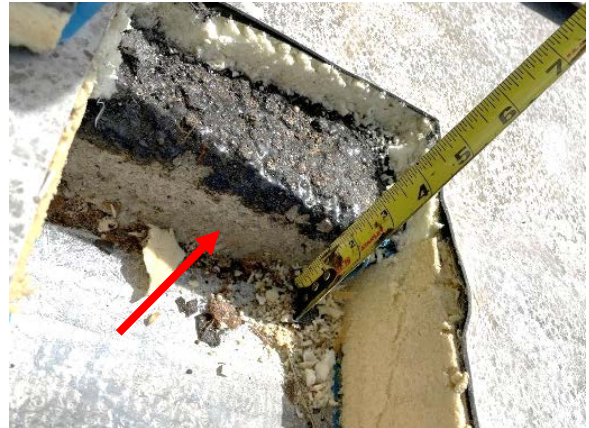
- o At three (3) locations, Gale observed a 2" thick lightweight concrete fill and asphaltic coating adjacent to the gutter line. This existed on Roof Area B where it abutted the east rising wall of Roof Area A, Roof Area A along the east roof edge, and Roof Area A along the west roof edge.

Figure 36: View of the 2" lightweight concrete fill on Roof Area A.

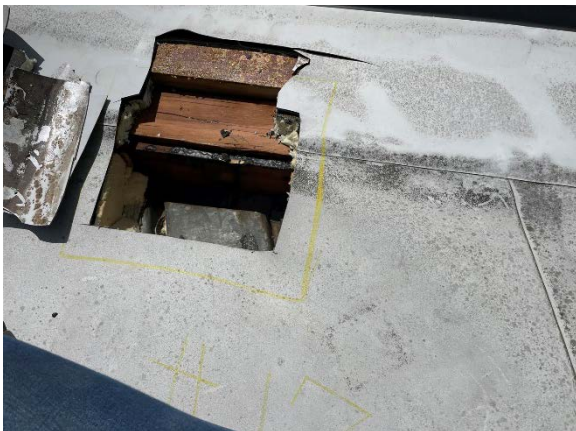
Figure 37: View of Test Cut #17 at the south roof edge of Roof Area A; note the vapor retarder stopping short of the wood blocking.

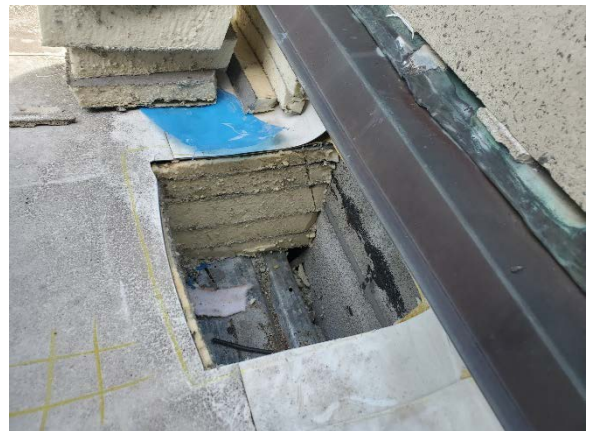
Figure 38: View of the test cut between Roof Area C and D.
