## Document 522 POST-ASSESSMENT REPORT

CHAPTER: Worcester Polytechnic Institute

COMMUNITY: Guachthu'uq/Rehquensal

PROJECT: Water and Stoves for Guachthu'uq

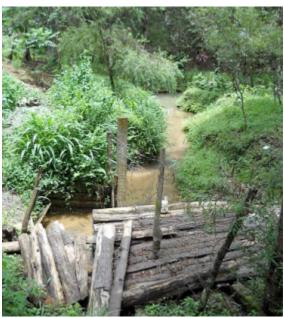
A view downstream the spring source

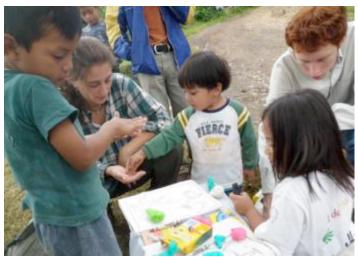
**Making Playdoh sculptures**
