531 – Post-Implementation Report

Community:	Guachtuq
Country:	Guatemala
Chapter:	Worcester Polytechnic Institute
Project ID(s):	6871 WORCH-S-GUAT-00687
Submittal Date:	07/19/2016
Dates Traveled:	05/07/2016-05/23/2016
Authors:	Amanda Gatz, Evelyn Grainger, Kerry Muenchow, Aaron Pepin, Andrew Petit, Alana Sher

531 – Post-Monitoring & Evaluation Report
Worcester Polytechnic Institute
Guatemala, Guachtuq, 6871 WORCH-S-GUAT-00687

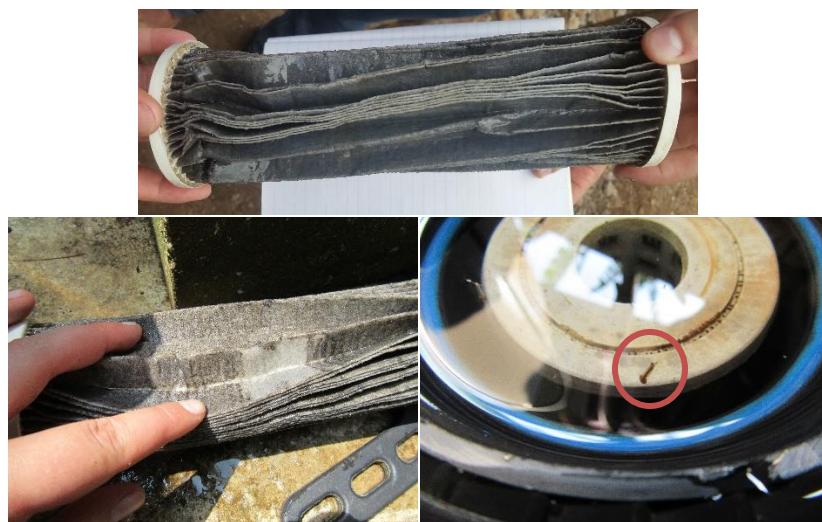
While some filters, such as house 4, which was newly implemented in 2015 and has shown great care for their filter continues to have improved water quality as a result of filters being included in the system, filters provide the opportunity for bacteria to grow. The pictures below show the variability in relation to the care families take of their filters.

Figure 2: Cleanliness of filters (Top) A filter 2 years old with little care from family. (Left) A filter 1 year old with family caring for filter with large amounts of staining but still functional. (Right) A filter with visible organisms growing in the filter cartridge.

The water quality data collected by the travel team with regards to the bacteria present in the systems confirmed EWB-USA WPI's decision to remove the cellulose cartridges, regardless of what they would be replaced with, and reinforced the data previously presented in the 530.

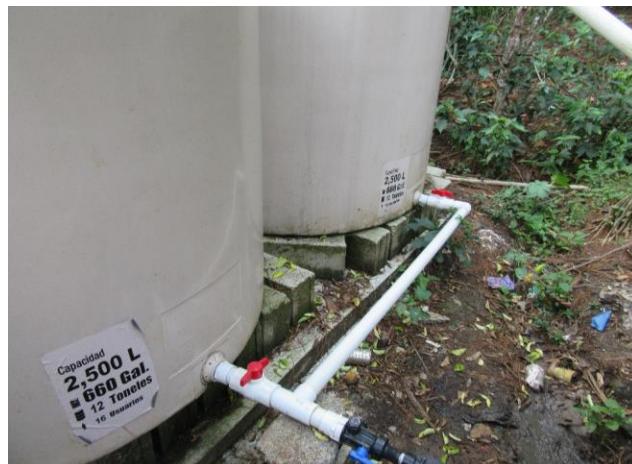
Figure 7: Picture of House 33's two valve separation completed independent of EWB-USA WPI

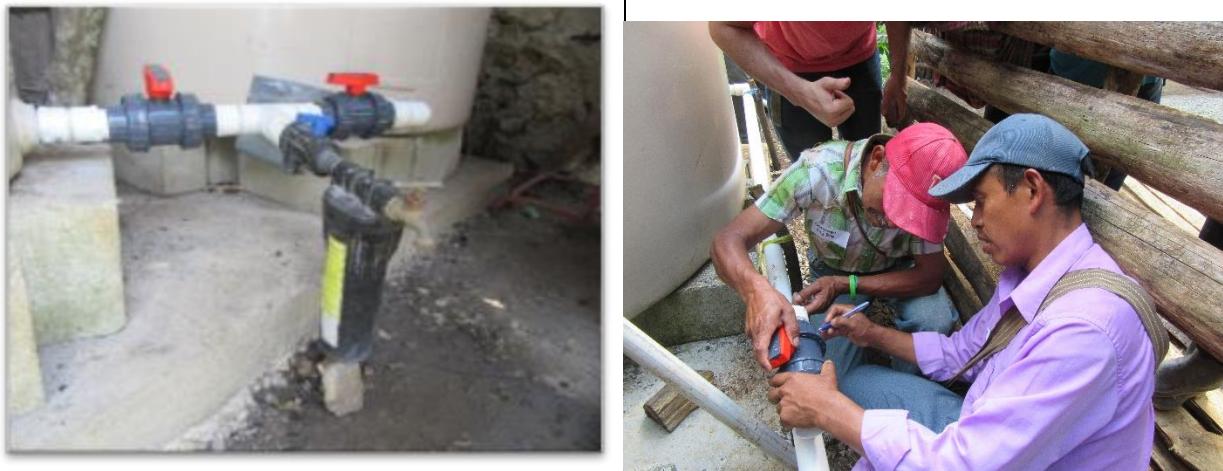
Figure 8: (Left) A completed EWB-USA WPI separation of tanks with two ball valves (Right) Men in the field component of the certification program completing a separation of tank with the oversight of a traveler.

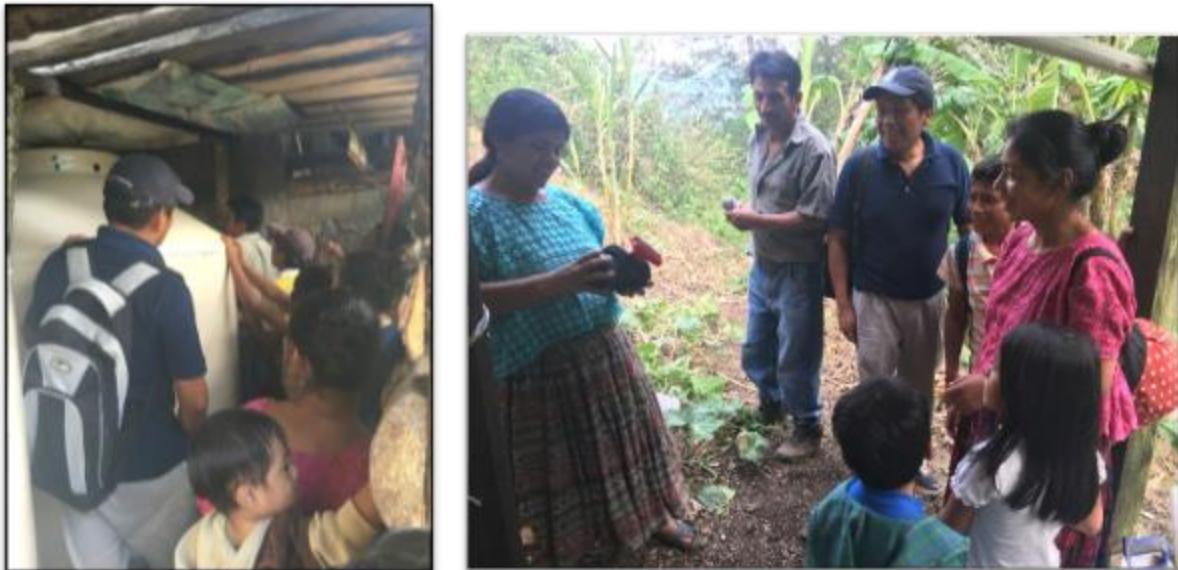
Figure 10 (Left) Community members participating in the second half of the certification program, performing a repair on House 36. (Right) Community members explaining to a system owner how the valve for the separation of tanks works.

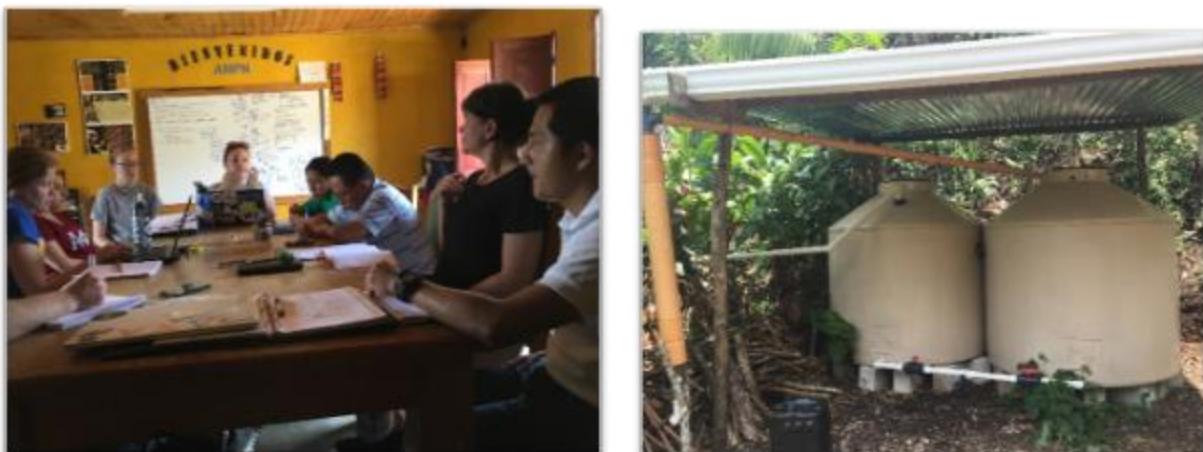
Figure 11 (Left) The travel team having a conversation concerning project process with the local NGO, CeCEP. (Right) The system of Teresa Yuja, House 22, after the separation of tanks was completed.
