Document 525
PRE-IMPLEMENTATION REPORT

CHAPTER: Worcester Polytechnic Institute
COUNTRY: Guatemala
COMMUNITY: Guachthu'uq
PROJECT: Rainwater Catchment
TRAVEL DATES: December 27, 2012 – January 9, 2013

Document 525 - Pre-Implementation Report
Worcester Polytechnic Institute
Guachthu'uq, Guatemala
Rainwater Catchment

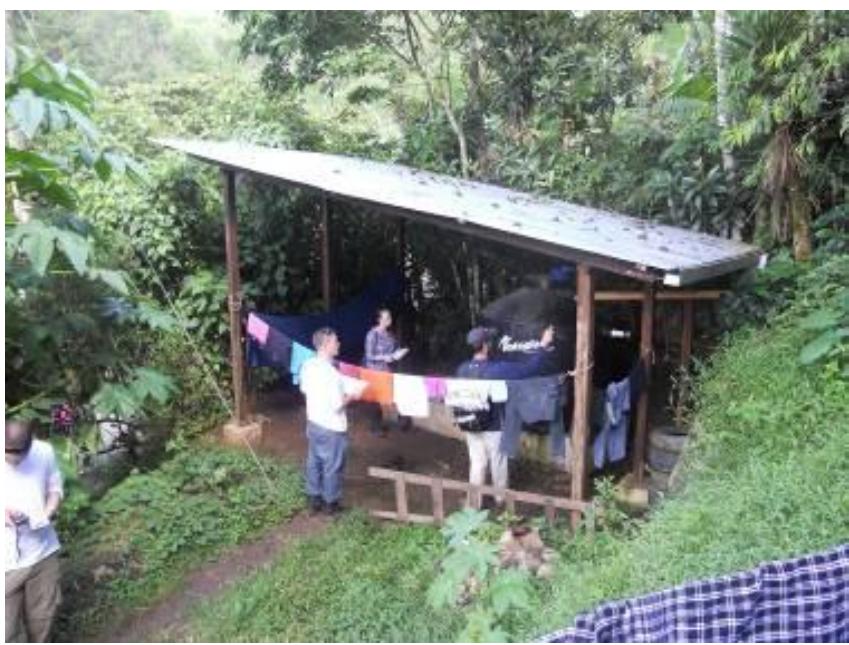
On Roof 1 of House A, the rust is minimal and therefore the roof need not be replaced. The gutter system already there will just need to be cleaned out thoroughly prior to the screen installations. In Figure 12, Roof 1 is shown surrounded by trees and with leaves and debris on the roof. Because of this high debris collecting area installing screen across the entire gutter is the best and safest option. There is only one section of gutter on Roof 1, so installing screen across top of the entire gutter is reasonable. The metal screen would have the same, or larger holes, as the screen used on the water tank pipe. It would be cut to length, attached between the gutter and roof, and then bent over the outside edge of the gutter. If six inches of screen were left to hang over the edge of the gutter, unsecured, this would allow for regular and easy maintenance of the gutter while also protecting it from debris flowing off the roof. We could also do this for Roof 1 on House L, but as shown in the pictures, there is little to no debris on the roofs, so an entire screen system may not be necessary.

House A currently is a mid-sized home that is composed of two separate structures. Roof 1 is separate from the entire house and was installed and built by the local government during a campaign season. Roof 1 is supported by four columns with no walls; its only purpose is to collect rainwater. The structure has its own gutter system that feeds into a 2500 L tank located underneath. The condition of the Roof 1 system is average, though it is beginning to rust.

Figure 12: House A, Roof 1 and Structure

For House A, we are not going to alter anything on the separate structure, Roof 1. Our proposed solution is to add another 2500L storage tank and to incorporate Roof 2, 3, and 4 into the system. We will need to replace each of these currently rusty roofs with new corrugated iron and install gutter systems along the bottom of each roof. Each of the gutter systems would run into the new 2500L tank. Based on our data and calculations displayed in the graph below (Figure 18), installing the proposed design would provide House A with water volume throughout the year.

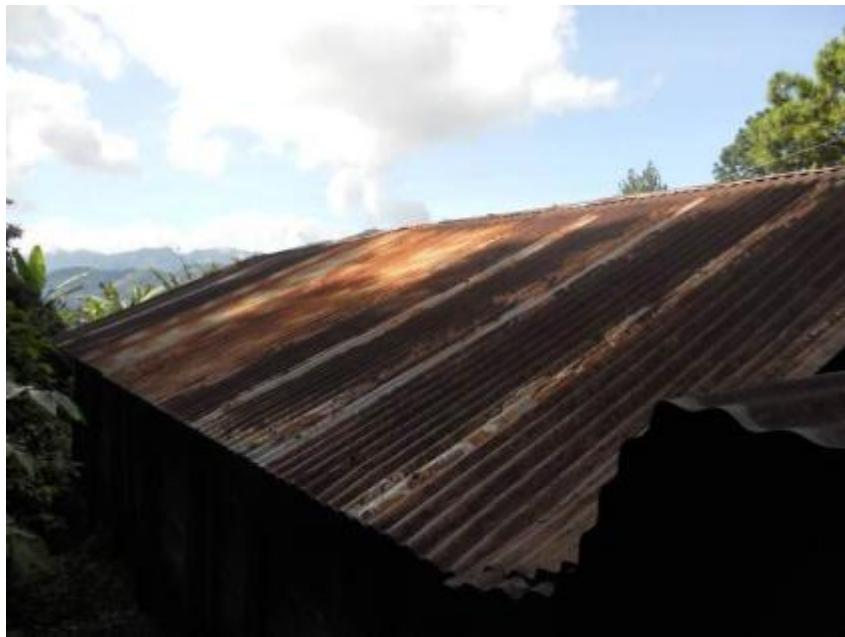
The second structure is the home in which the family lives. It consists of Roofs 2, 3, and 4. Currently on Roof 3 there are two separate gutter systems beginning on each side of the roof. The gutters do not attach in the middle and the water falls into two makeshift containers, which is the only means for catching and storing water off any of the three roofs on the main house. Because the house has a significant amount of roof area, it could be utilized to generate enough water for the family year round. Roofs 2, 3, and 4 have large amounts of rust and will need to be replaced.

Figure 13: House A, Roof 2 (Roof 3 opposite peak of Roof 2)

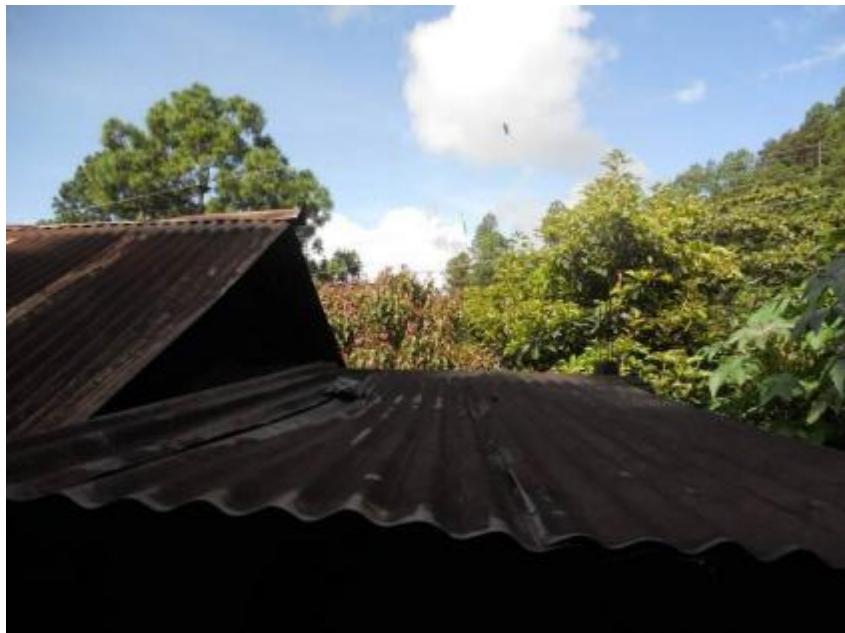
Figure 14: House A, Roof 4

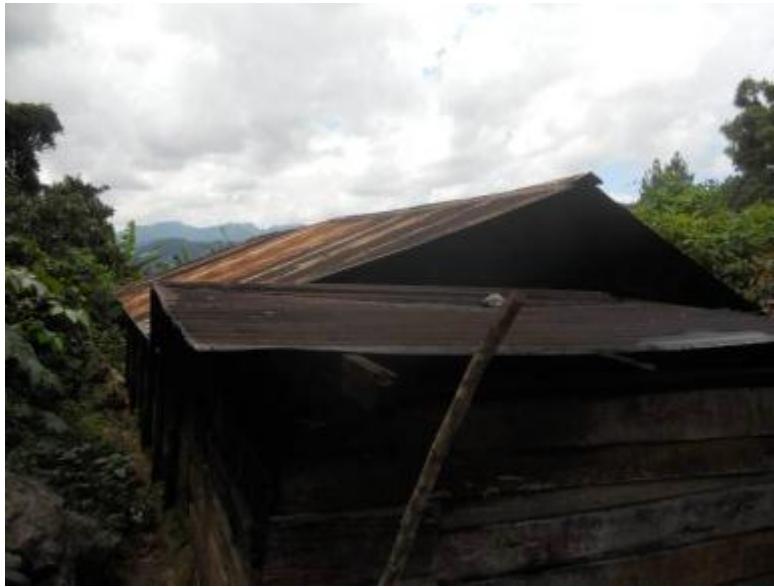
Figure 15: House A, Roof 2 (back left), Roof 3 (back right), and Roof 4 (front center)

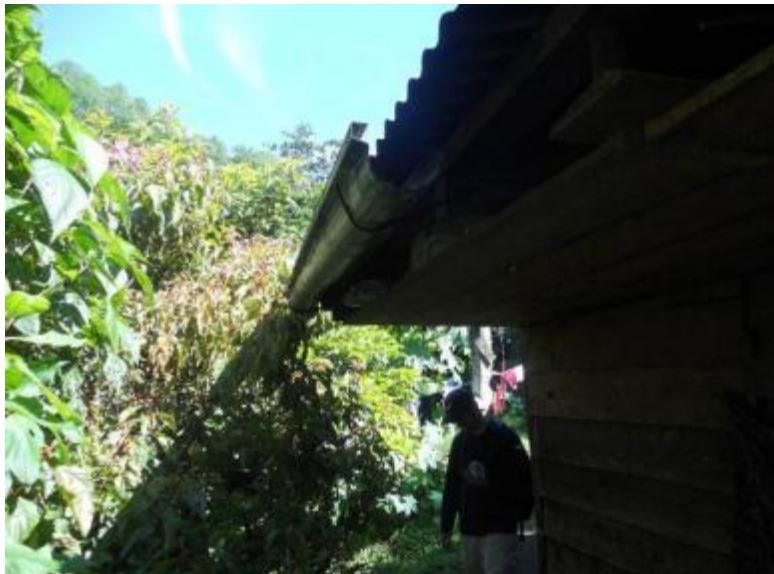
Figure 16: House A: Half Gutter on Roof 3 (water drops into small container from gutter)

Our proposed design for House A is based on the fact that currently they have enough roof area to support a rainwater system. At this time the problem with this house is that they are only utilizing about one full roof, Roof 1, and one half of a roof, Roof 3, to collect water. Also, the makeshift containers for water collection that are currently below Roof 3 on their main house are inadequate and lack the necessary collection volume.
