## Document 526 Post Implementation Report

Chapter: Worcester Polytechnic Institute

Community: Guachtuq

Project: Rainwater Harvesting

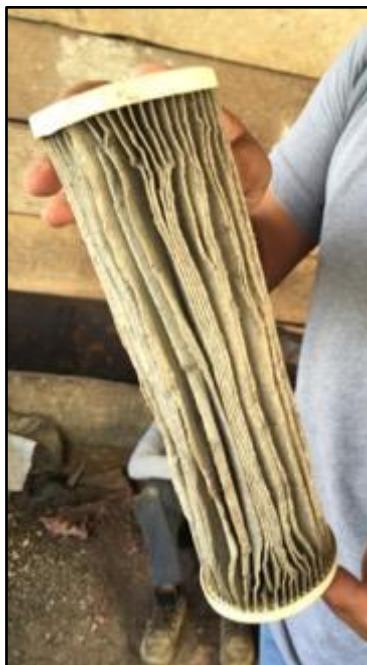
Figure 13: Intact Filter.

- *There is a possibility filters that are not cleaned properly have an adverse effect on water quality:* Due to the discovery that some filters were not being cleaned properly, there was concern that filters were becoming dirty enough that they decreased the water quality of the system. Focused water quality tests were completed as can be seen in Appendix B – Water Quality Data. Results indicated that the filters did not appear to be having adverse effects on the water quality of the systems. However, the team did not have enough tests with them to draw any definitive conclusions. Further testing on the planned May 2016 Monitoring Trip will be able to shed more light on the situation. Examples of filters seen on the May 2015 trip are below in Figures 14 and 15.

- *Proper cleaning and maintenance methods needed to be further emphasized within the community:* On the trip, it was observed that many of the systems were coming back with more bacteria than expected. While the systems still had improved results when compared to the *finca*, this data showed the need for some change. This was the first time the club had seen a significant number of systems after the rainy season, and therefore greater measures to emphasize cleaning the system were taken at the end of the trip. Additional testing on the planned May 2016 Monitoring trip will be able to show more specific trends.
