3/10/2011 Request to leave-in-place Five (5) Steel piles, 12" diameter, broken and driven below mud line at the Coup Abel Pass entrance to Barataria Bay

Coastal Use Permit Number P20101094

US Army Corps Permit: MVN 2010-1521-EKK, MVN 2010-1478-EKK

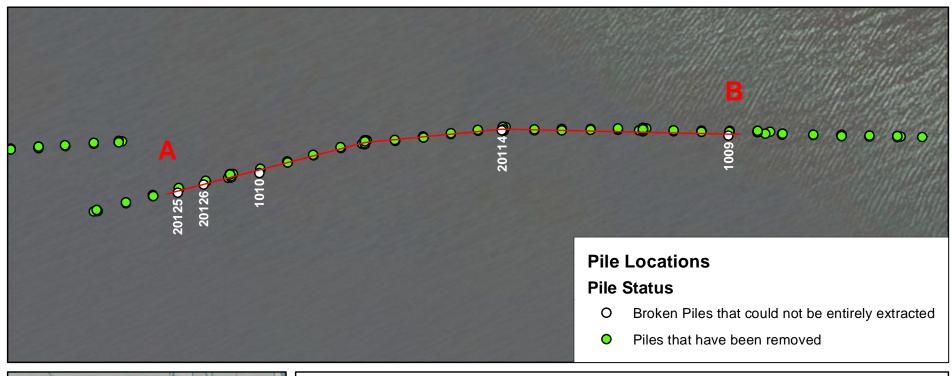
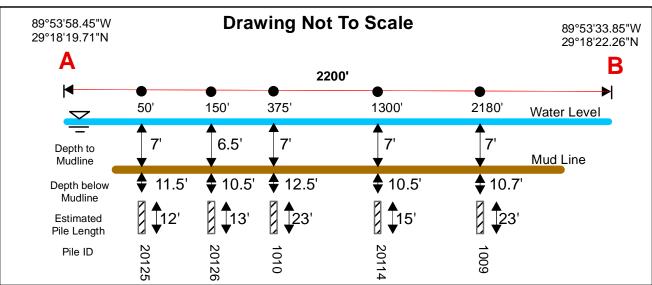
Coup Abel Pass Detail

Location of submerged piles stubs to remain in place

These 5 steel piles, originally approximately 40 feet in length, broke at or below the mud line during the extraction process between January 29 and February 17. Because they were no longer accessible from the water surface, their remaining stubs were driven more than 10 feet below the mud line as summarized on the attached cross-sectional diagram and per the request of regulatory agencies, so as not to pose any future threat to navigation or fisheries in the area.
