After Action Review

Dutchman Peak Fire Lookout Tower

Travis Newton

September 16, 2024

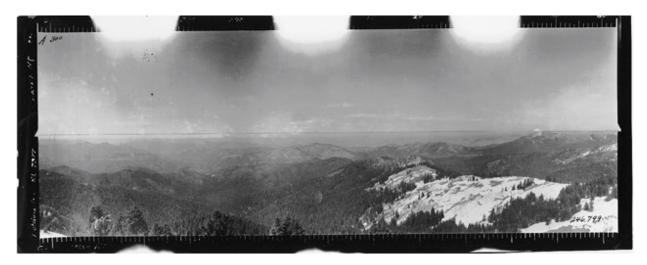
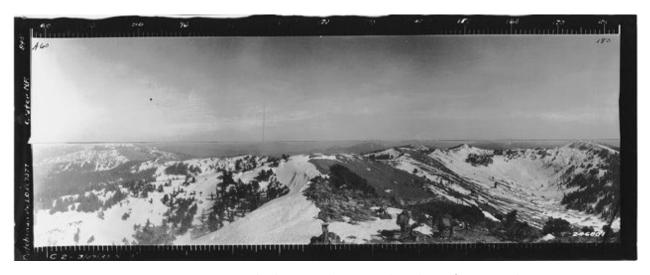
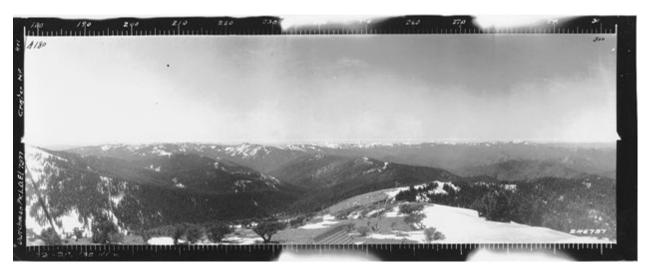
The Dutchman Fire Evacuation document specifically points out regulation PRC 4291, which states that a defensible space of 100 feet is clear of flammable material around structures. In 1939, panorama pictures were taken in all directions, depicting clear views with no bushes or trees. These bushes now surround the lookout at a height of 5-12ft, and trees have grown to such an extent the lower half of the tower can not see to the NW.

While visiting the Dutchman, USFS supervisor stated that trees and bushes can be "topped, lopped, and trimmed" without environmental plans. Utilizing regulatory knowledge, send the engine crews to mark off a circumference of 100ft around each structure and begin lopping. The lookout can not do their job if the tower burns down due to excess fire fuels or the lookout cannot see the forest due to overgrown trees.

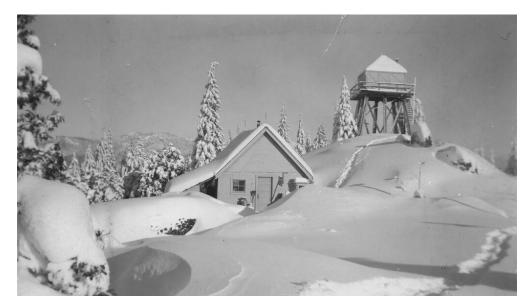
Figure 9: circa.1943, Mt.Stella Lookout

1. Mt.Stella lookout (circa.1933) has the same CCC garage turned into a house. Photos are available to visualize building requirements that depict the interior subfloor, walls, and ceiling. Start by taking the entire structure to the studs, saving windows for reconditioning. Extend the ceiling to the roof line to regulate temperatures. Wall the bathroom in and open the wall between the bathroom and bedroom. The walled bathroom allows a wrap-around kitchen complete with cabinetry, a propane stove, a refrigerator, and gravity-fed water from a 100gal tank, which can be pumped via electricity from the Dutchman Spring a few hundred feet down the south slope. Replace the wood fireplace with propane heating, locating a 100gal tank near the front accessible by a service truck. Add the second exterior door on the west side to a BBQ and wrap-around deck to the front foyer. Enlarge the front foyer to handle more snow gear and remove the wood storage add on. Replace roofing with original cedar shake and remove all non-house attachments such as solar and antennas. Solar panel field and additional antenna arrays can be relocated south of the circular driveway. During the winter time, the house goes on rec.gov as a snow camp rental, recouping money spent on the remodel. If the Dutchman House goes much longer, it will fall into Mt.Stella decay and be unrecoverable.

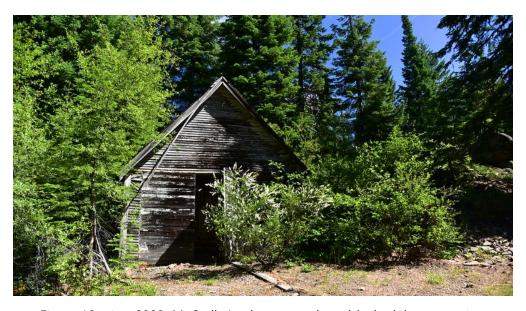
Figure 10: circa.2023, Mt.Stella Lookout, trees have blocked the tower view
