# CR30 ELECTRONIC-CAM DATA READOUT

## SELECTED CARD 01 - RECORDED BASELINE

**Machine:** KOSME TOP II AD TANDEM 20/1056 CE SA4 E2    **Registration:** L05358

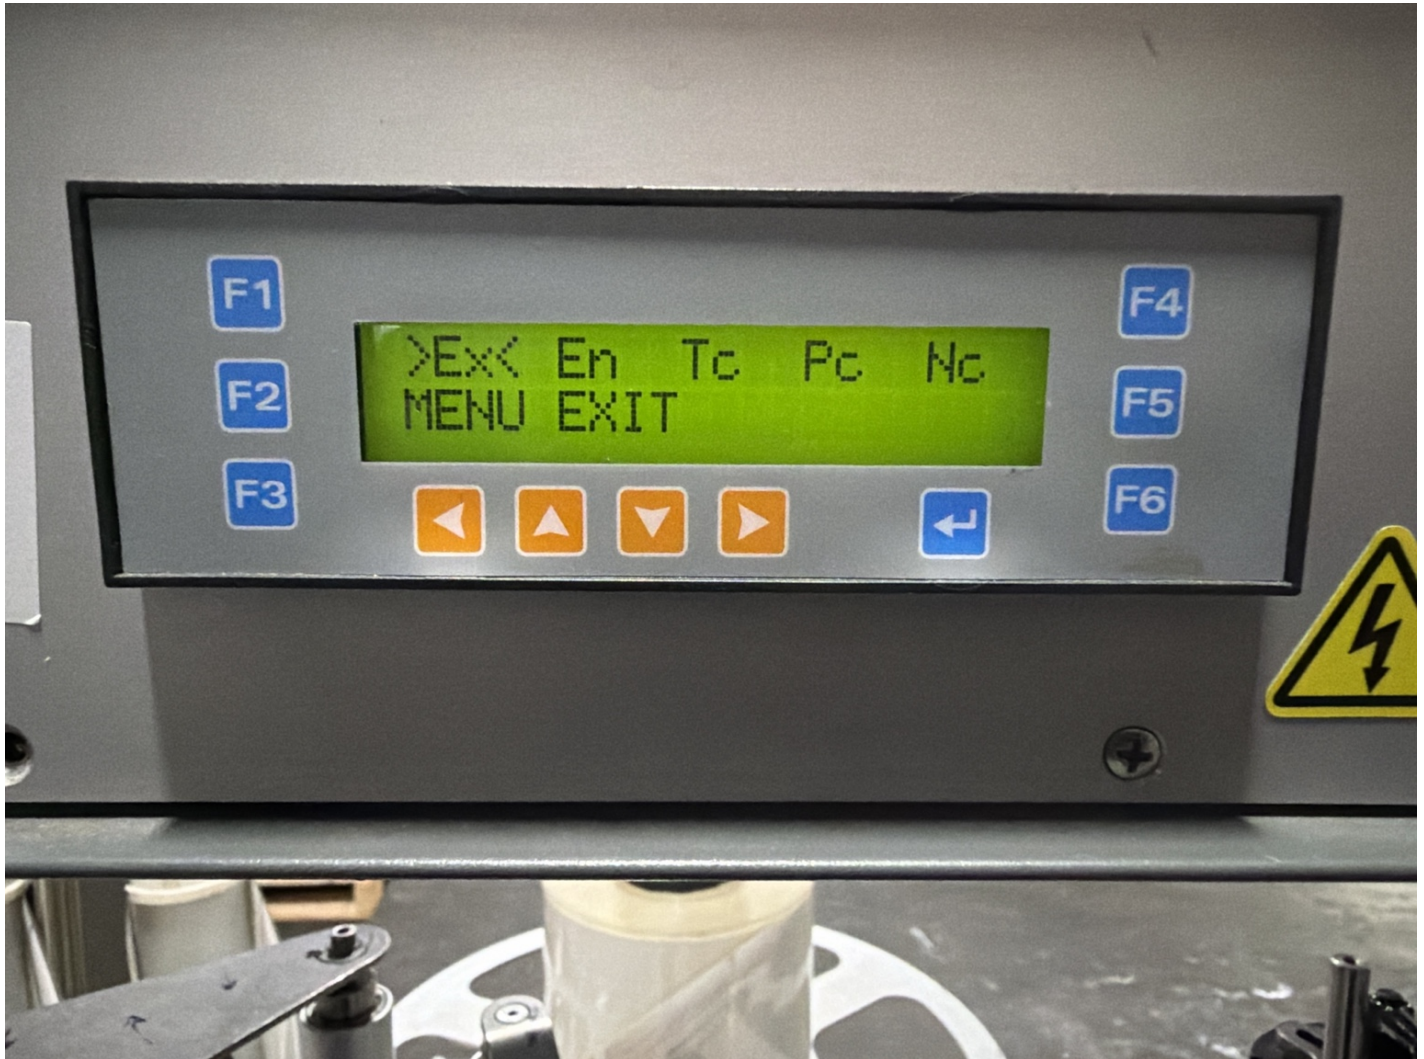
## PHOTO 1 OF 15

Card-data readout menu opened by holding Enter for approximately 3 seconds.

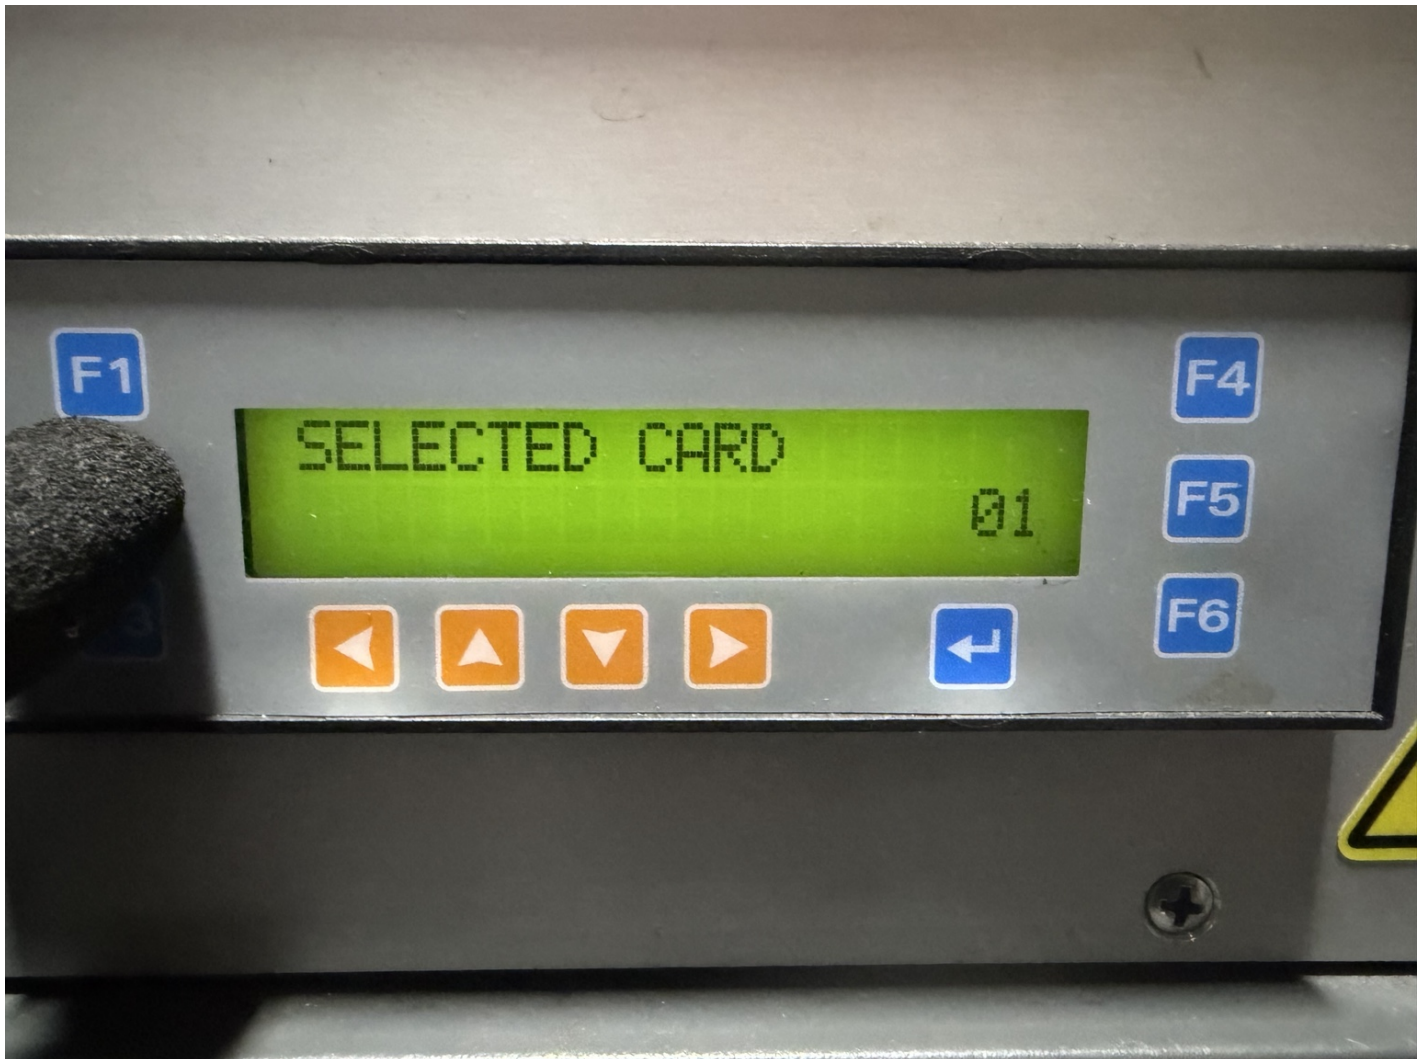
## PHOTO 2 OF 15

- **Address versus physical head:** CARD 01 is confirmed as network address 01. It must not be assumed to be physical platform/head 1 until the DIP-switch address or physical mapping is verified.

Selected electronic-cam network address: CARD 01.

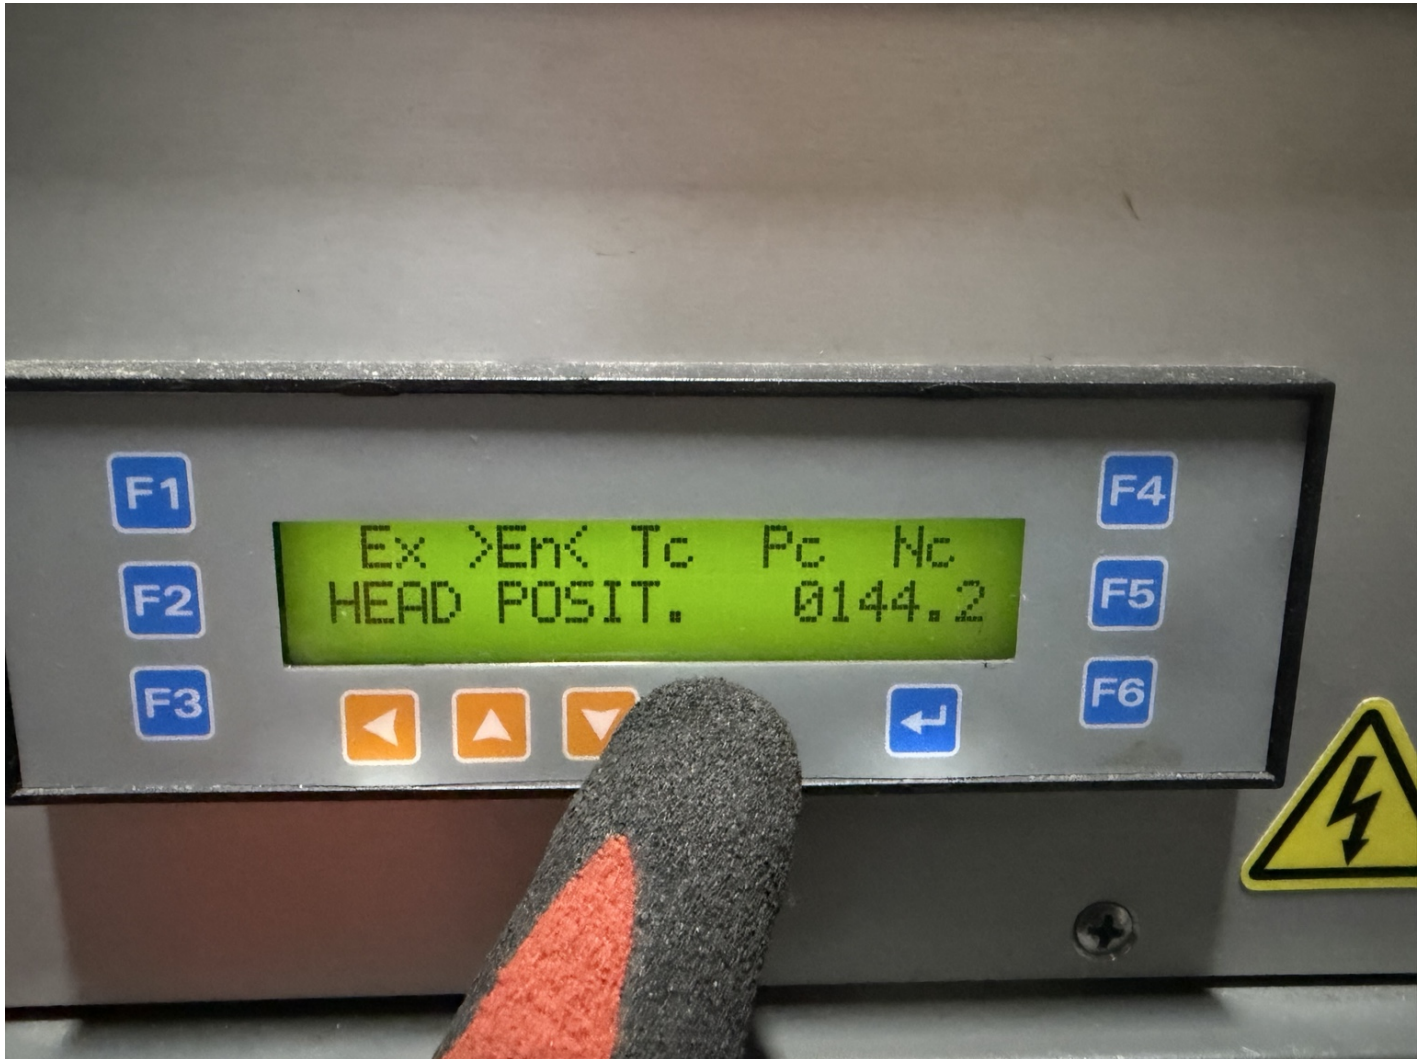
PHOTO 3 OF 15

En - head position: 0144.2 degrees.

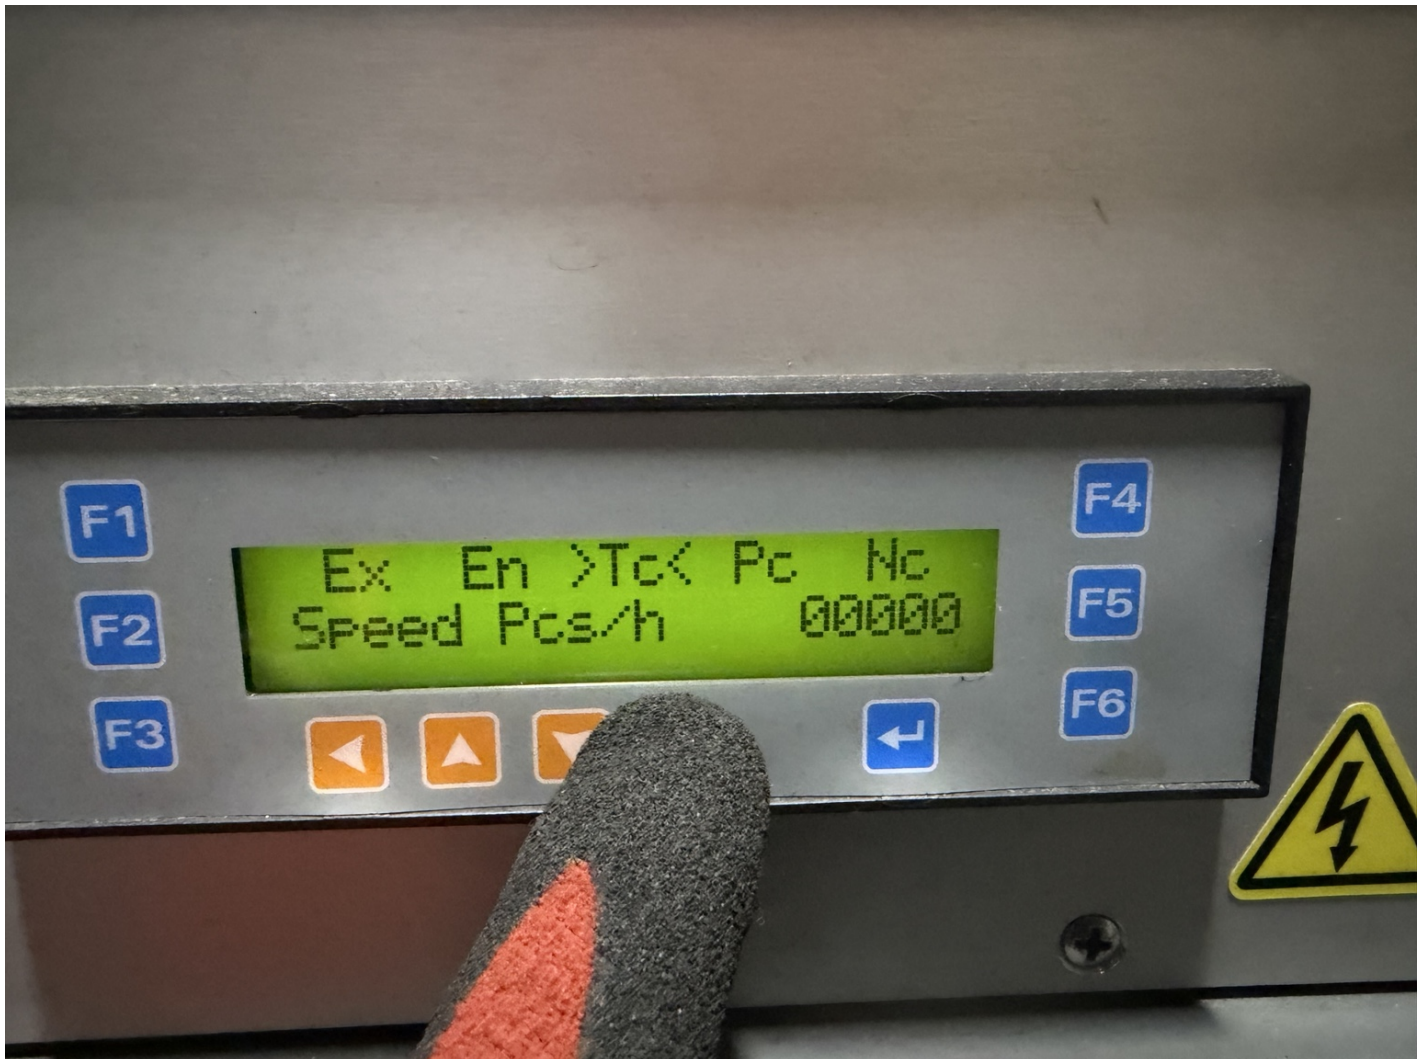
# PHOTO 4 OF 15

Tc - speed/output: 00000 pieces per hour.

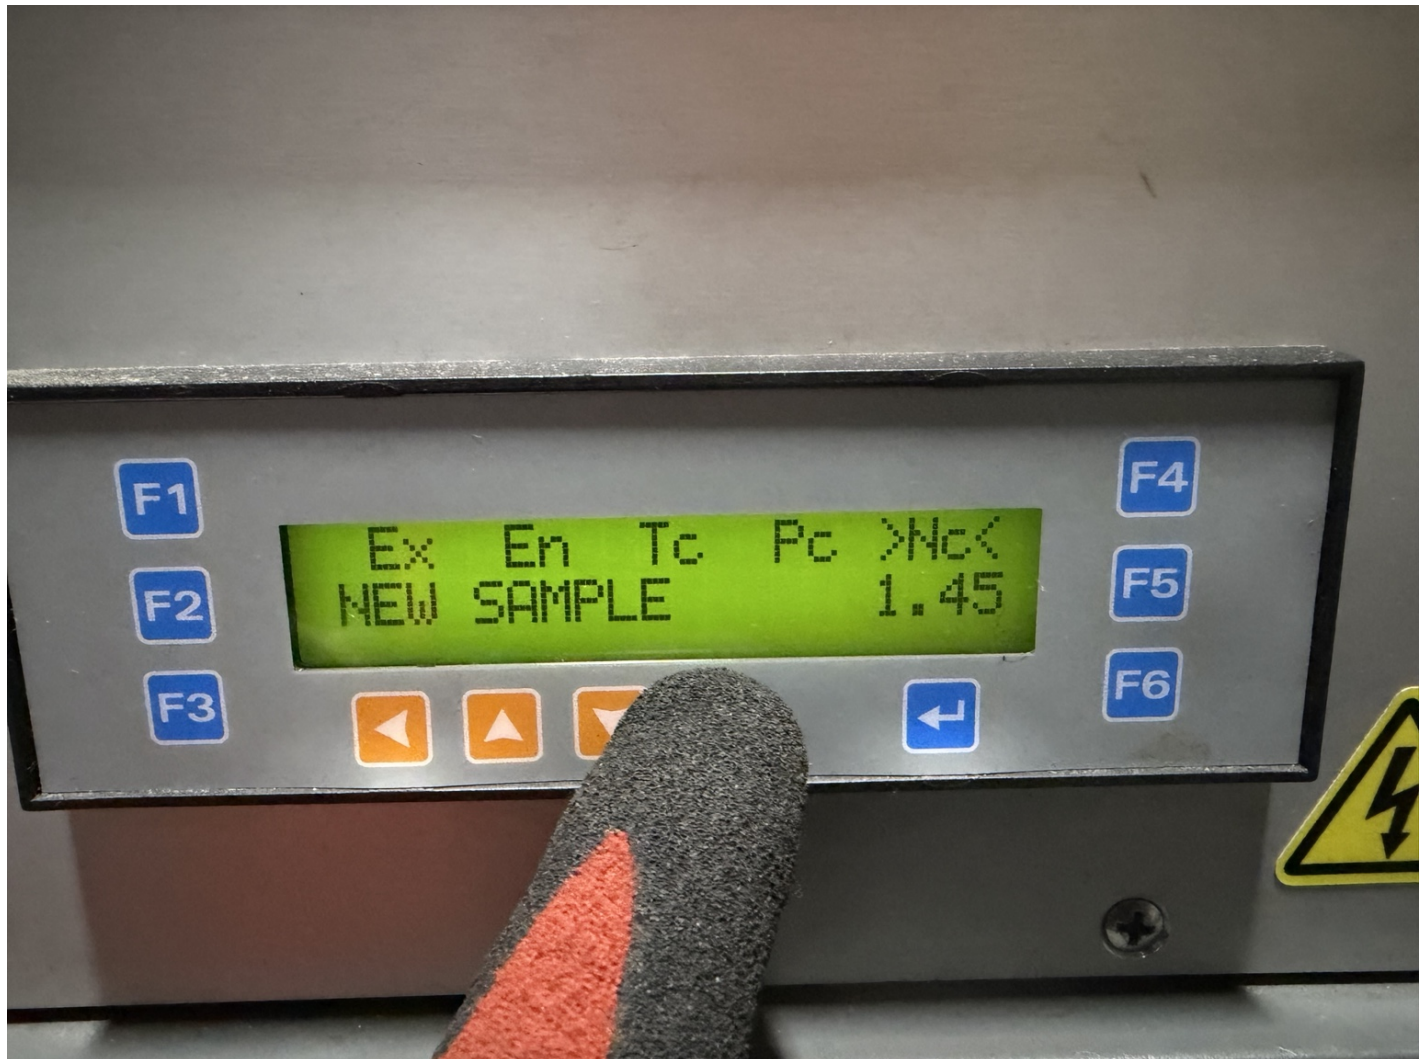
## PHOTO 6 OF 15

- **Sensor/input behavior:** Nc=1.45 and Sx=01 are snapshots. Their diagnostic meaning depends on whether they change with the associated photocell and input states.

Nc - new analog sample: 1.45.

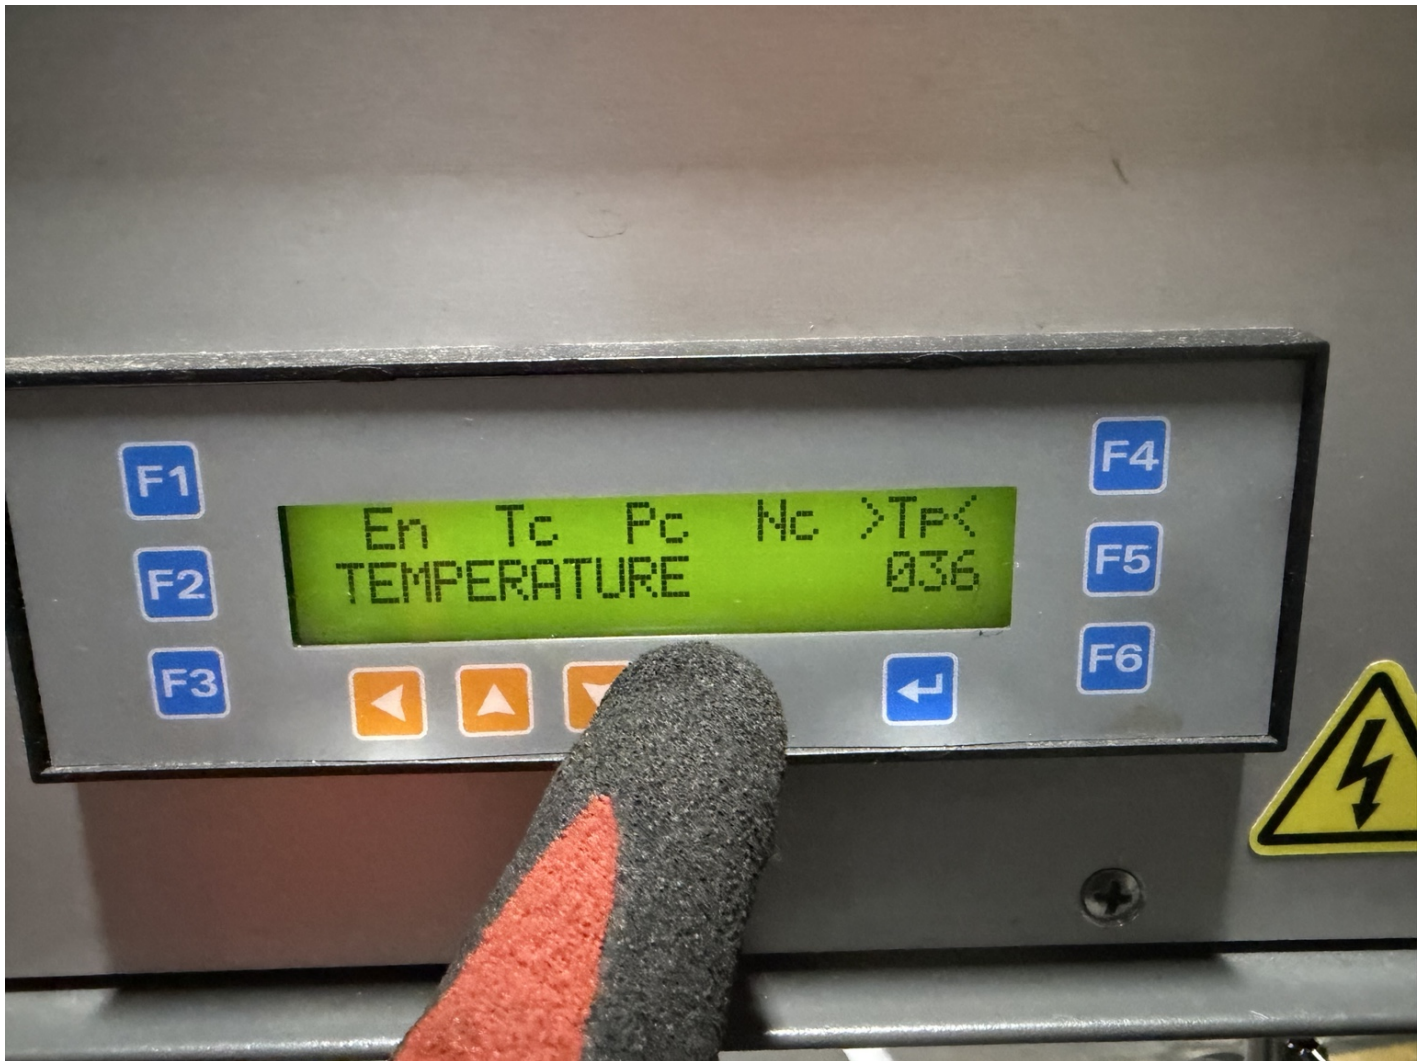
PHOTO 7 OF 15

- **Communication:** Card 01 is online and returning detailed live data to the CR30.
- **Temperature:** 36 C is far below the manual's approximate 85 C high-temperature threshold.

Tp - electronic-cam card temperature: 036 C.

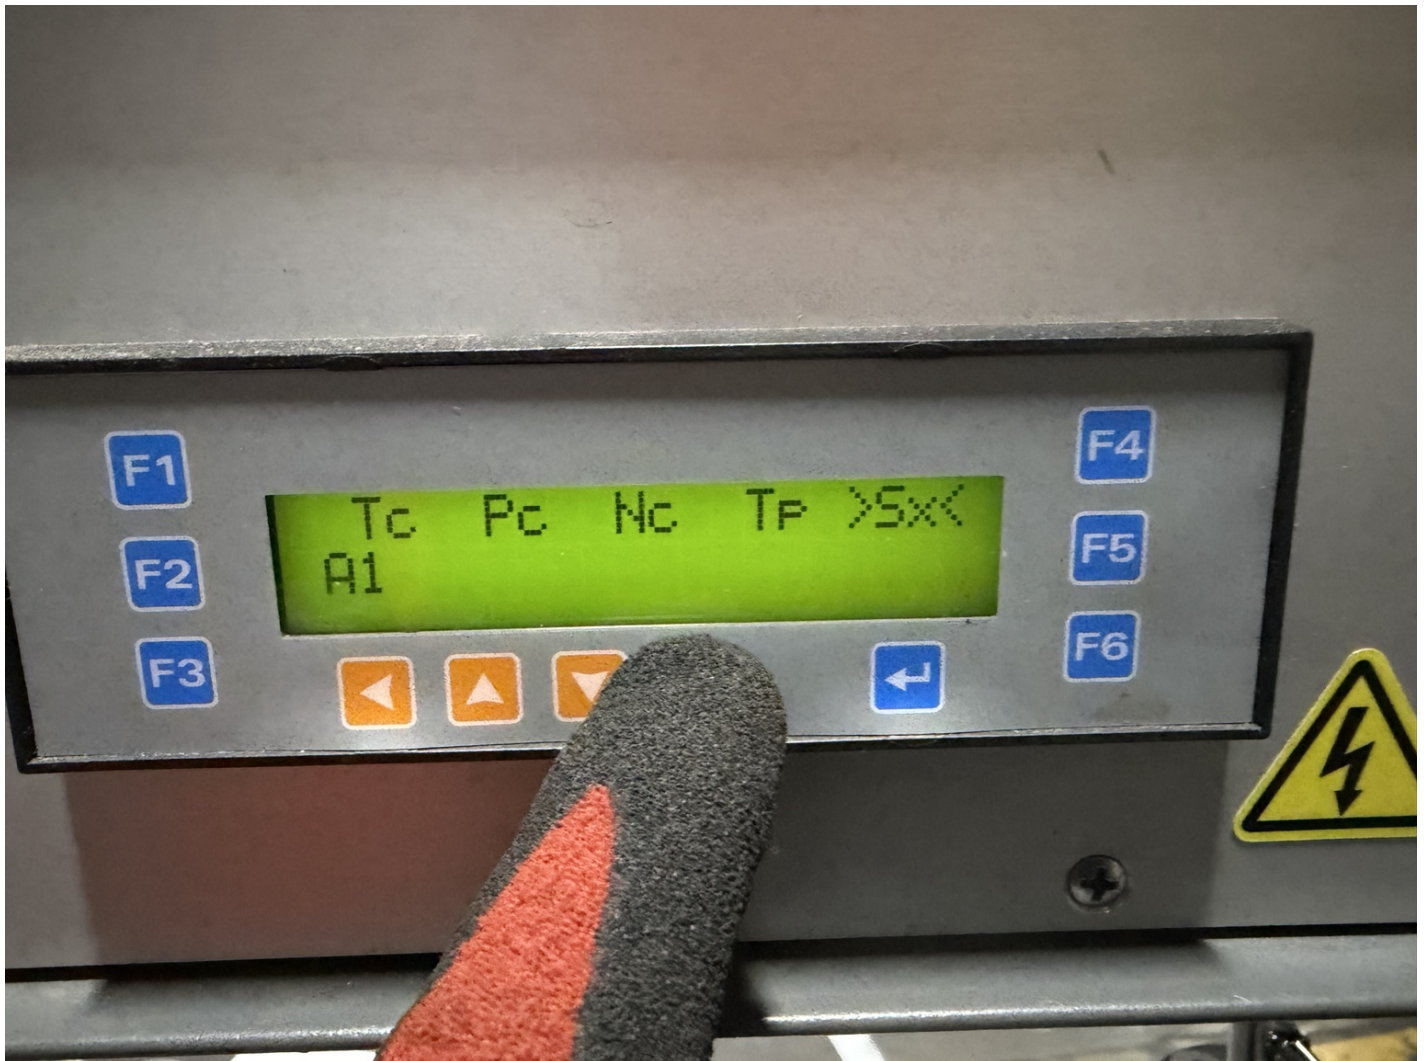
## PHOTO 8 OF 15

Sx - auxiliary/digital-signal status: 01.

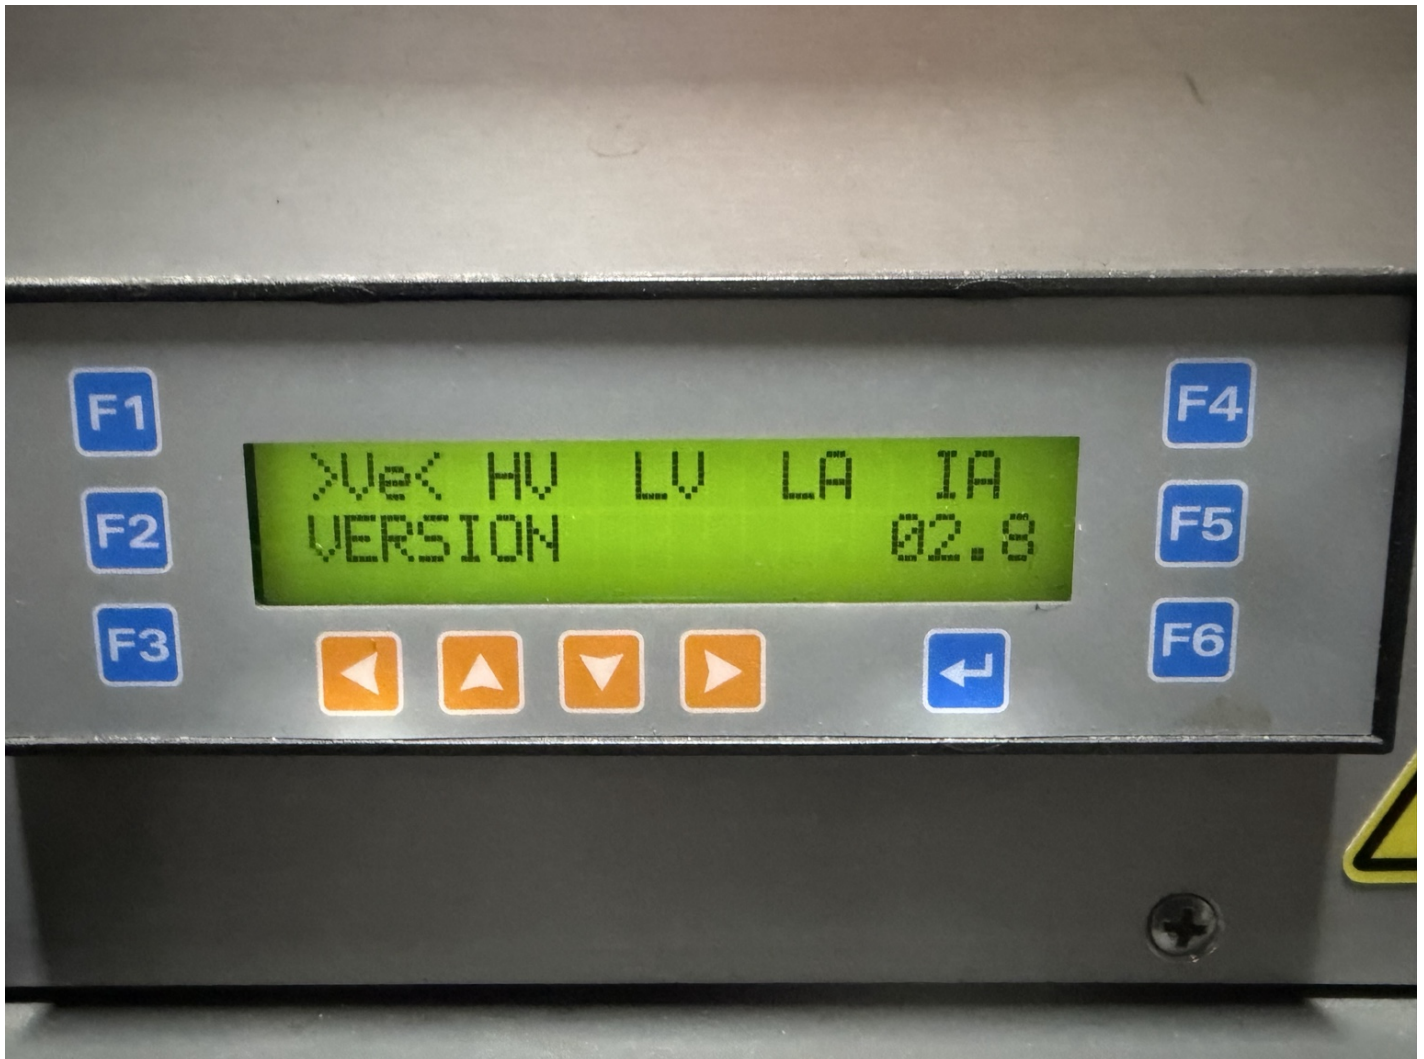
## PHOTO 9 OF 15

Ve - card firmware/version: 02.8.

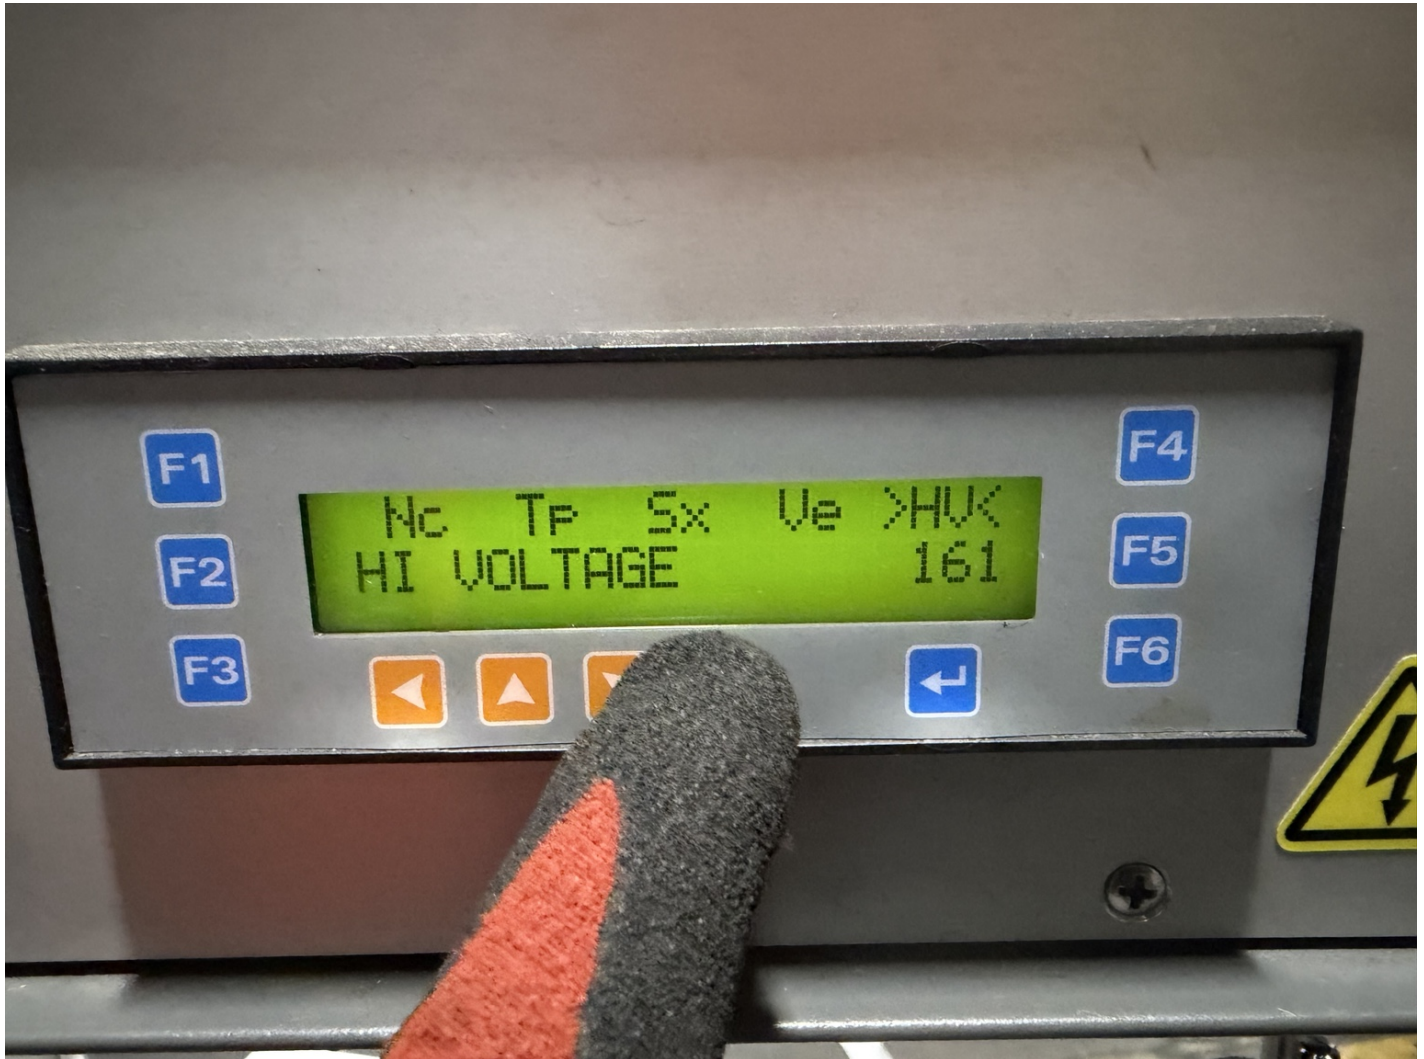
## PHOTO 10 OF 15

HV - high-voltage reading: 161 (display provides no unit).

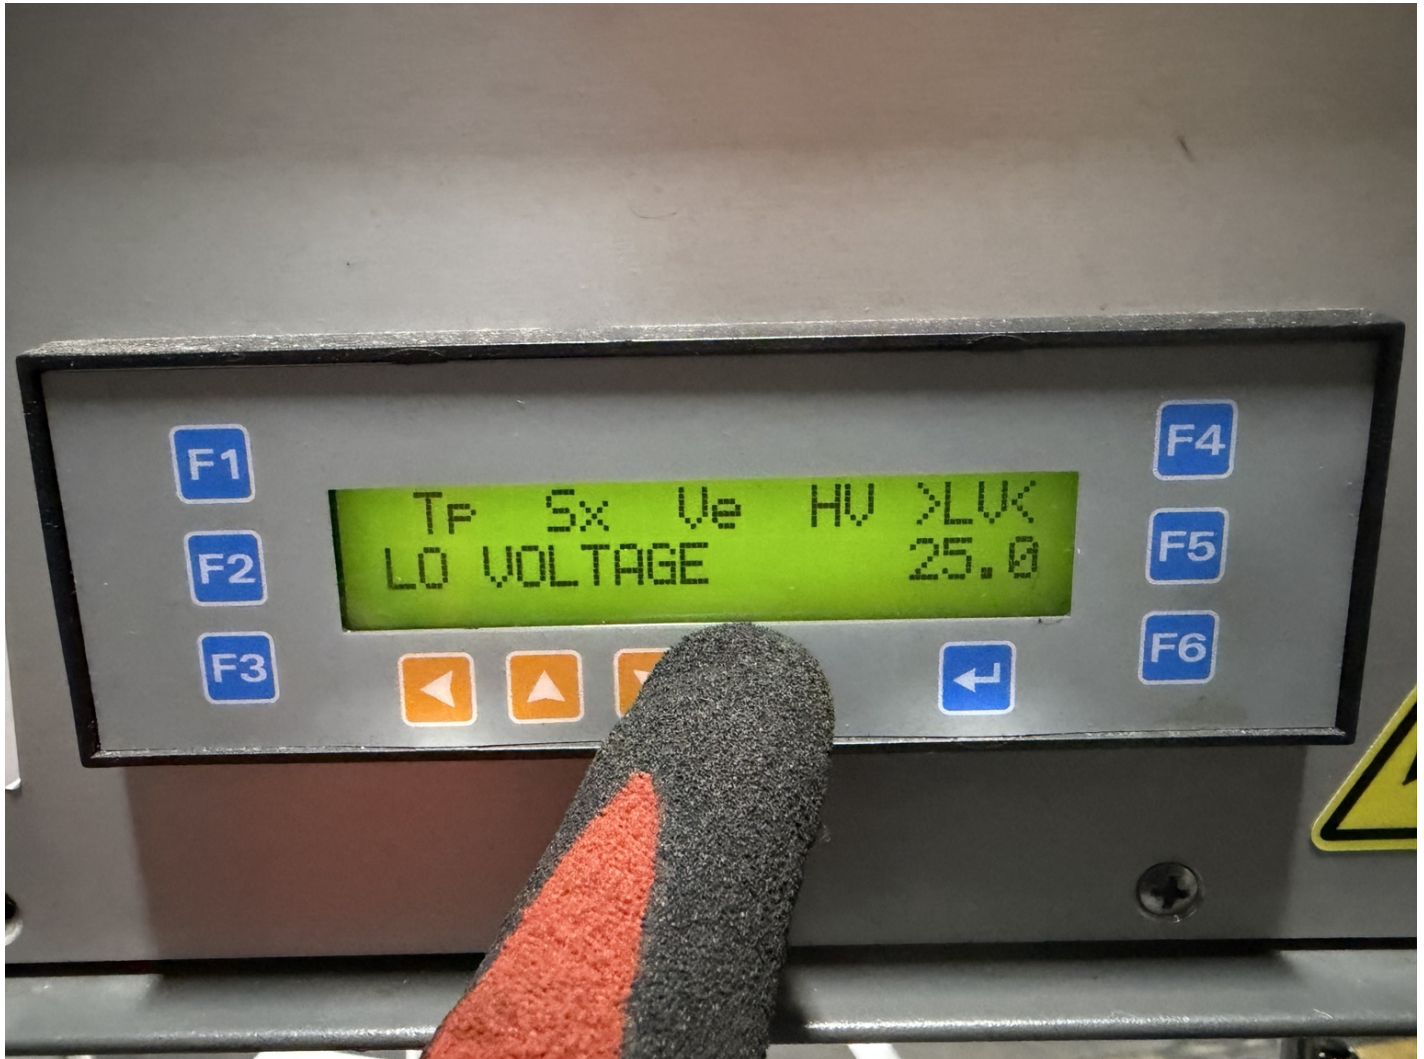
PHOTO 11 OF 15

LV - low-voltage supply: 25.0 V.

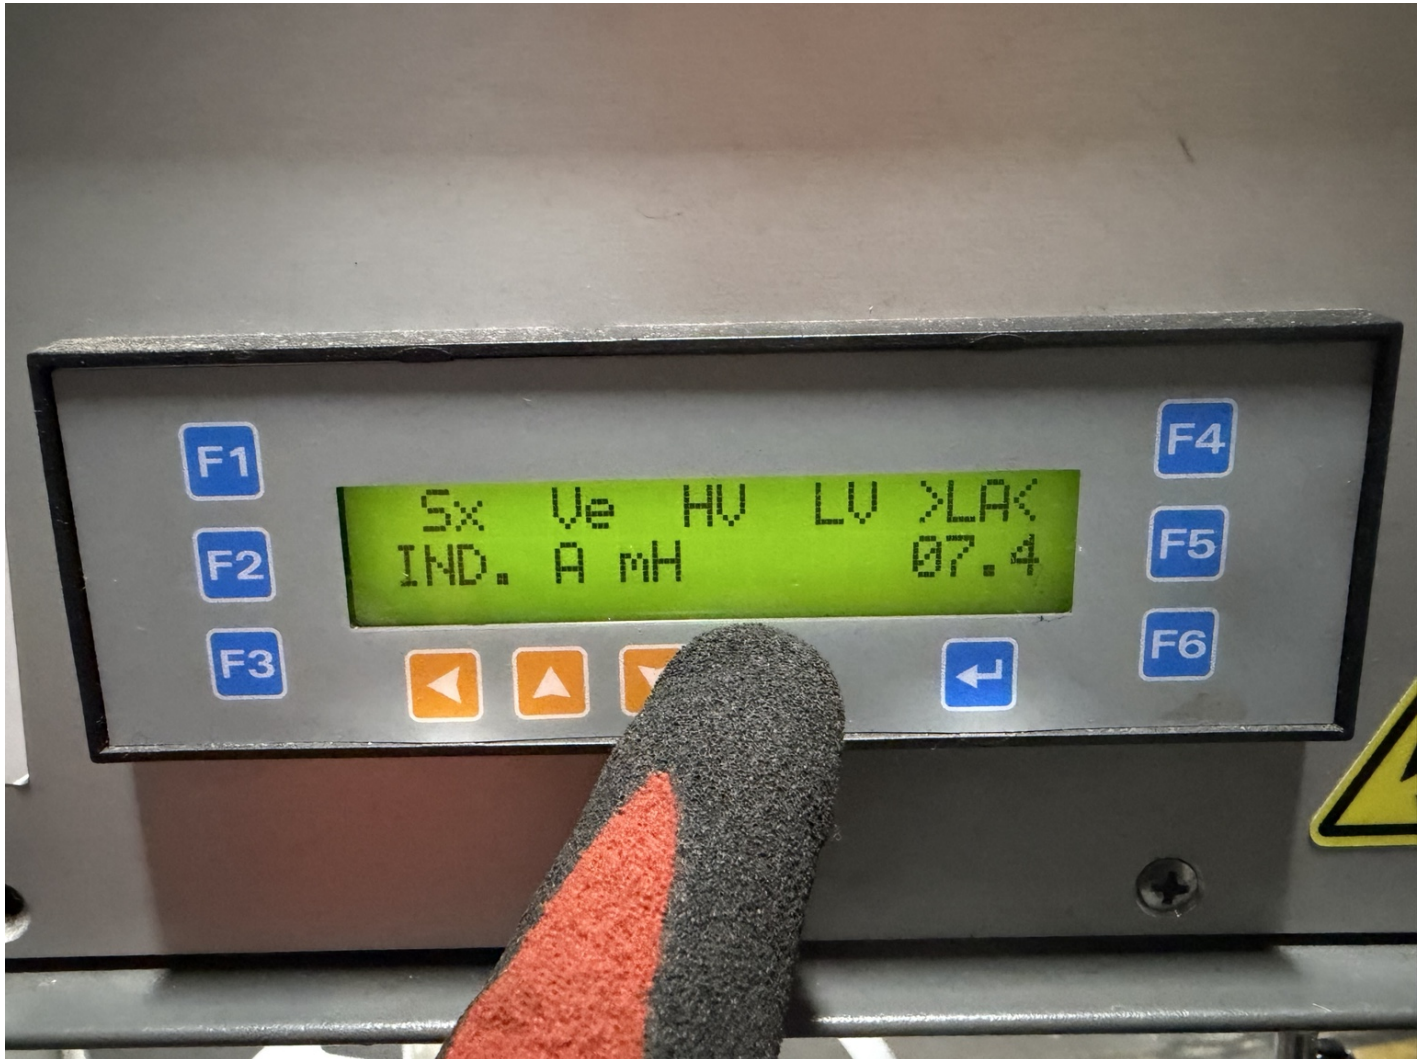
PHOTO 12 OF 15

- **Low-voltage supply:** 25.0 V is consistent with a nominal 24 V control supply.
- **Motor-channel balance:** IA and IB are both 2.8 A. LA is 7.4 mH and LB is 7.0 mH; the two channels are close, with no obvious missing phase in this snapshot.

LA - channel A inductance: 07.4 mH.

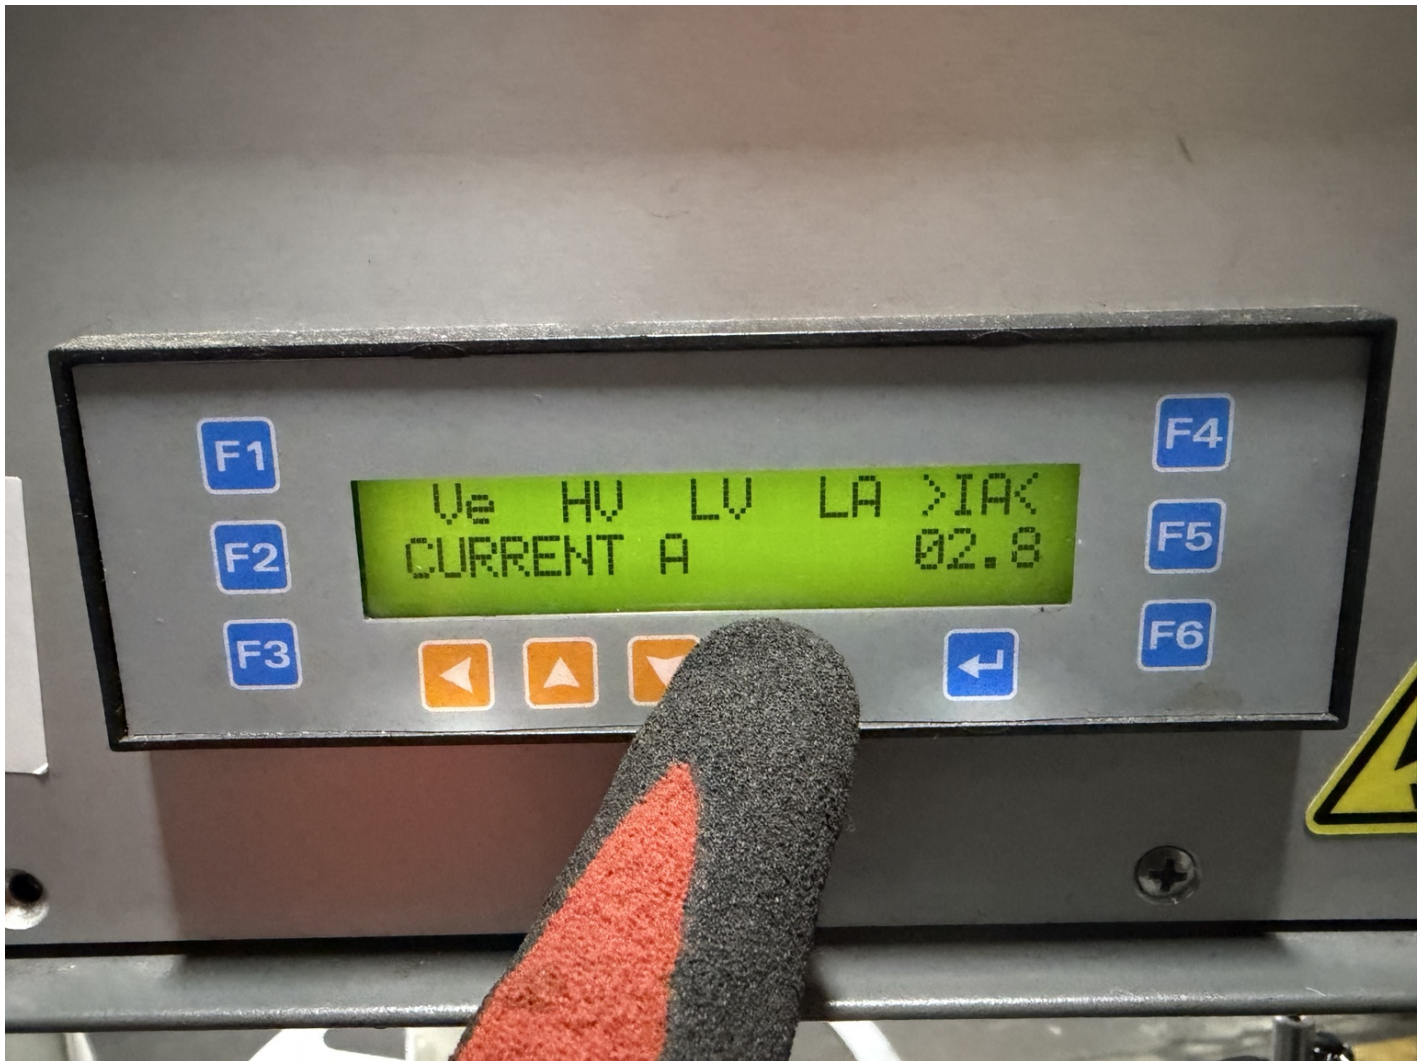
PHOTO 13 OF 15

IA - channel A current: 02.8 A.

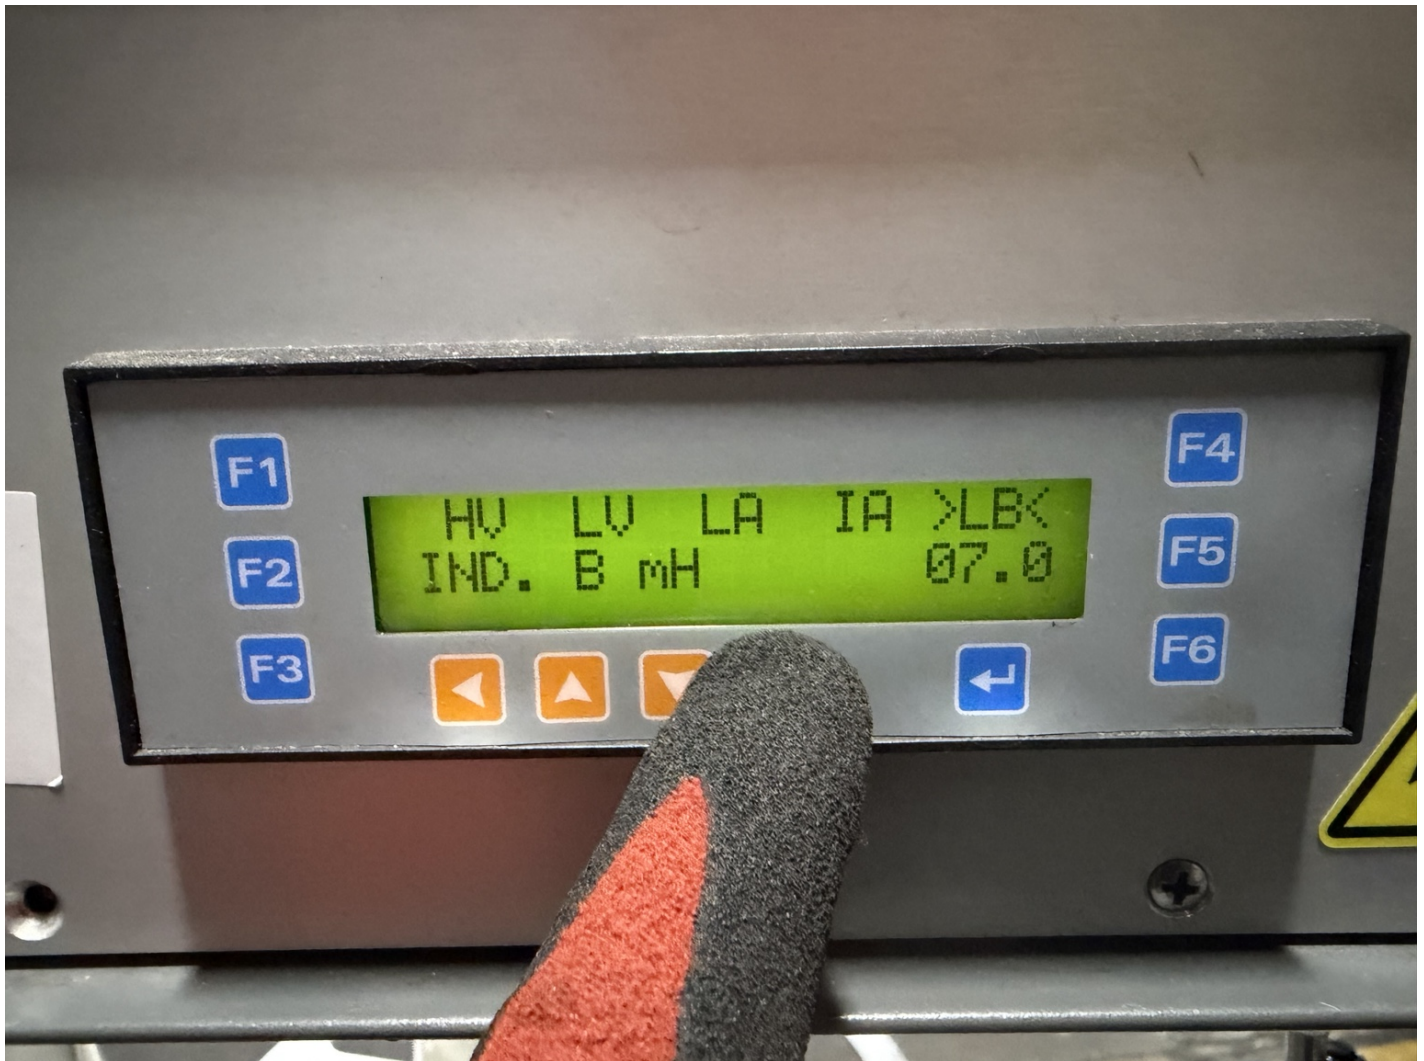
PHOTO 14 OF 15

LB - channel B inductance: 07.0 mH.

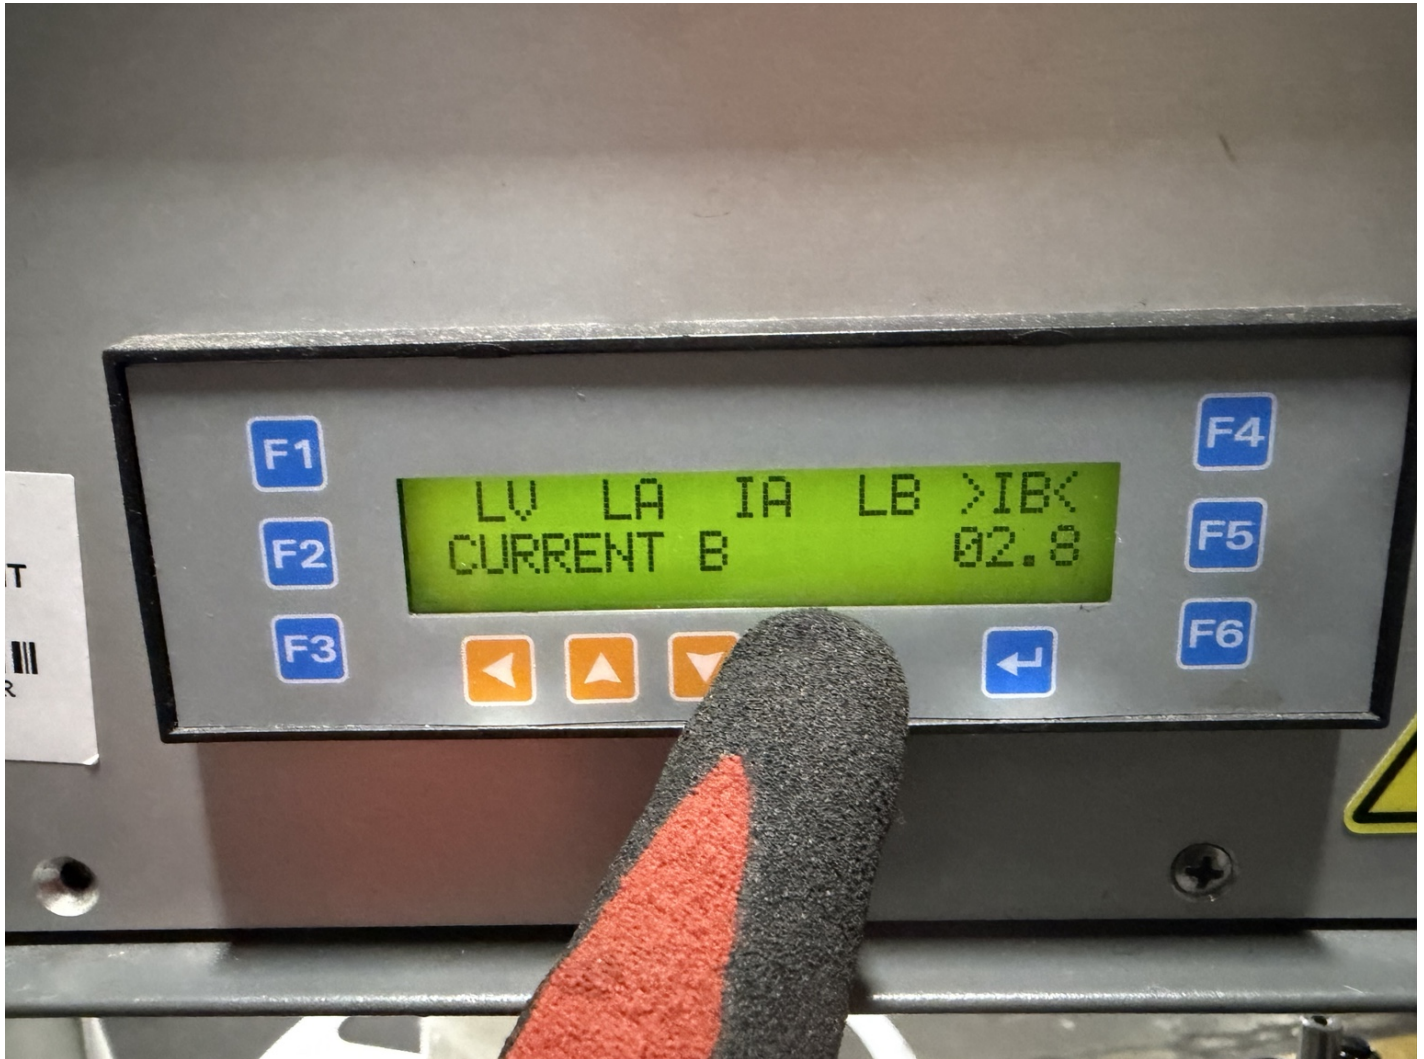
PHOTO 15 OF 15

IB - channel B current: 02.8 A.
