CJ Resotation

Insured: Gene McDaniel
Property: 7415 S Ukraine St
Aurora, CO 80016

Claim Number: [REDACTED] **Policy Number:** [REDACTED] **Type of Loss:** Hail, Wind and Water

MCDANIEL_6314

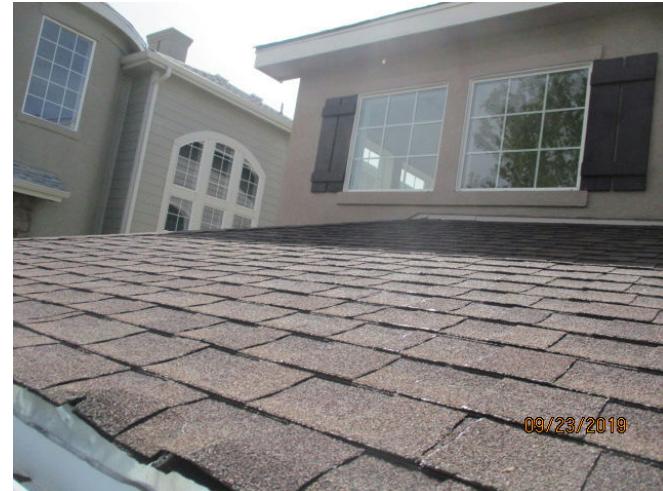
DESCRIPTION	QTY	RESET	REMOVE	REPLACE	*TOTAL
1. Remove Laminated - comp. shingle rfg. - w/out felt	32.06 SQ		52.18	0.00	1,672.89
The current shingle on roof is a laminated dimensional shingle and not a 3 tab a prescribed in the State Farm Original Scope

Image No.	Type	Date Taken	Taken By
65	65-IMG_0837	9/23/2019	
66	66-IMG_0838 in scope it says 3 tab but is a dimensional shingle	9/23/2019	
67	67-IMG_0839 step flashing will get damaged during tear off	9/23/2019	
68	68-IMG_0840	9/23/2019	
69	69-IMG_0841	9/23/2019	
70	70-IMG_0842	9/23/2019	
71	71-IMG_0843	9/23/2019	
72	72-IMG_0844	9/23/2019	
73	73-IMG_0845	9/23/2019	
74	74-IMG_0846	9/23/2019	
75	75-IMG_0847	9/23/2019	
76	76-IMG_0848	9/23/2019	
77	77-IMG_0849	9/23/2019

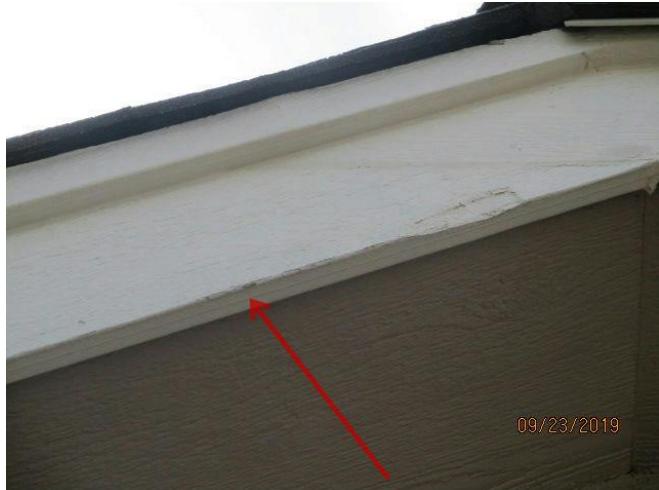
Image No.	Type	Date Taken	Taken By
91	91-IMG_0863	9/23/2019	
92	92-IMG_0864	9/23/2019	
93	93-IMG_0865	9/23/2019	
94	94-IMG_0866	9/23/2019	
95	95-IMG_0867	9/23/2019	
96	96-IMG_0868	9/23/2019	
97	97-IMG_0869	9/23/2019	
98	98-IMG_0870	9/23/2019	
99	99-IMG_0871	9/23/2019	
100	100-IMG_0872	9/23/2019	
101	101-IMG_0873 fasica that is damaged on the left elevation	9/23/2019
