# Appendix — Recommendations for Replication of the OpenRiverCam Station Design

Indonesia ORC Deployment — Spring 2026

PMI · IPB · BHLK · American Red Cross

Version 2026-08-31 (draft for internal review — not yet circulated) | Audience: IPB and BHLK — technical staff | Built 2026-08-31

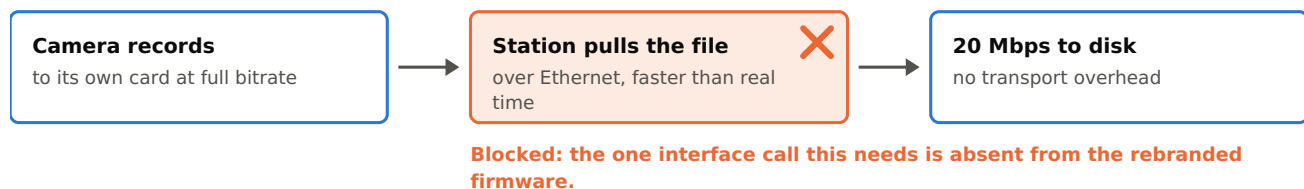
### Figure A1 The capture path: intended against implemented

Step 5 is the blocker. On genuine Hikvision firmware the endpoint returns the recorded file over HTTP at wire speed. **ANNKE's firmware exposes it for still images only**; recorded video files are not downloadable over HTTP ContentMgmt.

The limitation is in the firmware, not in the optics or the sensor.

The intended path had the camera record to its own card and the station pull the finished file over Ethernet. The one interface call that needs is absent from the rebranded firmware, so the path is blocked and capture falls back to a live stream that pays 10-20% transport overhead.
