# **Appendix — Recommendations for Replication of the OpenRiverCam Station Design**

Indonesia ORC Deployment — Spring 2026

American Red Cross / Palang Merah Indonesia

Version 2026-08-31 (draft for internal review — not yet circulated) | Audience: IPB and BHLK — technical staff | Built 2026-08-31

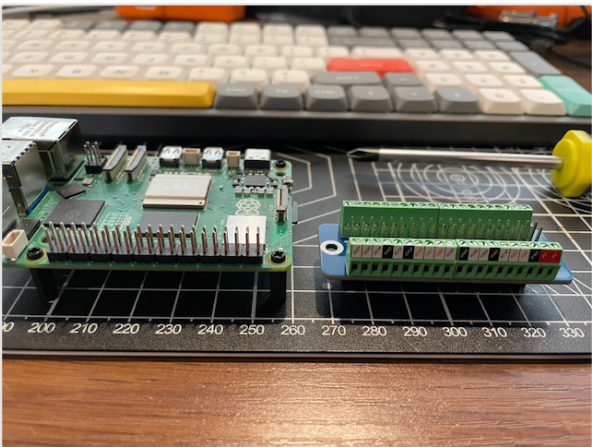
The compute board and the GPIO screw-terminal riser it stacks onto. Every signal leaves as a screw terminal, which is what lets a non-specialist rewire the station with a screwdriver — and what makes the scheduling board a swap rather than a rebuild. This is the assembly R8 would move indoors and R10 would simplify.
