NETCARE CONSTANTIA DAY CLINIC

# Solar Thermography Pro

Report

Generated for  
Kleanup Solar

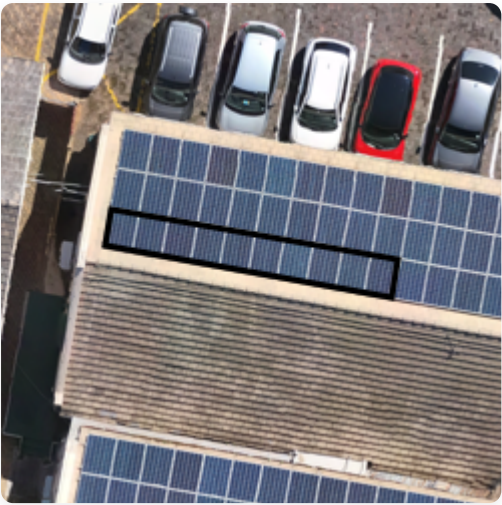
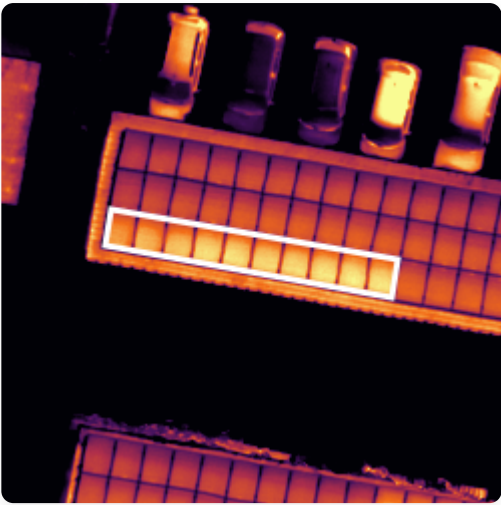
#1

| ID | Type | Cause | Delta Temp | Severity |
|---|---|---|---|---|
| 1 | String (open circuit) | Unknown | 4.6 °C | Critical |

| Status | To Do | Anomaly Type | String (open circuit) |
| Affected Modules | 10 | Anomaly Cause | Unknown |
| Severity | Critical | Estimated Loss | 100 % |
| Delta Temperature | 4.6 °C | Max Temperature | 61.3 °C |
| Mean Temperature | 56.8 °C | Min Temperature | 39.9 °C |

| Detection History | Unknown | Remedial Action | Field Check |

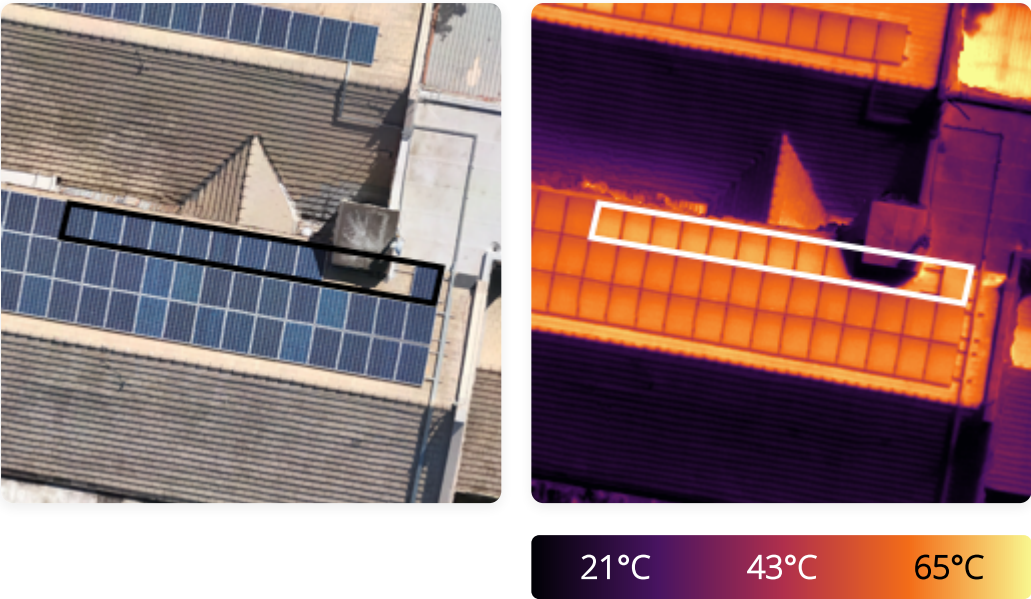
#2

| ID | Type | Cause | Delta Temp | Severity |
|---|---|---|---|---|
| 2 | String (open circuit) | Shadowing | 14.8 °C | Critical |

| Status | To Do | Anomaly Type | String (open circuit) |
| Affected Modules | 10 | Anomaly Cause | Shadowing |
| Severity | Critical | Estimated Loss | 100 % |
| Delta Temperature | 14.8 °C | Max Temperature | 65.2 °C |
| Mean Temperature | 50.5 °C | Min Temperature | 21.2 °C |

| Detection History | Unknown | Remedial Action | Move |

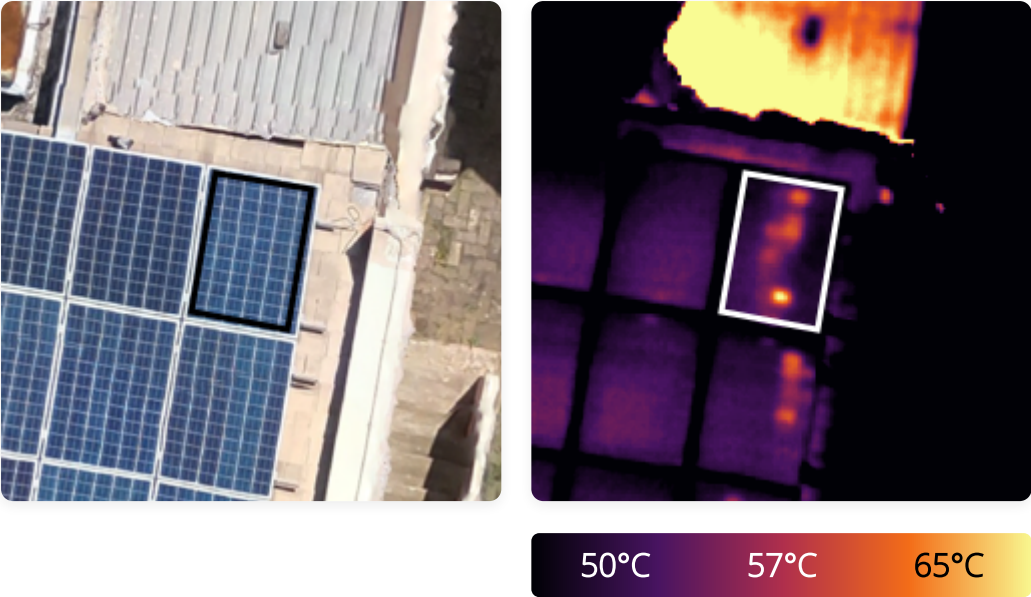
#3

| ID | Type | Cause | Delta Temp | Severity |
|---|---|---|---|---|
| 3 | Multi hotspot | Physical internal | 13.3 °C | Critical |

| Status | To Do | Anomaly Type | Multi hotspot |
| Anomaly Cause | Physical internal | Severity | Critical |
| Estimated Loss | 32.97 % | Detection History | Unknown |
| Latitude | -26.1479215 ° | Delta Temperature | 13.3 °C |
| Max Temperature | 65.2 °C | Mean Temperature | 51.9 °C |
| Min Temperature | 49.8 °C | | |

| Remedial Action | Field Check | Longitude | 27.9004981 ° |

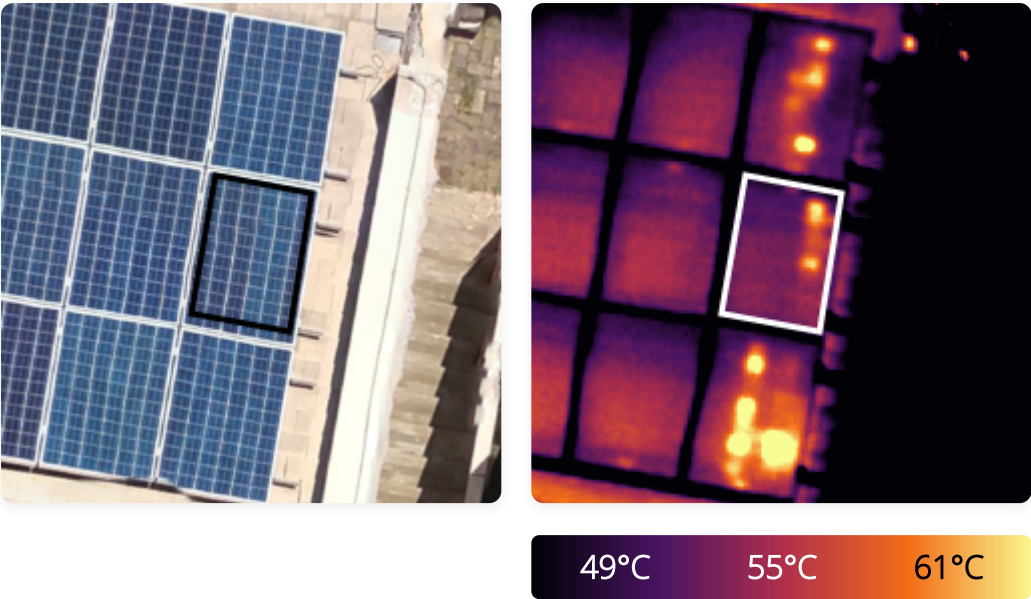
#4

| ID | Type | Cause | Delta Temp | Severity |
|---|---|---|---|---|
| 4 | Multi hotspot | Physical internal | 8.2 °C | Critical |

| Status | To Do | Anomaly Type | Multi hotspot |
| Anomaly Cause | Physical internal | Severity | Critical |
| Estimated Loss | 25.02 % | Detection History | Unknown |
| Latitude | -26.1479331 ° | Delta Temperature | 8.2 °C |
| Max Temperature | 60.5 °C | Mean Temperature | 52.3 °C |
| Min Temperature | 48.7 °C | | |

| Remedial Action | Field Check | Longitude | 27.9004961 ° |

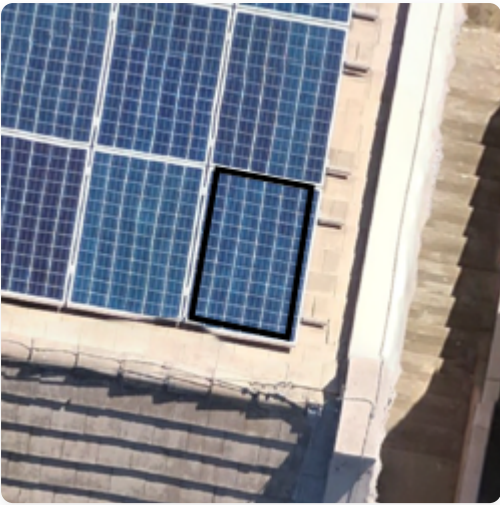
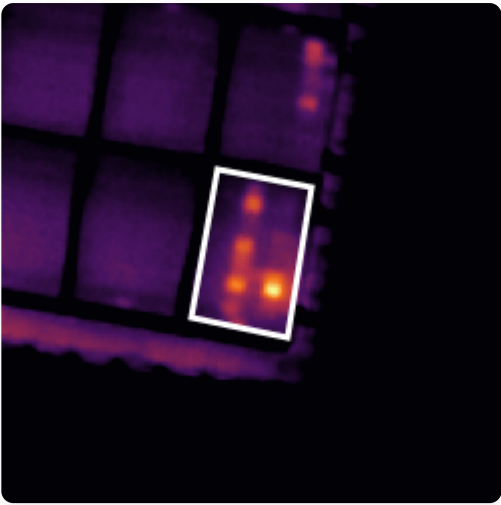
#5

| ID | Type | Cause | Delta Temp | Severity |
|---|---|---|---|---|
| 5 | Multi hotspot | Physical internal | 15.8 °C | Critical |

| Status | To Do | Anomaly Type | Multi hotspot |
| Anomaly Cause | Physical internal | Severity | Critical |
| Estimated Loss | 36.88 % | Detection History | Unknown |
| Latitude | -26.1479452 ° | Delta Temperature | 15.8 °C |
| Max Temperature | 70.1 °C | Mean Temperature | 54.2 °C |
| Min Temperature | 49.9 °C | | |

| Remedial Action | Field Check | Longitude | 27.9004938 ° |

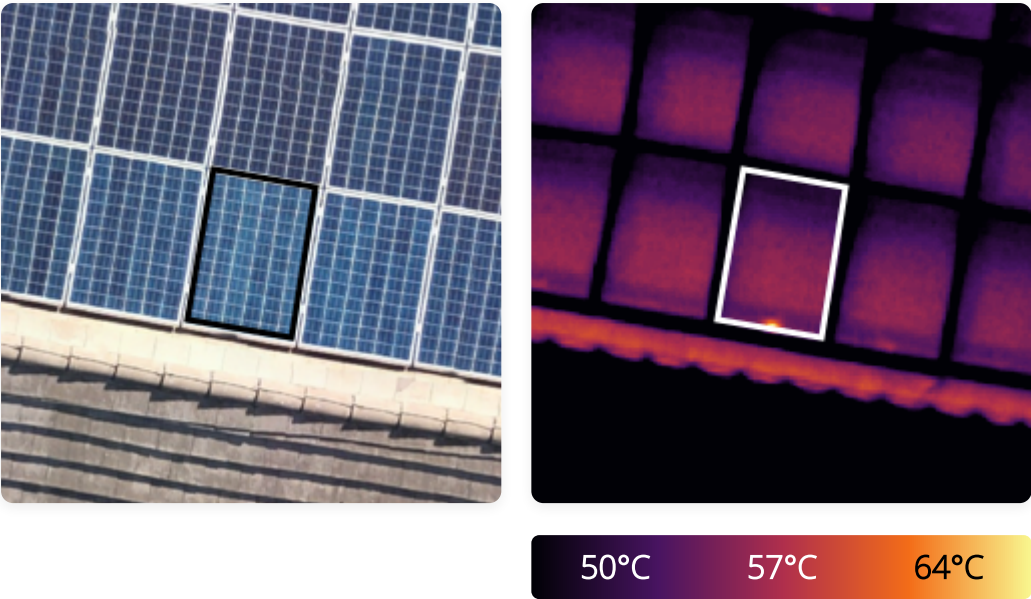
#6

| ID | Type | Cause | Delta Temp | Severity |
|---|---|---|---|---|
| 6 | Heated junction box | Physical internal | 10.1 °C | Mild |

| Status | To Do | Anomaly Type | Heated junction box |
| Anomaly Cause | Physical internal | Severity | Mild |
| Estimated Loss | 10 % | Detection History | Unknown |
| Delta Temperature | 10.1 °C | Max Temperature | 64.2 °C |
| Mean Temperature | 54 °C | Min Temperature | 49.5 °C |

| Remedial Action | Monitor | Estimated Remedial Cost | 0 EUR |
