# Detailed Diagnostic Report

## 1. Property Issue Summary

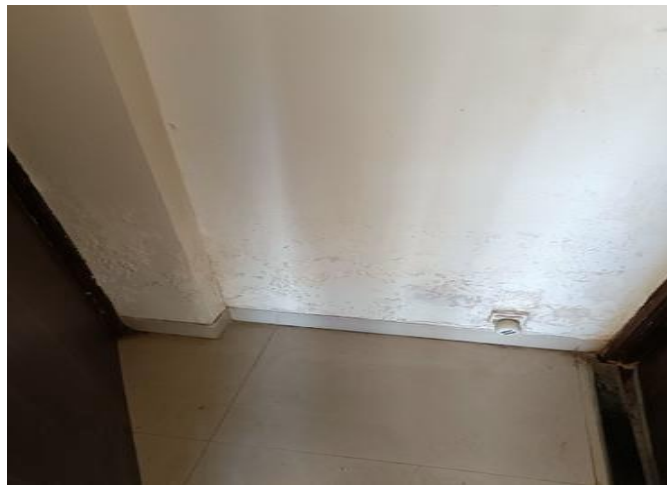
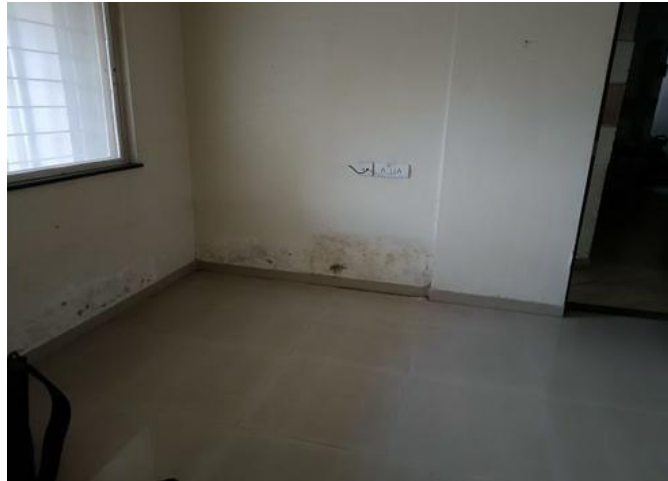
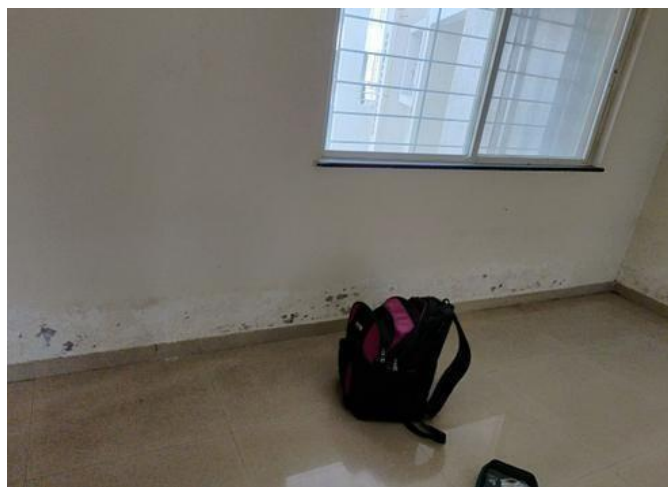
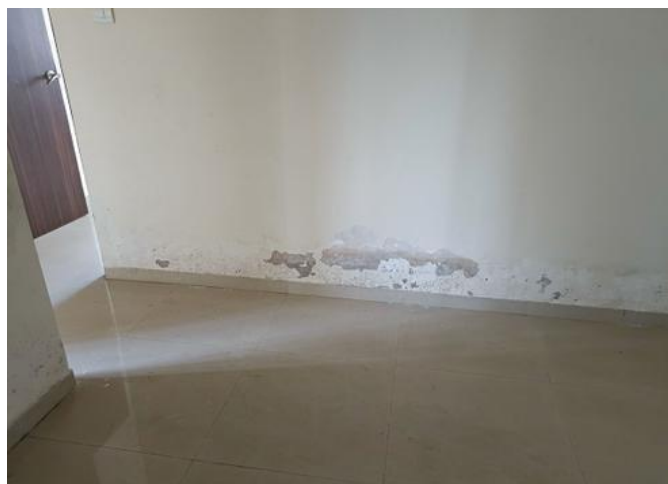
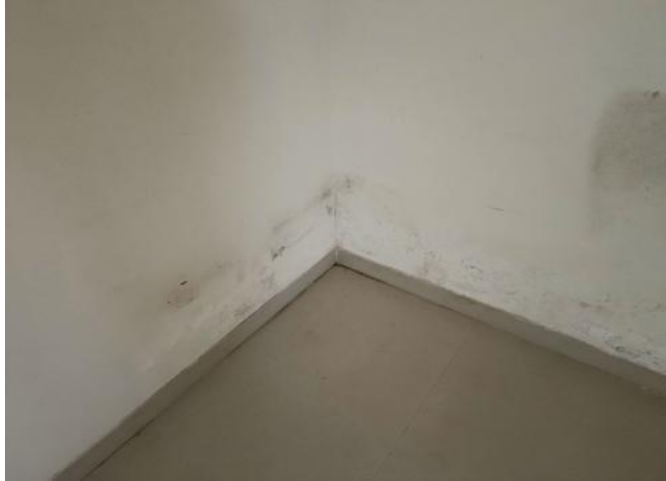
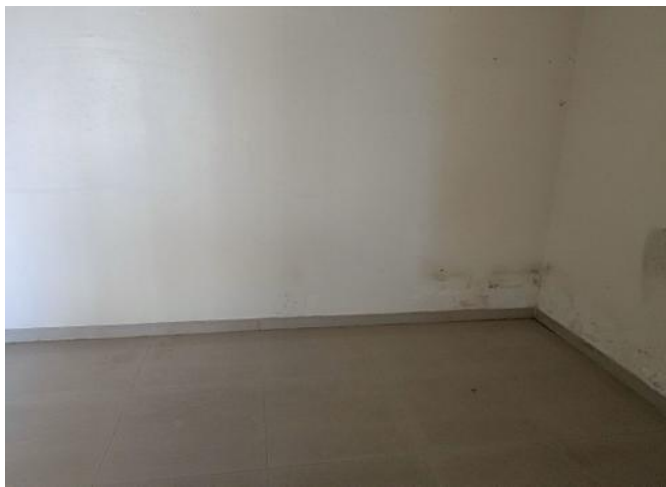
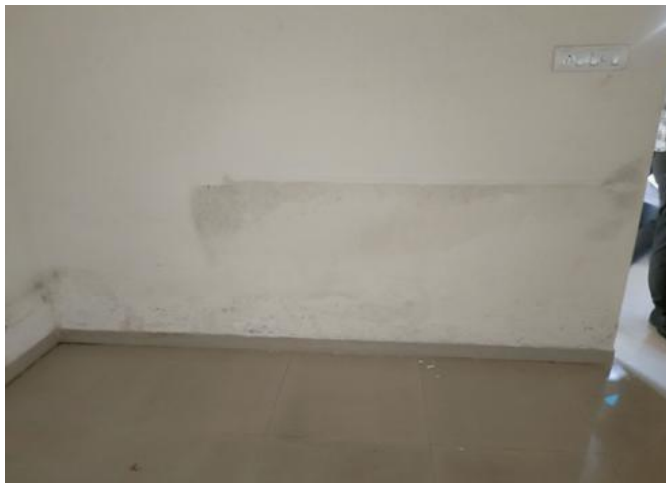
**Observation:** Dampness observed at the skirting level of the Hall.

**Severity:** Moderate — Skirting level dampness observed, aligning with general 'Condition of leakage at adjacent walls' noted as Moderate in the checklist.

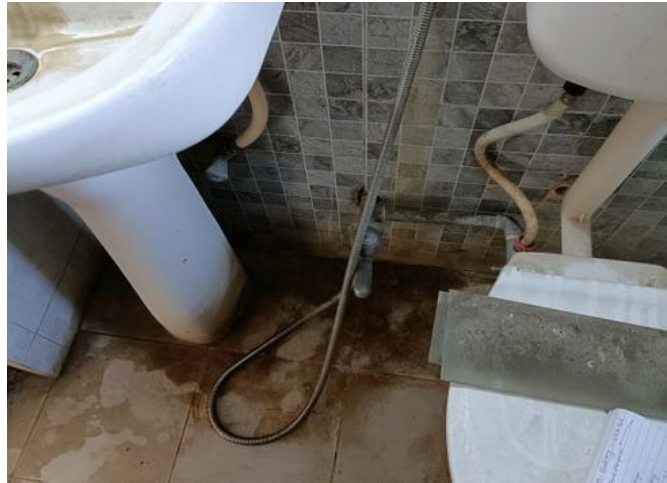
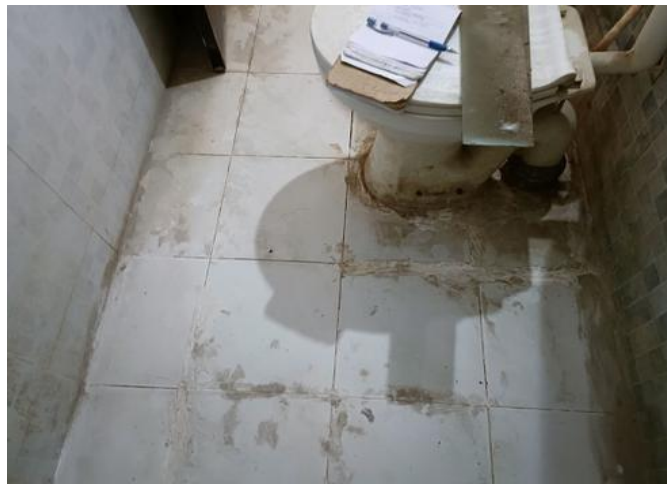
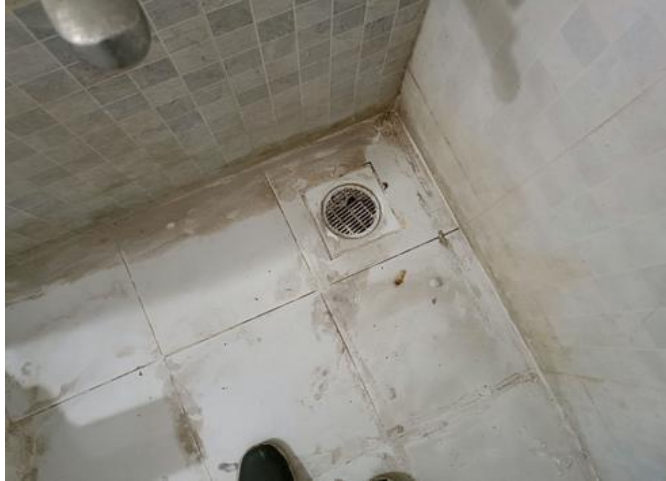
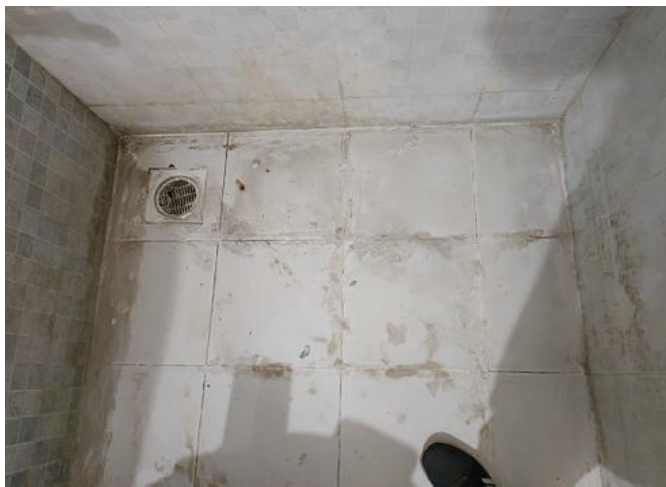
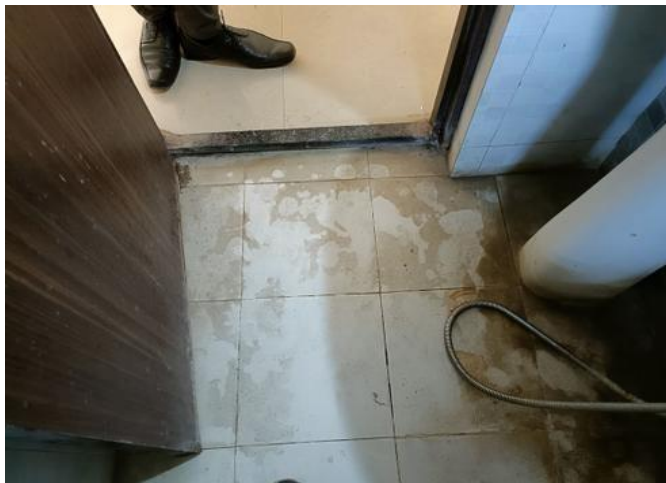
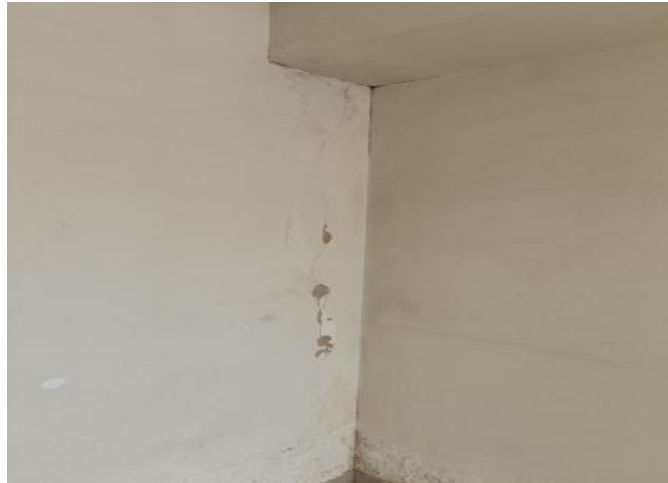
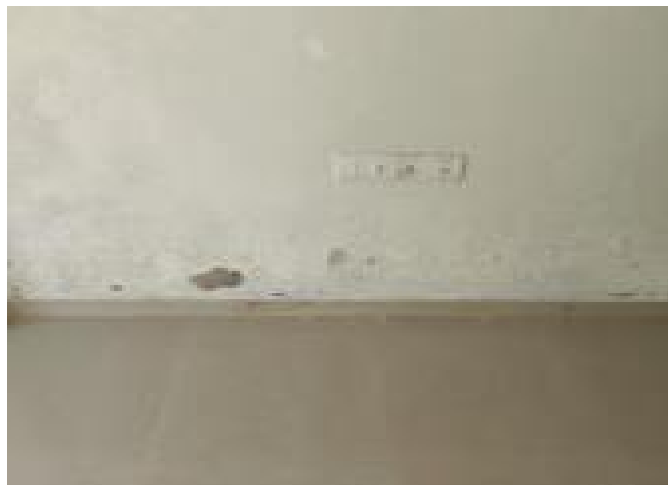
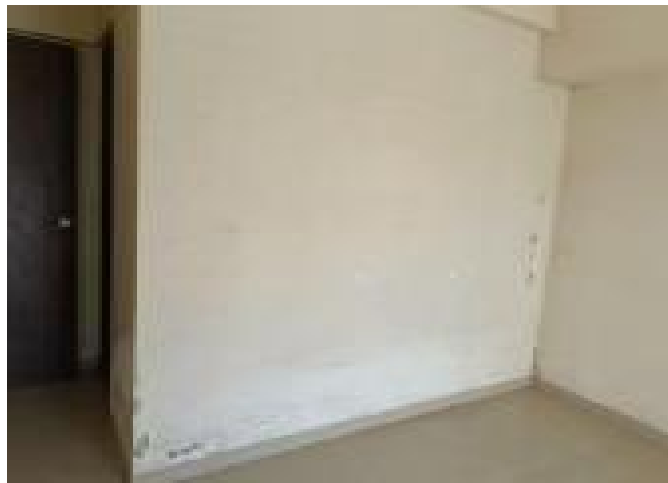
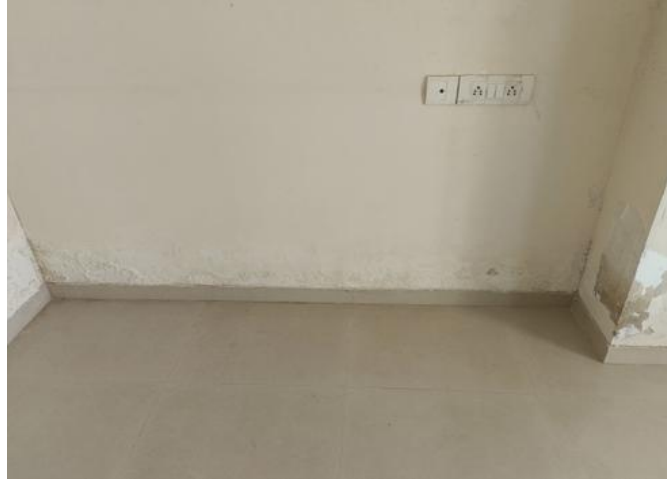
**Observation:** Observed gaps between the tile joints, tile hollowness, and plumbing issues in the Common Bathroom.

**Probable Root Cause:** Leakage due to concealed plumbing, leakage due to damage in Nahani trap/Brickbat coba under tile flooring, gaps/blackish dirt observed in tile joints, gaps around Nahani Trap Joints, and loose plumbing joints/rust around joints and edges.

**Severity:** Moderate — Gaps in tile joints, tile hollowness, and plumbing issues observed, which are noted as causes for 'leakage at adjacent walls' and general WC leakage conditions flagged as Moderate.

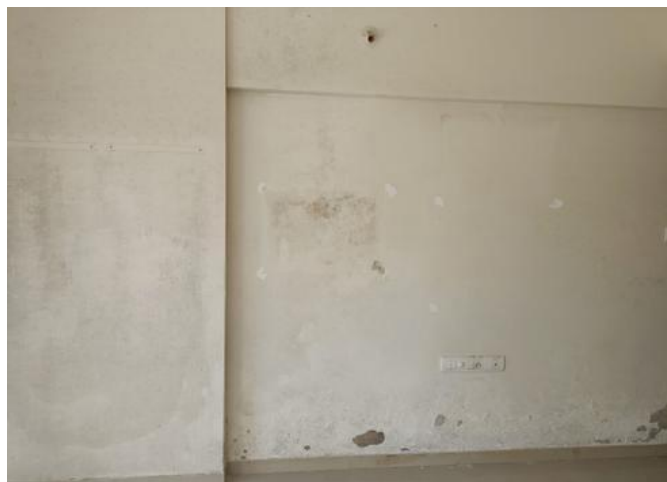
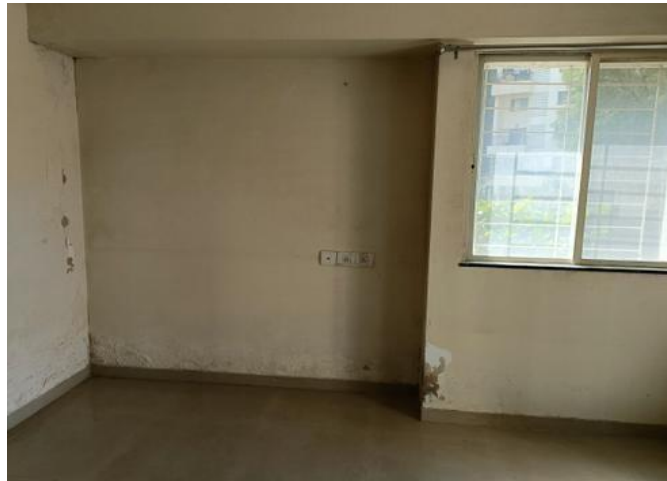
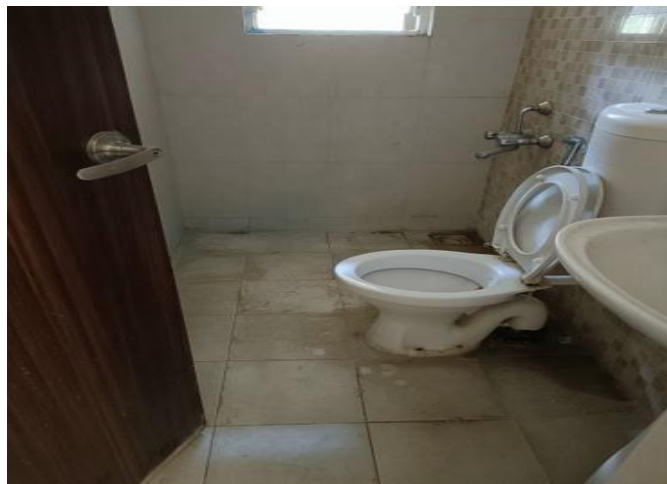
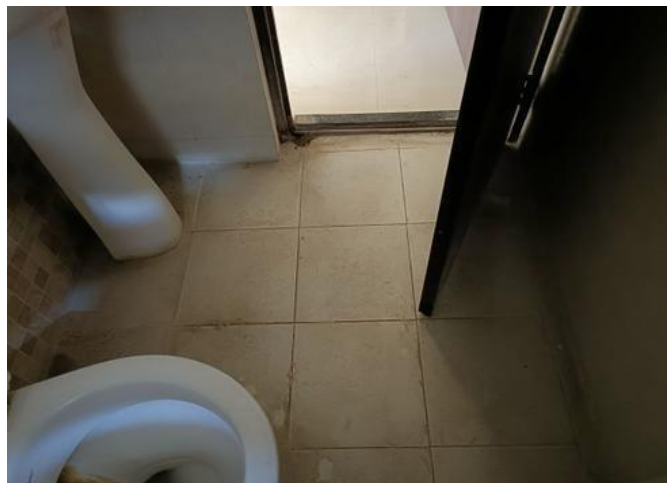
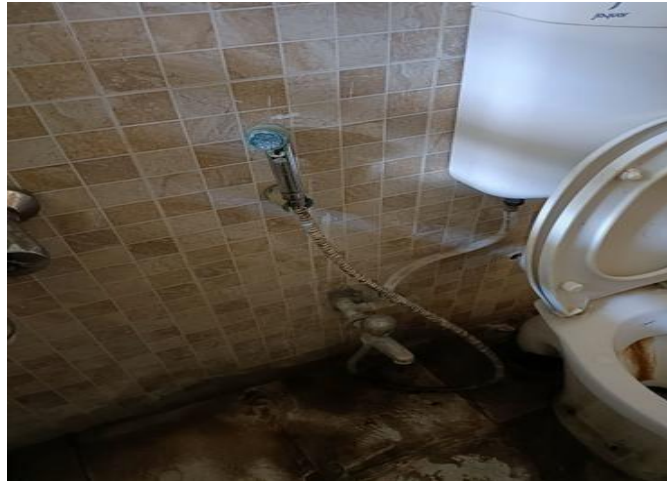
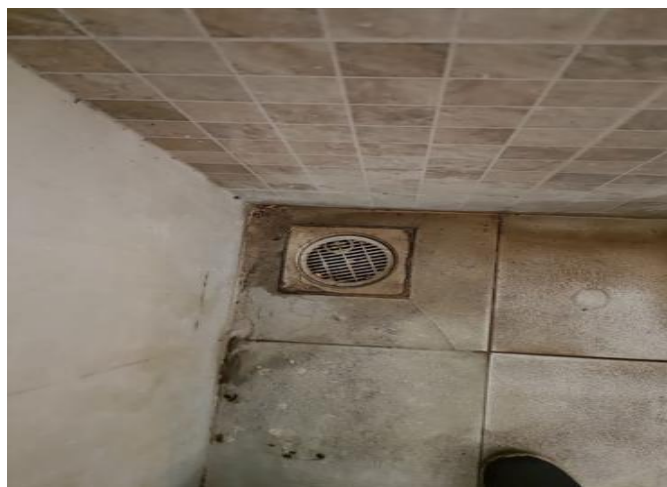
**Observation:** Dampness observed at the skirting level of the Master Bedroom.

**Severity:** Moderate — Skirting level dampness observed, aligning with general 'Condition of leakage at adjacent walls' noted as Moderate in the checklist.

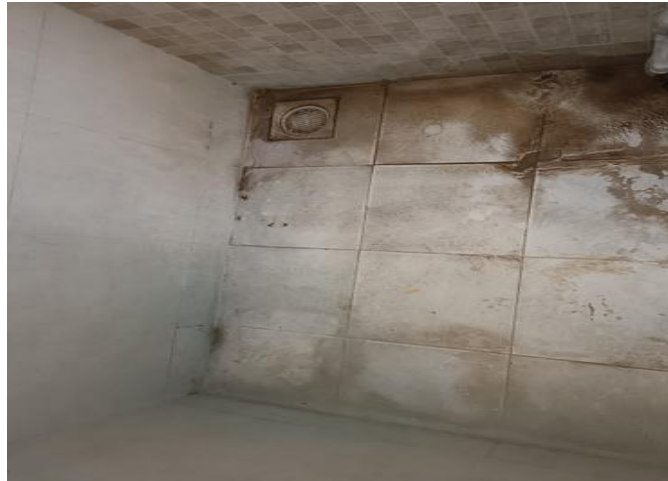
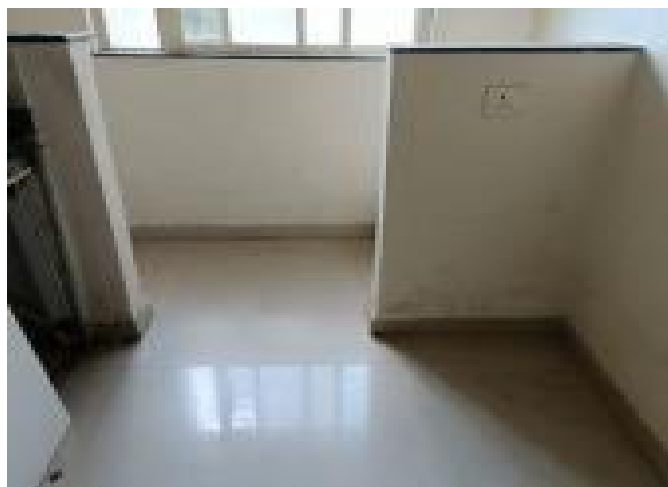
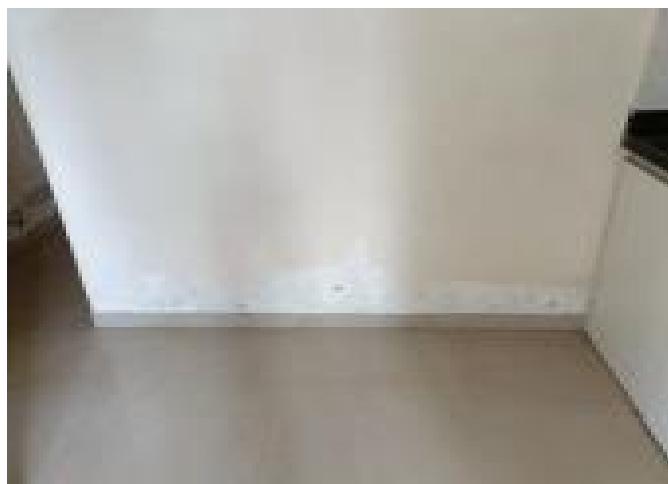
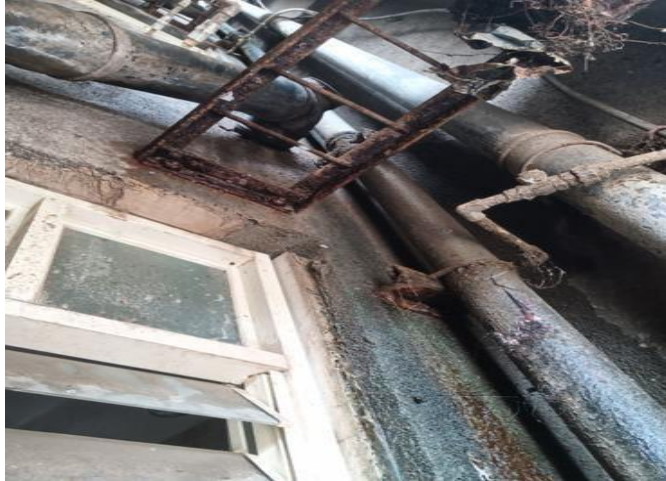
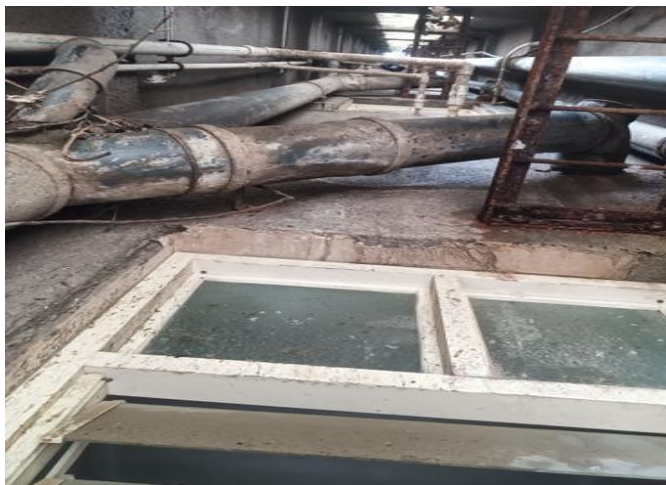
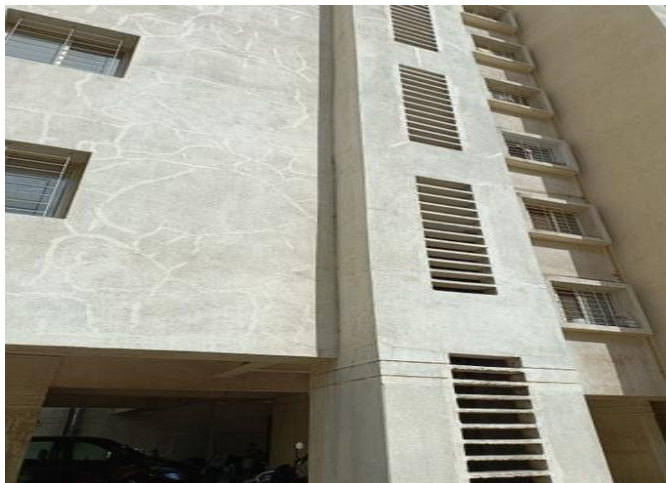
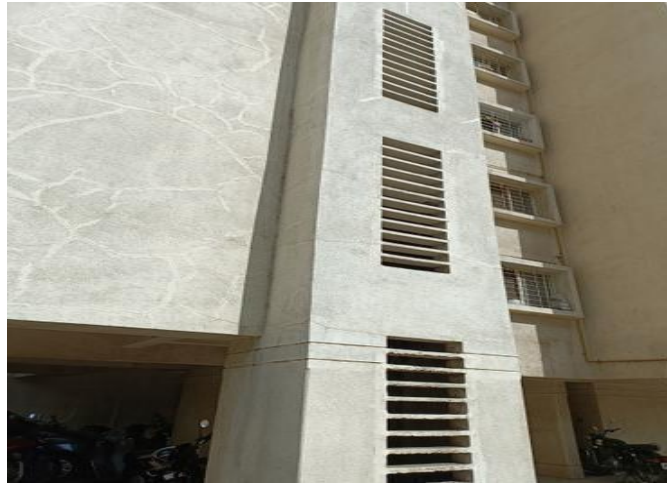
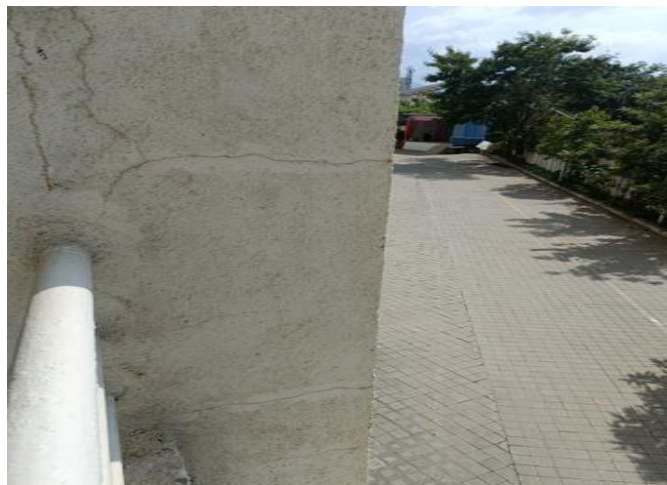
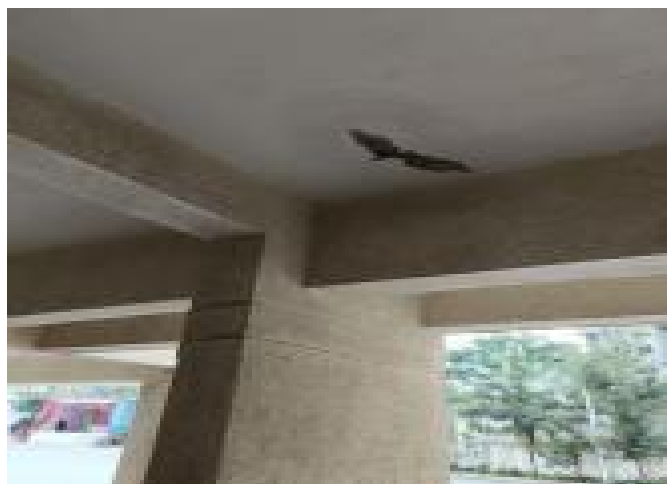
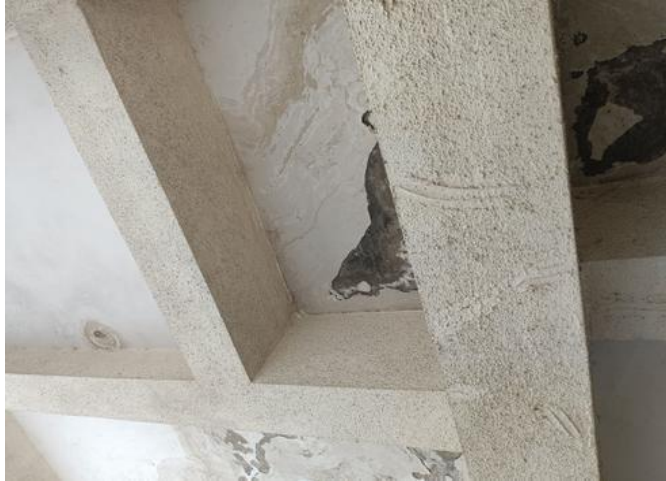
**Observation:** Observed gaps between the tile joints and tile hollowness in the Master Bedroom Bathroom.

**Severity:** Moderate — Gaps in tile joints and tile hollowness observed, indicating potential for leakage.

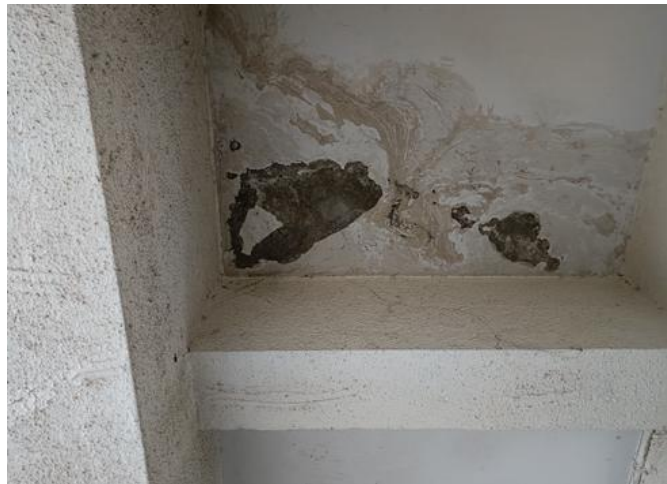
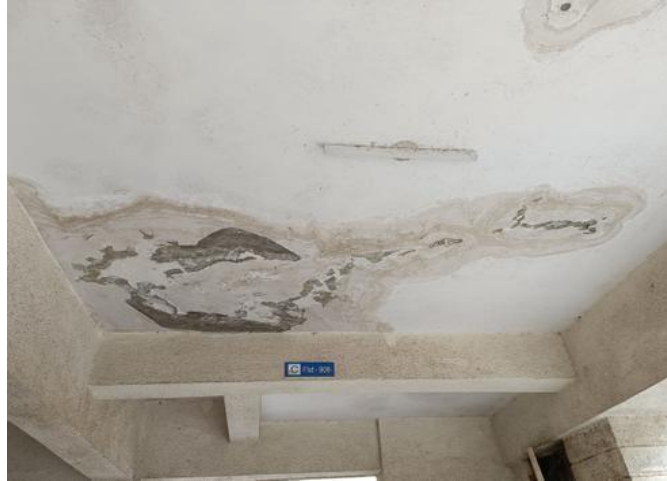
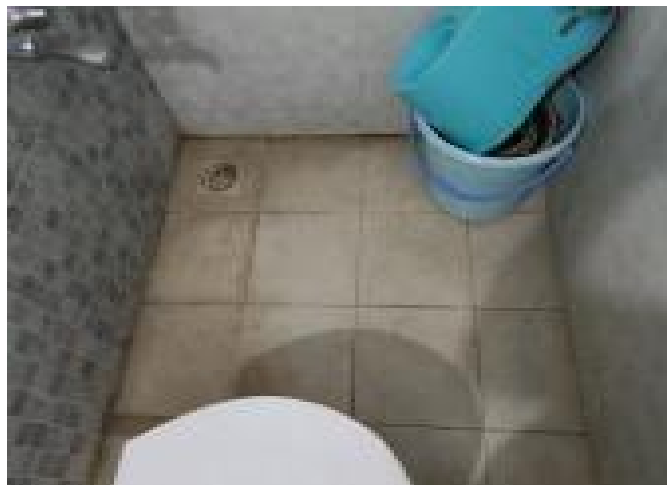
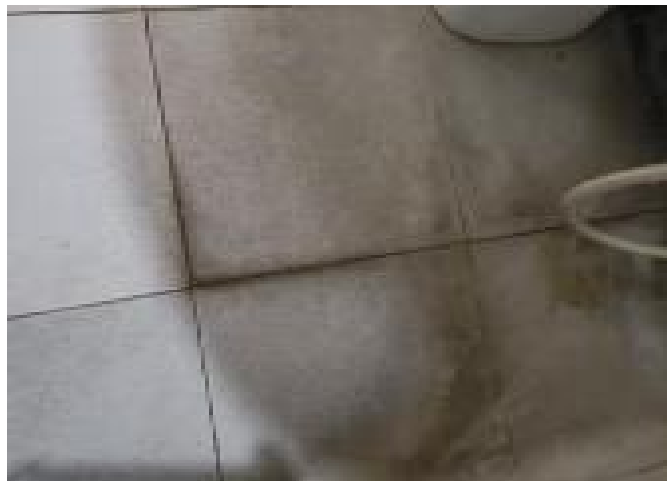
**Observation:** Dampness and efflorescence observed on the wall surface of the Master Bedroom.

**Severity:** Moderate — Dampness and efflorescence indicate prolonged moisture issues, aligning with general 'Condition of leakage at adjacent walls' noted as Moderate.
