INTERNAL AND EXTERNAL
SCHEDULE OF CONDITION

WREN TOWER,
ST MARY'S,
SOMERSET GARDENS,
LONDON EC4

Ref: C:ASA/mk/6397
 Inspection Date: 22nd June 01

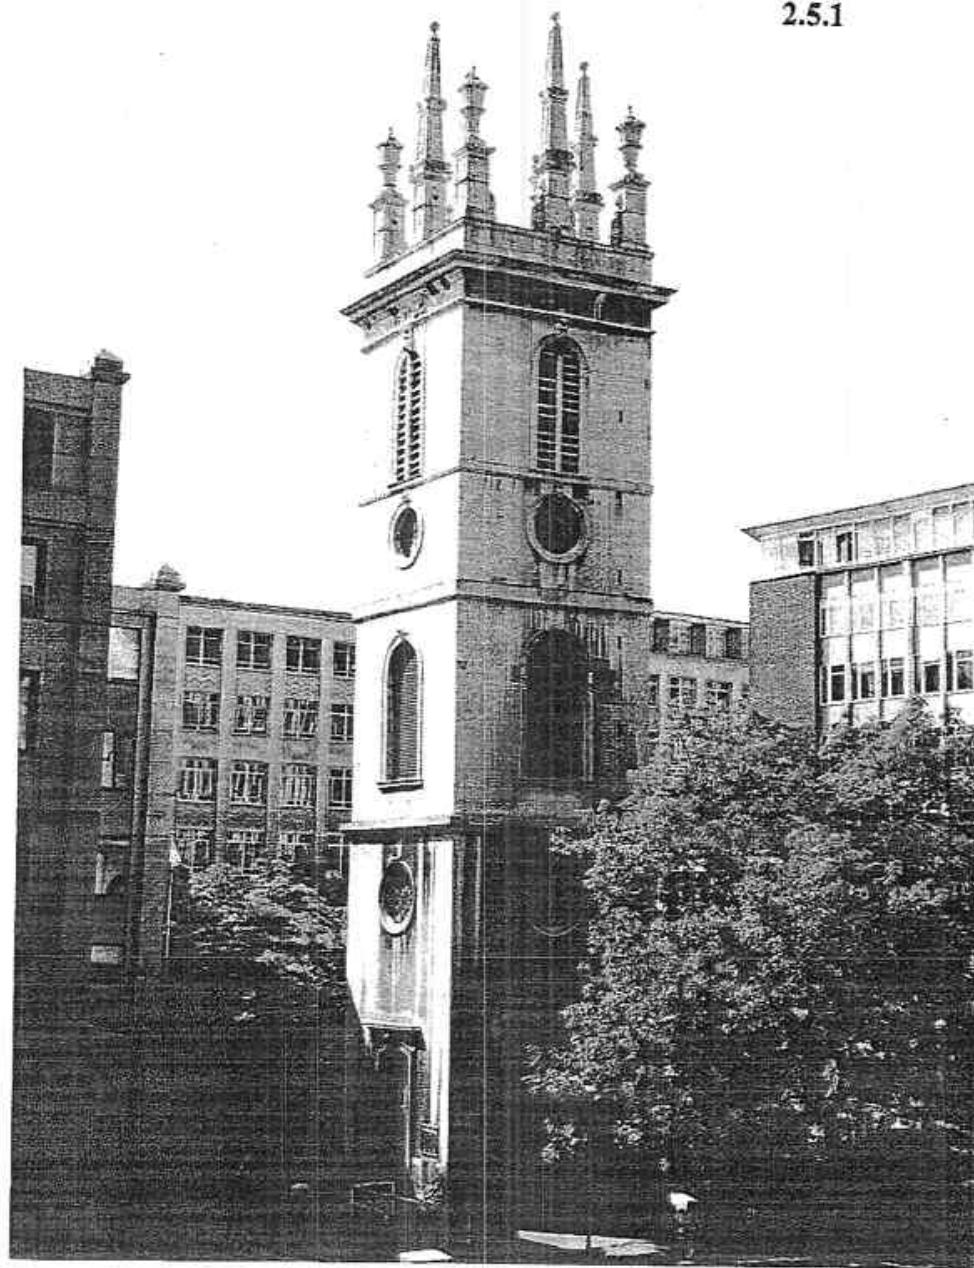
2.5.1

- Portland stone facings incorporating decorative cornice details and relief around opening at all levels and painted timber doors.
- 2.5 East Elevation
(See photograph 1)

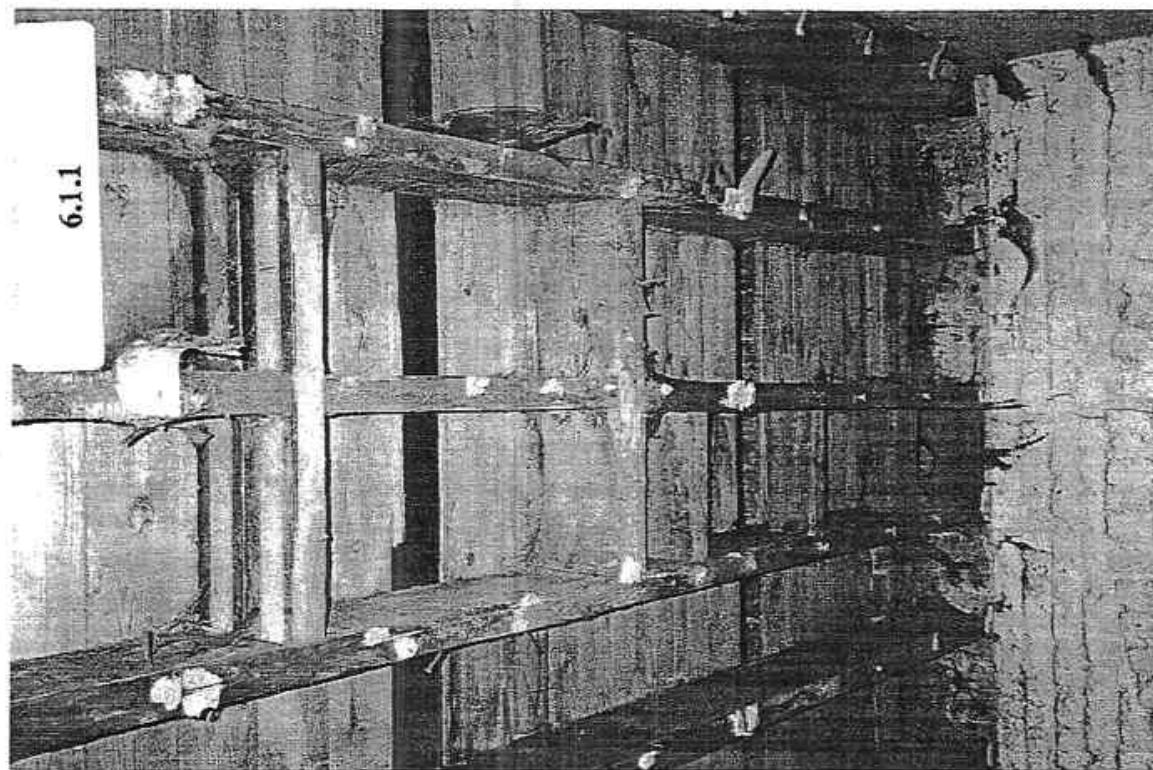
6.1.1

6.1	Soffit	Exposed suspended timber floor. Floor timbers are in reasonable order, plaster board ceiling has been removed and remnants of board remain around nail fixings. (See general photograph 1).
