Ref: 153/07/08

PRE-CONSTRUCTION SURVEY OF THE SEWER AT LAMBETH HILL PRIOR TO WORKS BEING UNDERTAKEN ON ST MARY SOMERSET TOWER

The Infrastructure Section, Contract & Drainage Management Group (CDMG) has prepared this report on behalf of STMS ("the client").

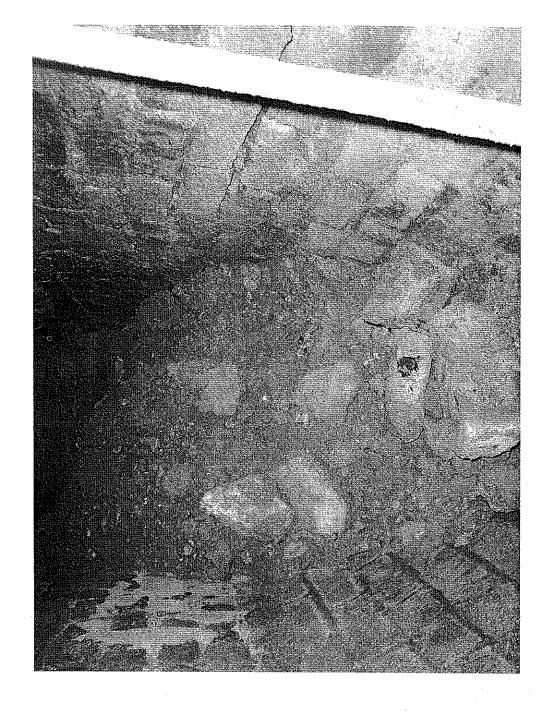
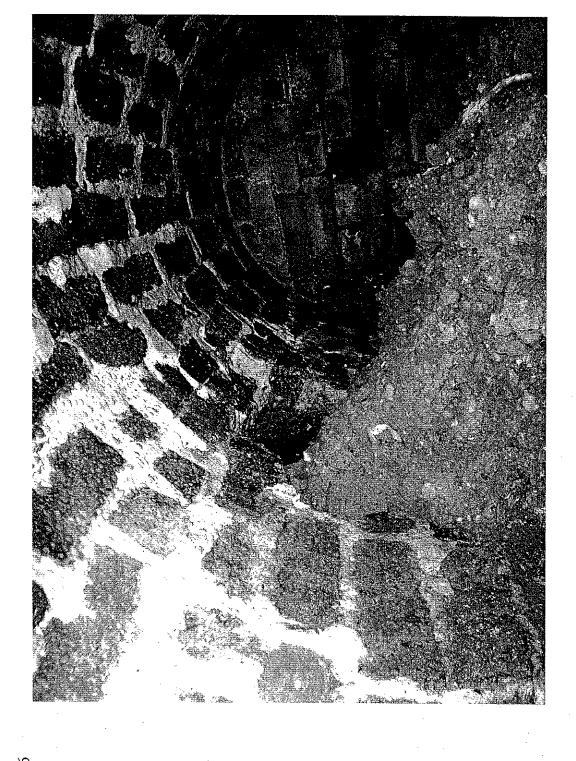
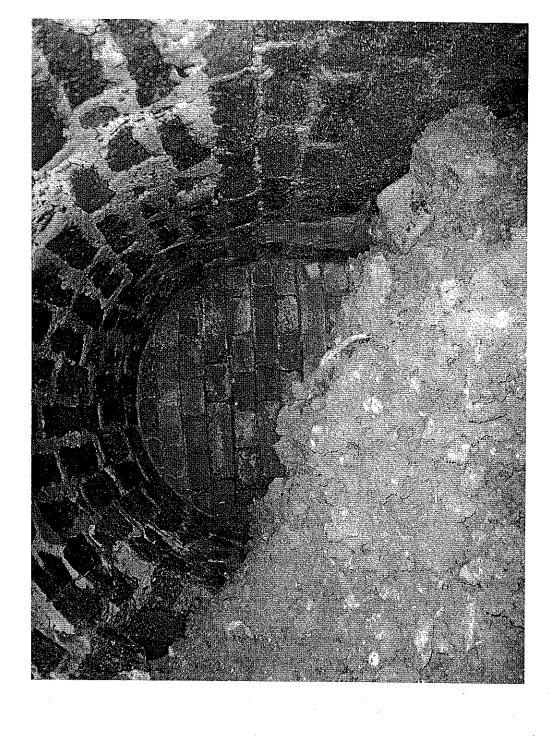
Up stream of the area surveyed, bricks and rubble were noticed in the invert of the sewer. This deposit does not seem to have had an affect on the function of the sewer, however, Thames Water Utilities Ltd have been informed of what was found.

ustance metres) 0.0	CONTIN'S DEFECT	LETTERS Code	Color San			
				Dlameter JN/CN	Clock at to	Intrusion % pim	REMARKS
			MH				Annual No. 100, 100 and 100 an
	0.0		WL			5	
1	0.5		CN	225	4		
2	2.0		CN	225	4		
3	12.0		CN	150	4		
4	17.0		FC		1 12		Top of steps
5	18.2		INGz				Start of ingress brick/sand
6	19.1		Н		10	70	Infiltration of sewer rubble
7							General view/rubble and head wall
	21.3		SF				Head wall
	I						
	,				- :		
						· ·	
		na.
