PRELIMINARY REPORT

HIGHWAY

HWY18MH016

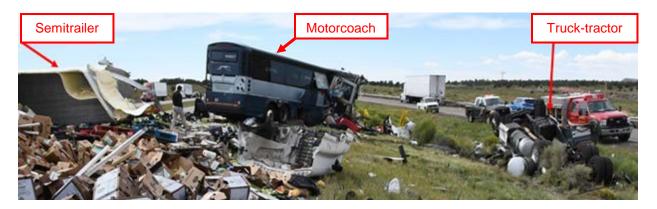
In the vicinity of milepost 50, the left front tire of the combination vehicle experienced a sudden air loss. After impact, the semitrailer separated from the truck-tractor and came to rest in the westbound lane and center median on its right side, spilling its load onto the roadway. After rolling onto its roof, the truck-tractor came to rest just off the westbound lanes of I-40, next to a service road. The final rest position of the motorcoach was on the right edge of the roadway, westbound. Figure 1 shows the combination vehicle and the motorcoach at final rest.

Figure 1. Postcrash scene, looking westbound, with service road at far right (Source: New Mexico State Police).
