SOIL INVESTIGATIONS AS A CORNERSTONE FOR GEOTECHNICAL DESIGN OF LIQUEFACTION MITIGATION MEASURES BELOW LEVEES

MARIO BACIC¹, KATARINA ANDACIC², KENNETH GAVIN³, KOSTA URUMOVIC⁴

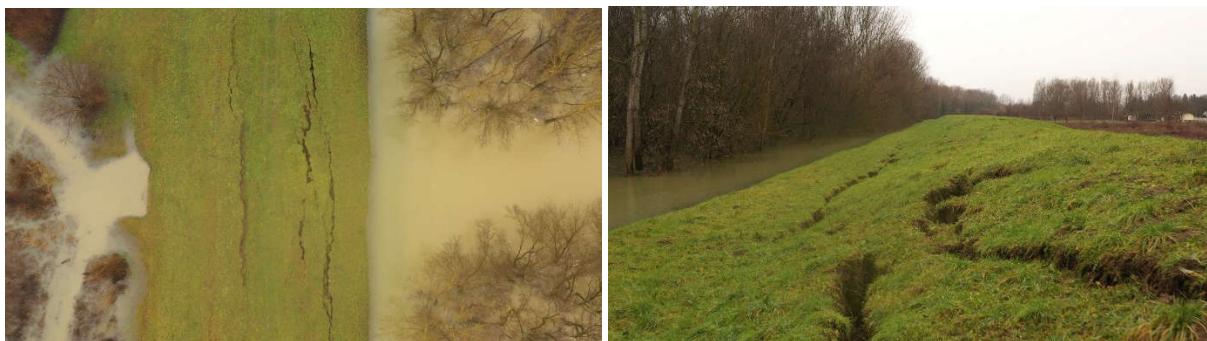
As one of the consequences of the strong Petrinja earthquake in 2020, liquefaction occurred in large parts of Sisak–Moslavina County, whose geology is generally characterized by saturated, poorly graded sands and silty sands (Pollak et al., 2021). In the Rapid Damage Assessment Report (Republic of Croatia, 2021), it was estimated that liquefaction occurred on almost 1600 ha of the county area at varying depths from 3 to 15 m. All liquefaction zones are located in the alluvial deposits of the Kupa, Sava, Glina and Maja rivers at a maximum distance of about 1 km from the riverbanks. About 7% of the area affected by liquefaction is located under the levees. This was detected by numerous cracks in the ground surface and erupted sand, as well as numerous cracks and deformations of the levees (Figure 1).

The levee deformations shown correspond well with the levee damage patterns D-2 and D-3 of Oka et al. (2012) (Figure 2), which were detected after the magnitude 9.0 Tohoku earthquake in 2011 in Japan, where damage to the levees was recorded at 2,115 locations. These patterns include longitudinal cracking and lateral expansion of the levee slope near the toe, as well as settlement of the levee crest. The authors state that the associated damage is due to liquefaction of the foundation soil, liquefaction of the soil in the levees as the water-saturated area was above ground level, and the long duration of this huge earthquake, or a combination of the above factors.

Figure 1. Deformed levees as a consequence of earthquake - induced liquefaction in Sisak – Moslavina County

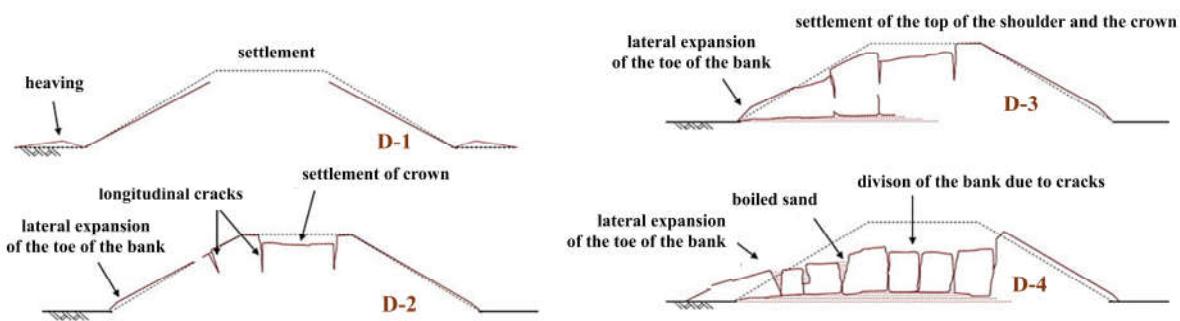
Figure 2. Typical damage and failure patterns of river embankments, modified from Oka et al. (2012)

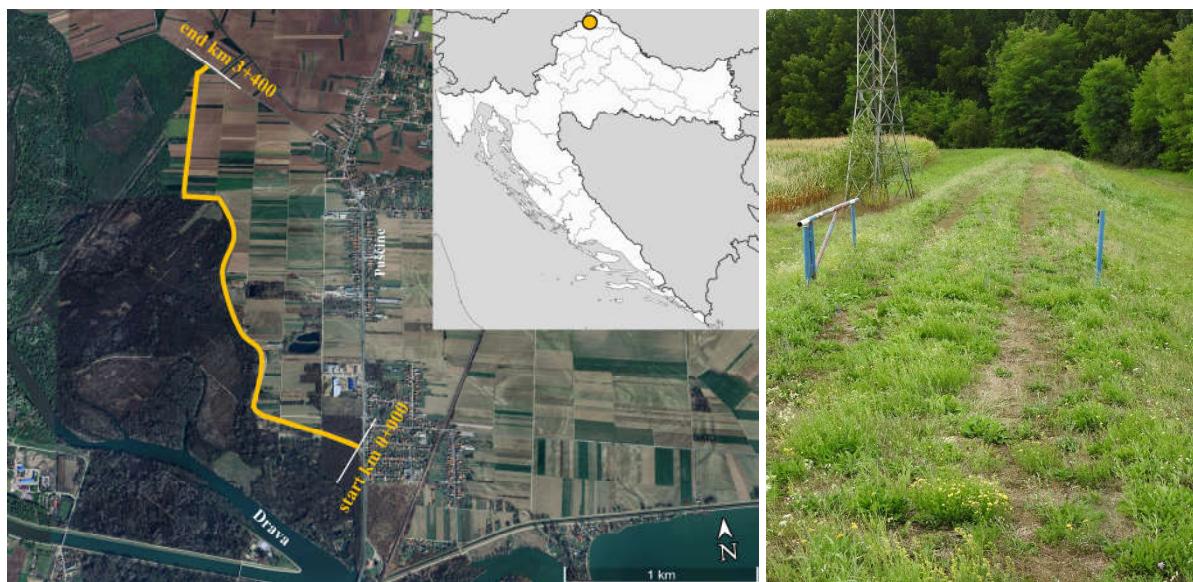
The Pušćine levee is located on the left bank of the Drava River in northern Croatia, Međimurje County, Figure 3, and is 3.4 km long. Initially built in 1966 to protect the settlements of Pušćina and Gornji Hrašćan from flooding, the levee does not have a sufficient safety height. This was demonstrated in November 2012, when the largest recorded water wave led to severe flooding in the area. It was decided to reconstruct the levee so that it meets the flow rate requirements of $2900 \text{ m}^3/\text{s}$, which in turn means an increase of up to 1.5 m compared to the existing crest level. However, the raising and construction of the access road will shift the levee 12 to 20 m towards the water side to fit into the existing Croatian Waters' cadastral parcel.

Figure 3. The layout and the current condition of the Pušćine levee

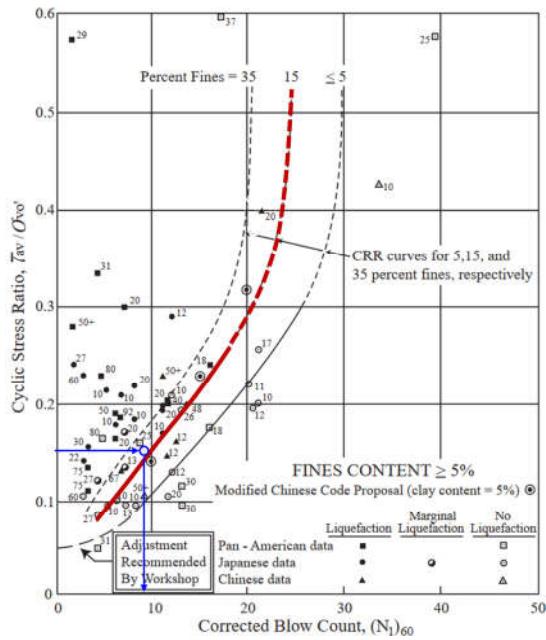
where the r_d is stress reduction factor, a_{max} is the peak horizontal ground acceleration, while σ_{vo} and σ'_{vo} represent total and effective vertical stress, respectively. The liquefaction resistance CRR parameter is the CSR value required to activate liquefaction, which happens when $CSR \geq CRR$. Using the a_{max} of 0.14g which corresponds to the seismic event of 475-year return period, and applying the stress-reduction, the calculated CSR is 0.156. For the silty sands with 15% of fines, which form soil just below the levee, the critical SPT blow number is 9 (without groundwater) to 11 (with groundwater), Figure 4. Therefore, main design identifies two criteria which should be fulfilled in order to consider the liquefaction mitigation measures: (1) the material of the surface soils are uniformly to poorly graded sand or silty sand; (2) SPT blow number in sand or silty sand should be lower than 9 or 11. When the obtained DPL blow numbers (Premur, 2022) are correlated with the SPT values, the associated SPT values range from 2 to 7 in sandy formations, followed by the significant increase in number of blows in lower gravel layers.

Figure 4. An SPT-based soil liquefaction chart, modified from Seed et al. (1984)

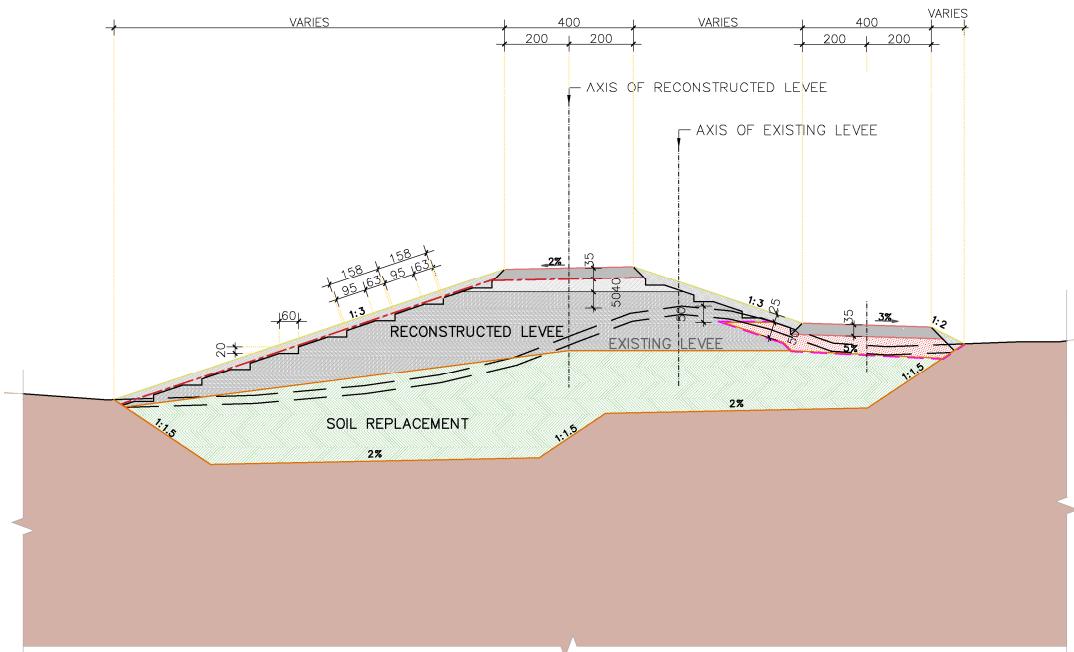
Figure 5. A cross section of reconstructed Pušćine levee (CFCE, 2022)

As an optimal liquefaction mitigation solution, a replacement of upper, liquefaction-prone, layer is chosen. It is done in such a way that the excavated layer, which consists mainly of silty sands, is mixed with coarse-grained gravel in a ratio of 70 % (sand) – 30 % (gravel). This increases the liquefaction resistance of the sands, while at the same time meeting the hydraulic (seepage) requirements of the design. The typical cross-section of the reconstructed Pušćine levee is shown in Figure 5.

Advanced numerical simulations were used to test the influence of different replacement depths on the behavior of the levees by calculating the levee settlements in the event of liquefaction. If no replacement is carried out, the expected liquefaction-induced settlements are between 100 and 150 cm, which is considered unsatisfactory. If the replacement is carried out to the depth of the lower gravels, the expected

settlements are between 6 and 10 cm. However, as 60% of the length of the levee lies on soils at risk of liquefaction and both the financial and technical aspects of such large-scale soil replacement need to be considered, it was decided to replace the soil to a depth of 2 m or lower if gravels are encountered. This solution leads to settlements in the range of 30 to 40 cm, which is considered acceptable as it is assumed that the levee will retain its function as flood protection during the subsequent remediation works.

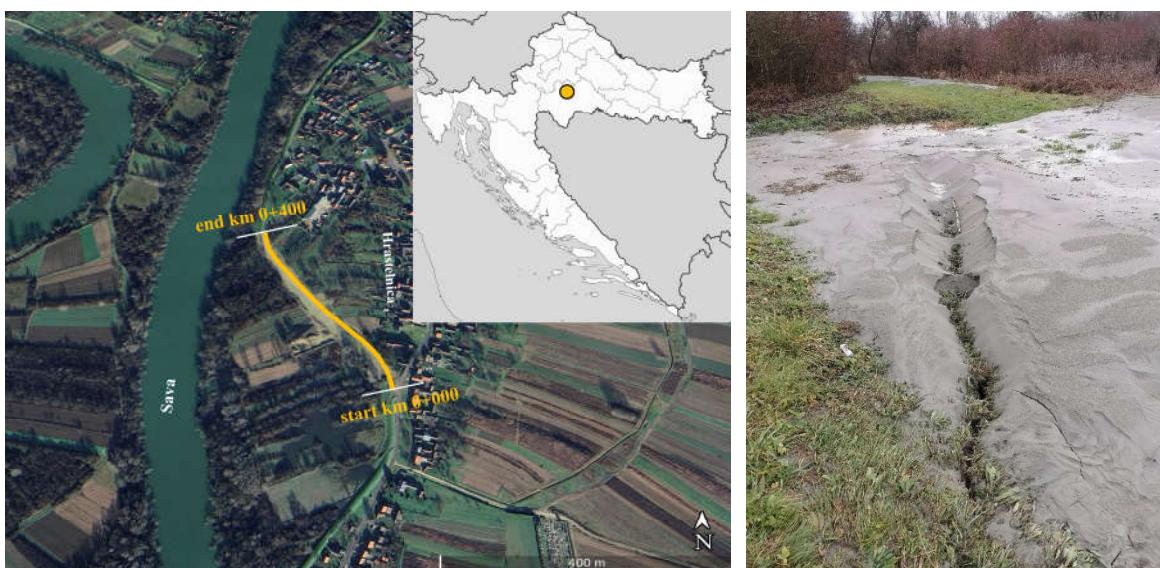
As a result of the 2020 Petrinja earthquake, a levee on the left bank of the Sava River in Hrastelnica, Sisak-Moslavina County, showed significant deformations and cracks on the crest, slopes and surrounding soil. The length of the damaged section is 400 m, from km 106+200 to km 106+600 (Figure 6). The damage is largely due to liquefaction, with a large amount of sand ejecta observed.

Figure 6. The layout of the damaged section of Hrastelnica levee with observed sand ejecta

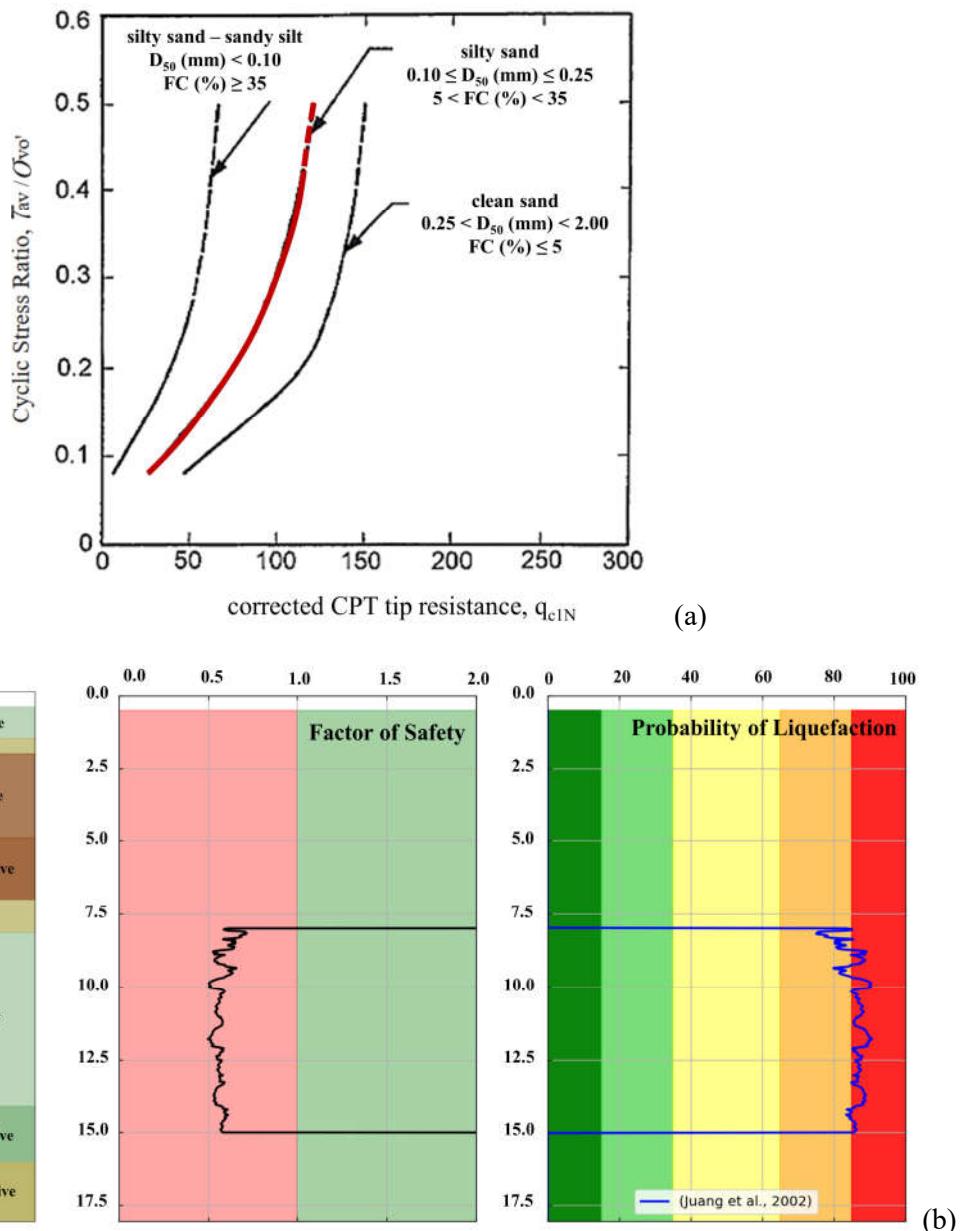
The liquefaction assessment for the design of the mitigation measures for Hrastelnica levee rely on is the CPTU tip resistance and associated liquefaction chart for silty sand, Figure 7a. For the calculation of CSR, the equation (1) is used, with the a_{max} of 0.30g which corresponds to a seismic event of 475-year return period.

The calculated values of the factor of safety to liquefaction, i.e. the ratio of CRR to CSR, are shown in Figure 7b for one CPTU at the location. All CPTUs show similar consistent results, with the high probability of liquefaction calculated for the layers identified as clayey sand layers during drilling. In addition, customised software (Librić et al., 2022) is used to calculate the probability of liquefaction (PL) along the depth based on the methodology proposed by Juang et al. (2002) with the governing equation:

Figure 7. Assessing the soil liquefaction potential through the CPTU tests: (a) An CPT-based soil liquefaction chart, modified from Stark and Olson (1995), (b) results of one CPTU test showing the estimated soil profile with calculation of factor of safety and probability of liquefaction occurrence

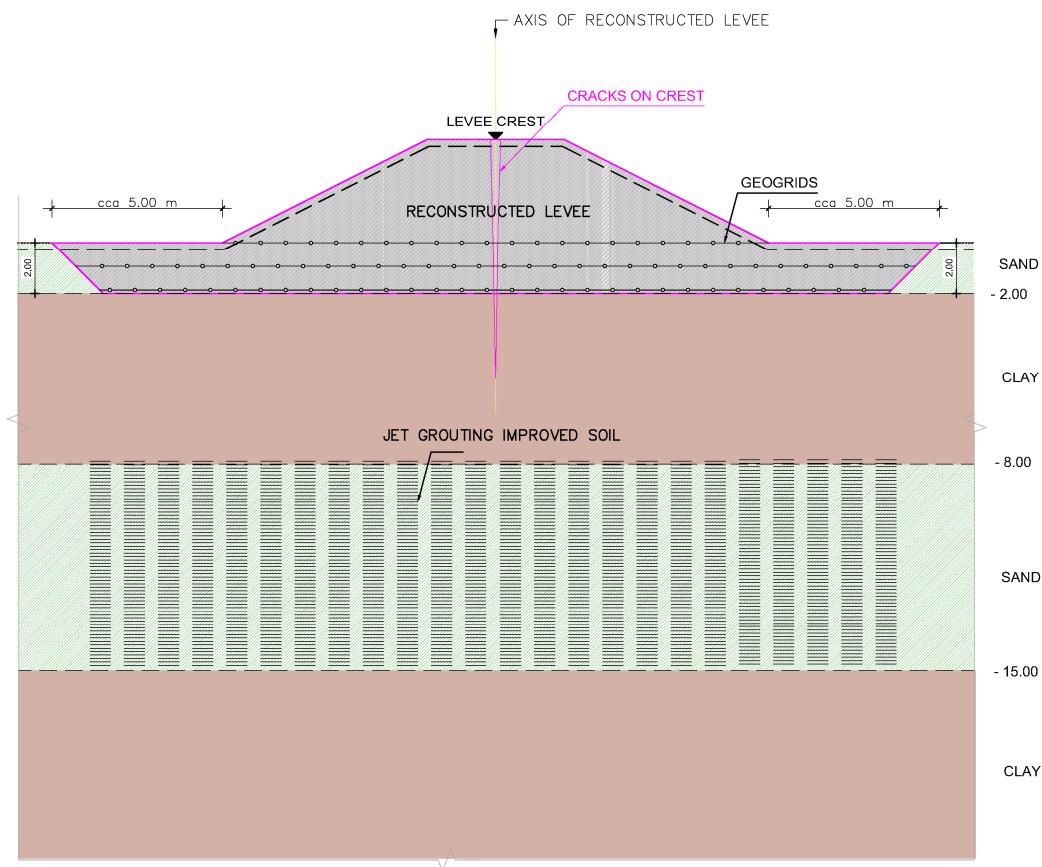
Figure 8. A cross section of reconstructed Hrastelnica levee (CFCE, 2021b)

Considering the greater depth of the liquefiable layers, deep soil improvement by means of jet grouting

is chosen. Jet grouting is a soil improvement method in which a binding agent is injected into the soil under high pressure to form a compact "soil concrete" with better mechanical properties. The grouting columns are to be installed in a 3 x 3 m arrangement with an expected diameter of 80 cm and a variable length depending on the depth of the sands at risk of liquefaction. By applying the procedure proposed by Özsoy and Durgunoğlu (2003) with the CSR reduction coefficient based on the selected improvement arrangement, the factors of safety increase due to jet grouting implementation is significant (values > 4), so that the probability of liquefaction occurrence decreases to < 2 %. In places where sand layers are encountered in the upper part of the soil profile, the reconstructed levee is "deepened" so that the upper soil profile is replaced by material with the same properties as that used for the levee reconstruction, with geogrids being installed at several levels. The typical cross-section of the reconstructed Hrastelnica levee is shown in Figure 8.
