# Investigate the cut fault.

## Rebuild and restart.

I inspected the high-pressure pump, performed its scheduled rebuild, reassembled it, and checked the machine after repair.

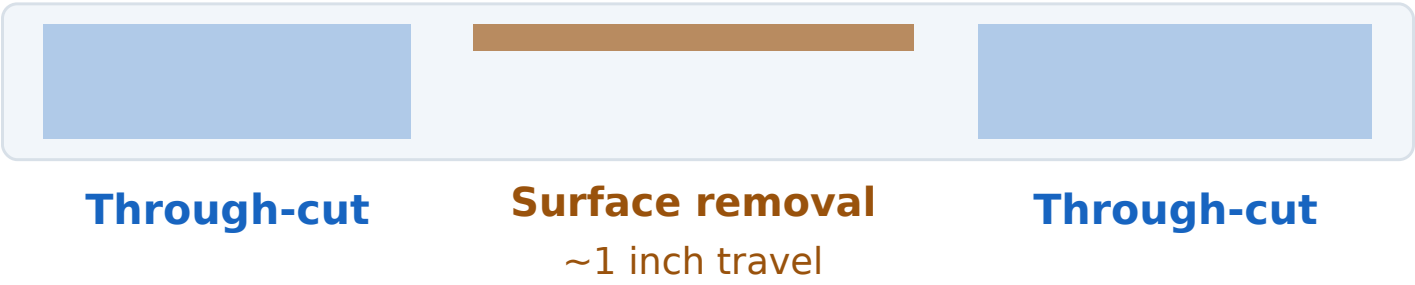
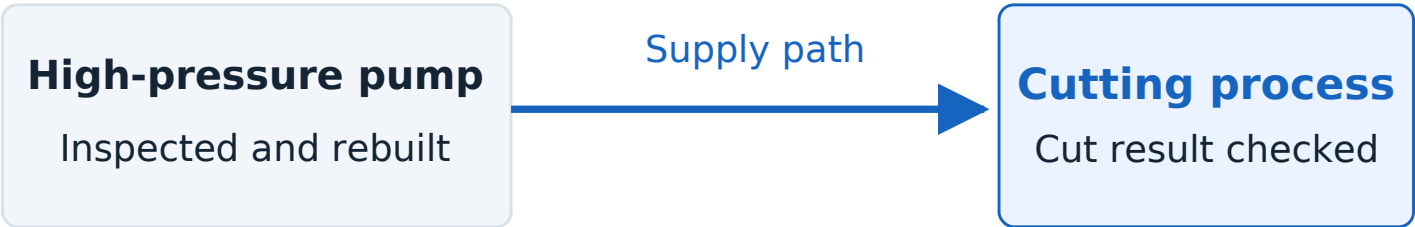
### Reported cutting pattern and supply path

The colored strip sketches penetration; it is not a measured cut-depth trace.

| Finding | More mechanical play than expected in the pump cylinder assemblies. |

| Action | Standard 5,000-hour rebuild kit, reassembly, and machine checks. |
| Checks | Consistent through-cuts returned; pump output readings were higher. |
