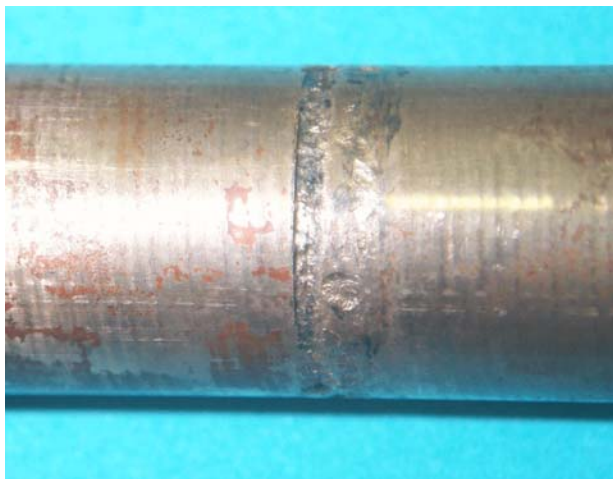
**Failure Mechanisms:** The principle problems we have found are Baffle Wear and Under Baffle Corrosion. The wear results from the tube vibrating in the baffles and is predominate around the perimeter of the bundle. Under Baffle Corrosion is due to poor or non-existent water treatment, and is most likely galvanic in nature.

Tubes removed from a York YCWZ88 Reciprocal showed Grooves and Pitting. It was noted that the baffles used in this unit were 1/8 inch thick but the grooves were 1/16 inches wide. See Figures 2 through 5.

**Figure 2** 5% - 10% Groove

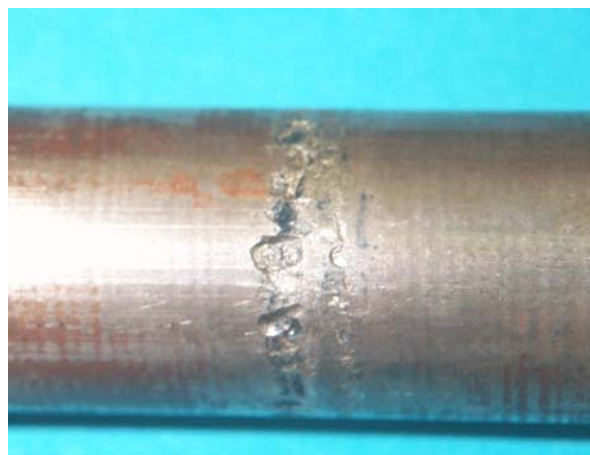
**Figure 3** 58% Pitting Under Baffle

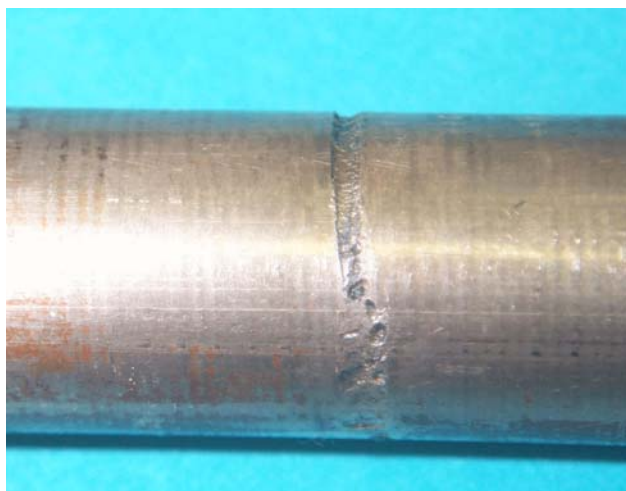
**Figure 4** 62% Groove Under Baffle

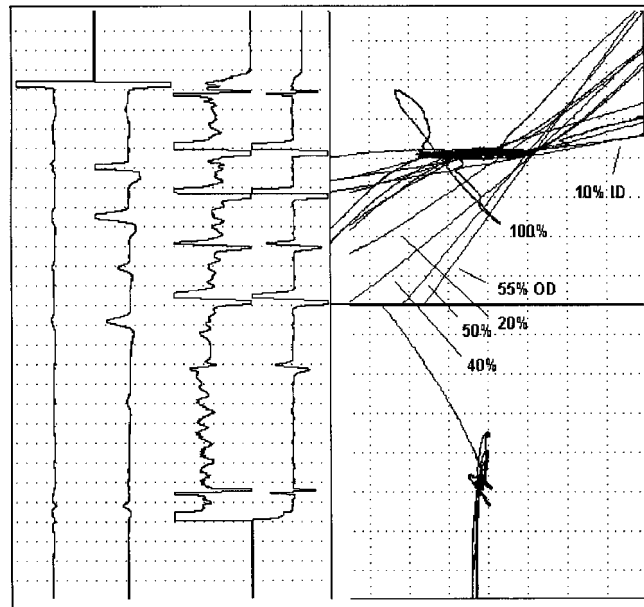
**Figure 5**  
 .620 x .020 PSIE Copper Calibration Standard

The tubes used in this document have a .020 wall, but can be ordered with a .025 or .028. These tubes were tested at 36KHz. Even at this high frequency there was a large separation between the OD Grooves and the 100% through hole milled into the calibration standard. See Figure 5. The calibration standard used was an exact match to the tubes tested. It contained OD Grooves ranging from 20% to 55%.

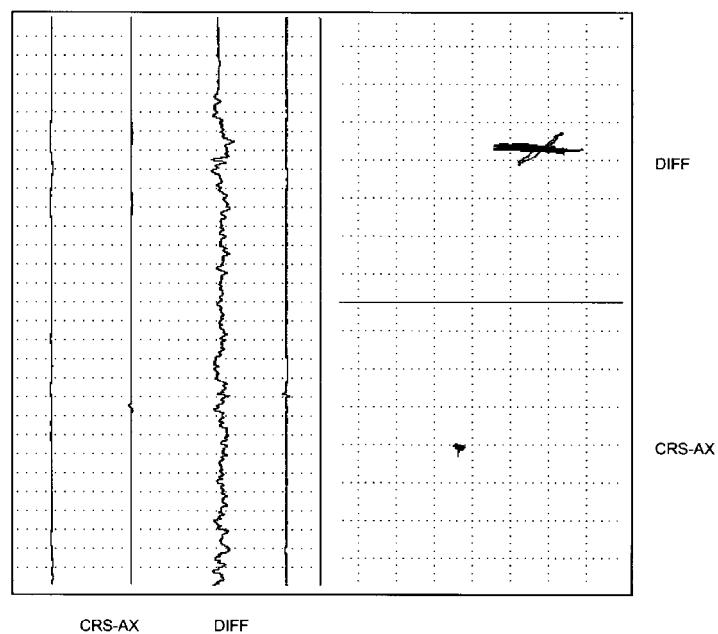
*When inspecting units containing these tubes you must prepare a "Phase Chart" and evaluate damage, if found, on the differential channel. Significant grooving at a baffle can appear minor. However, as can be seen in Figures 6 through 8 the damage can be quite significant. The tubes shown here are actual tubes removed from a failed unit. As can be seen the phase angles appear minor until compared to a phase chart. See Figure 9.*

**Figure 6**  
 5% Baffle Wear

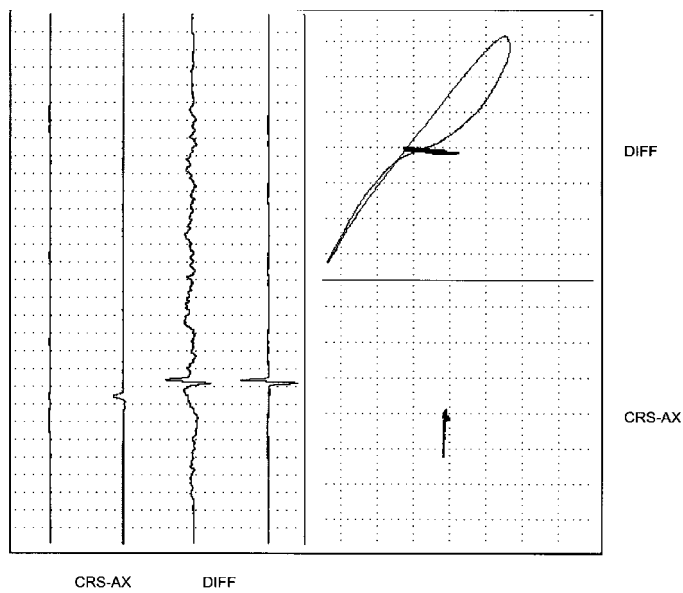
**Figure 7**

58% OD Groove

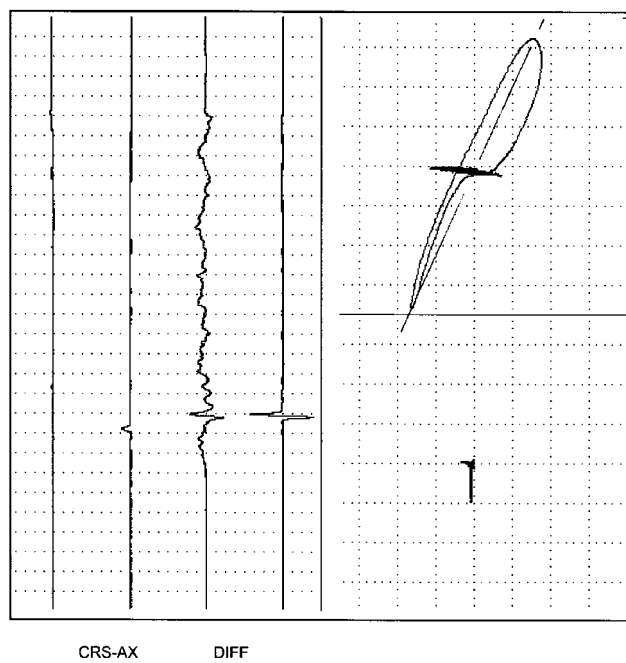
**Figure 8**

62% OD Groove

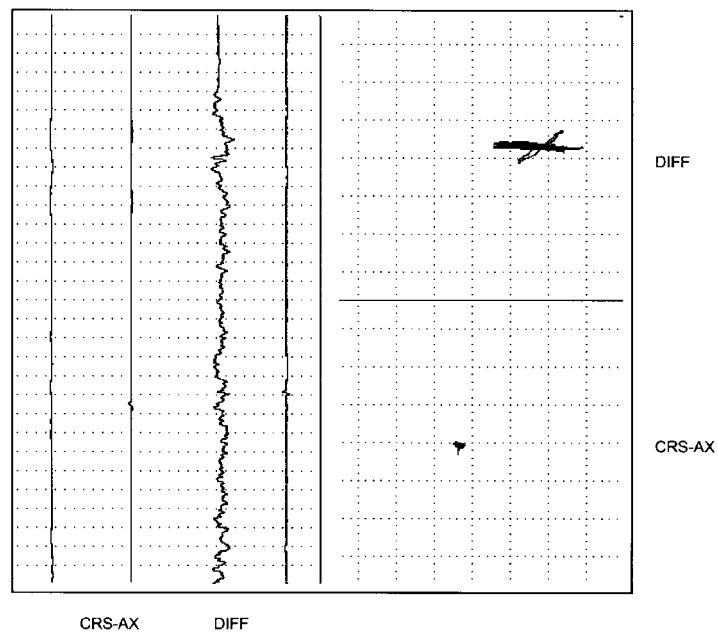
**Figure 6**  
 5% Baffle Wear

*When inspecting units containing these tubes you must prepare a "Phase Chart" and evaluate damage, if found, on the differential channel. Significant grooving at a baffle can appear minor. However, as can be seen in Figures 6 through 8 the damage can be quite significant. The tubes shown here are actual tubes removed from a failed unit. As can be seen the phase angles appear minor until compared to a phase chart. See Figure 9.*

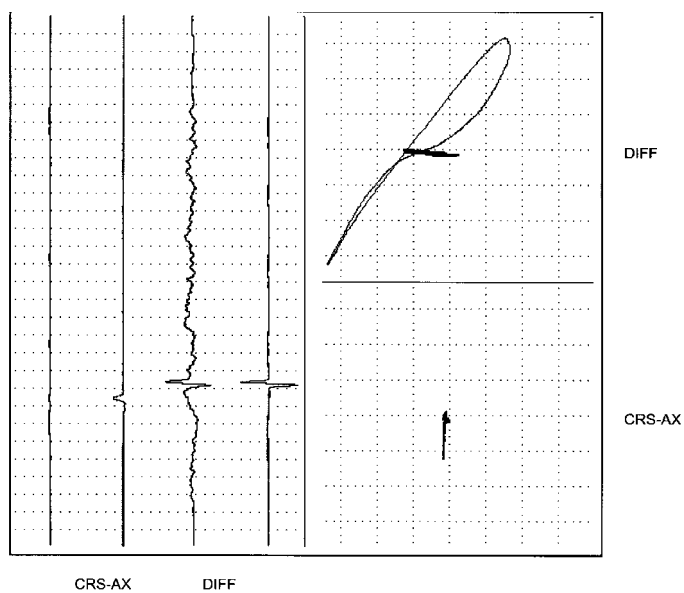
**Figure 7**

58% OD Groove

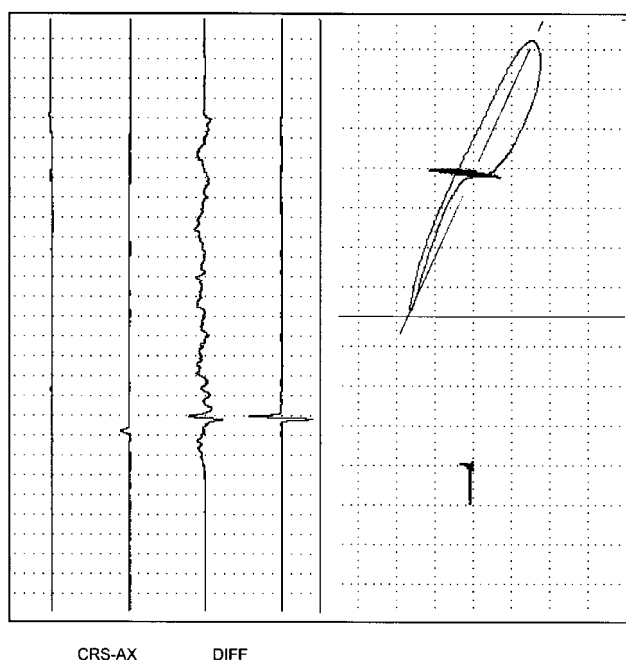
**Figure 8**

62% OD Groove
