DISTRICT BRIDGE REPAIR WORK ORDER

| BRIDGE INFORMATION | The second secon | |
|--|--|--|
| Bridge Number: 8\$23.61035 | FHWA Number: 49360 | |
| Facility Carried: SB I-35 | | |

| REPAIR NEEDED | | |
|--|---|---|
| Description: 531 - Guardrail - Repair guardrail - Far approach | Function: 670 | Repair Code: 531 |

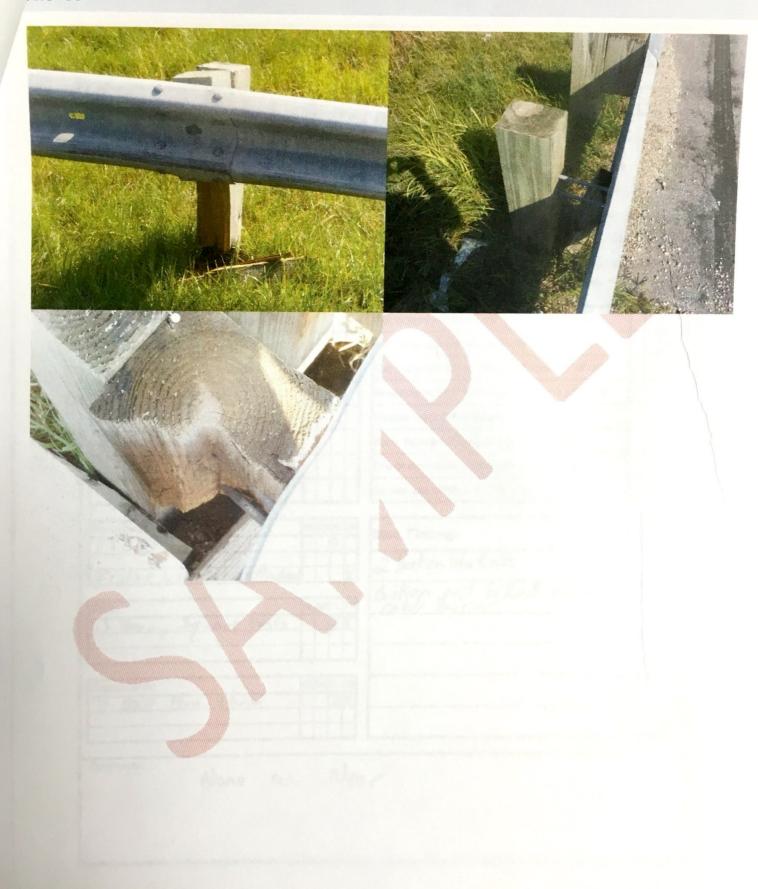
Inspection Recommendation: The guardrail at the far end of the bridge is in need of repair. Two broken blockouts are present on the far left and 1 broken post on the far right. Both anchor cables are loose.

The guardrail at the far end of the bridge is in need of repair. Two broken blockouts are present on the far left and 1 broken post on the far right. Both anchor cables are loose.
