# COBALT RIDGE AUTOMATION · COMPONENT ANALYSIS LABORATORY

Milwaukee, WI · Report CAL-2026-0731 · Issued 21 April 2026

## Returned Component Inspection Report

Preliminary · Analysis in progress · Not for external distribution

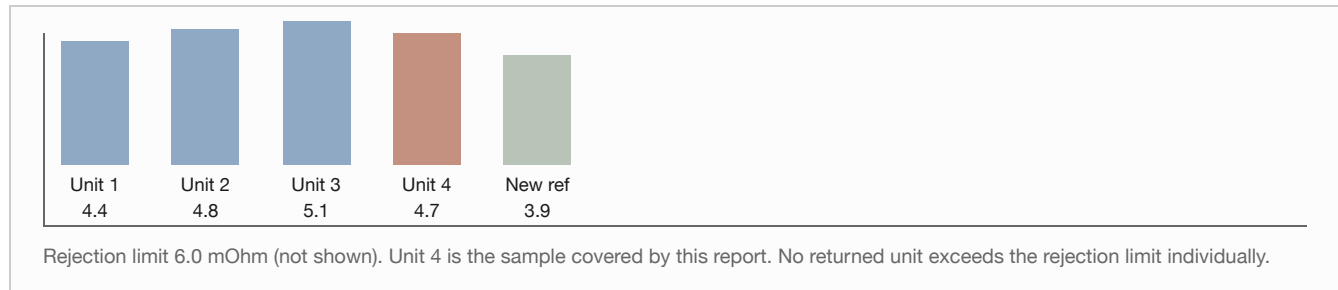
**Figure 1 · Power stage junction resistance by unit (mOhm)**

| Measurement | This unit | Units 1-3 (range) | New reference |
|---|---|---|---|
| Power stage junction resistance (mOhm) | 4.7 | 4.4 - 5.1 | 3.9 typical |

1. All four returned units show the same discoloration pattern in the same location.
2. All four show elevated junction resistance relative to a new reference unit, though none exceed the rejection limit taken individually.
3. Three of the four units, including this one, came from sites where the recorded ambient in the equipment aisle exceeded 27C during the reported failure period.
4. This unit was operated for an undetermined period with the thermal cutback threshold raised above the released baseline value, per the third-party work order associated with the site. The duration at the elevated threshold is not established.
