# USING SANBORN MAPS TO IDENTIFY RECS

Tyler Dardis  
Minnesota State University, Mankato  
GEOG 480 GISc and Environmental Hazards

Cherry Street Parking Ramp

Verizon Center Expansion

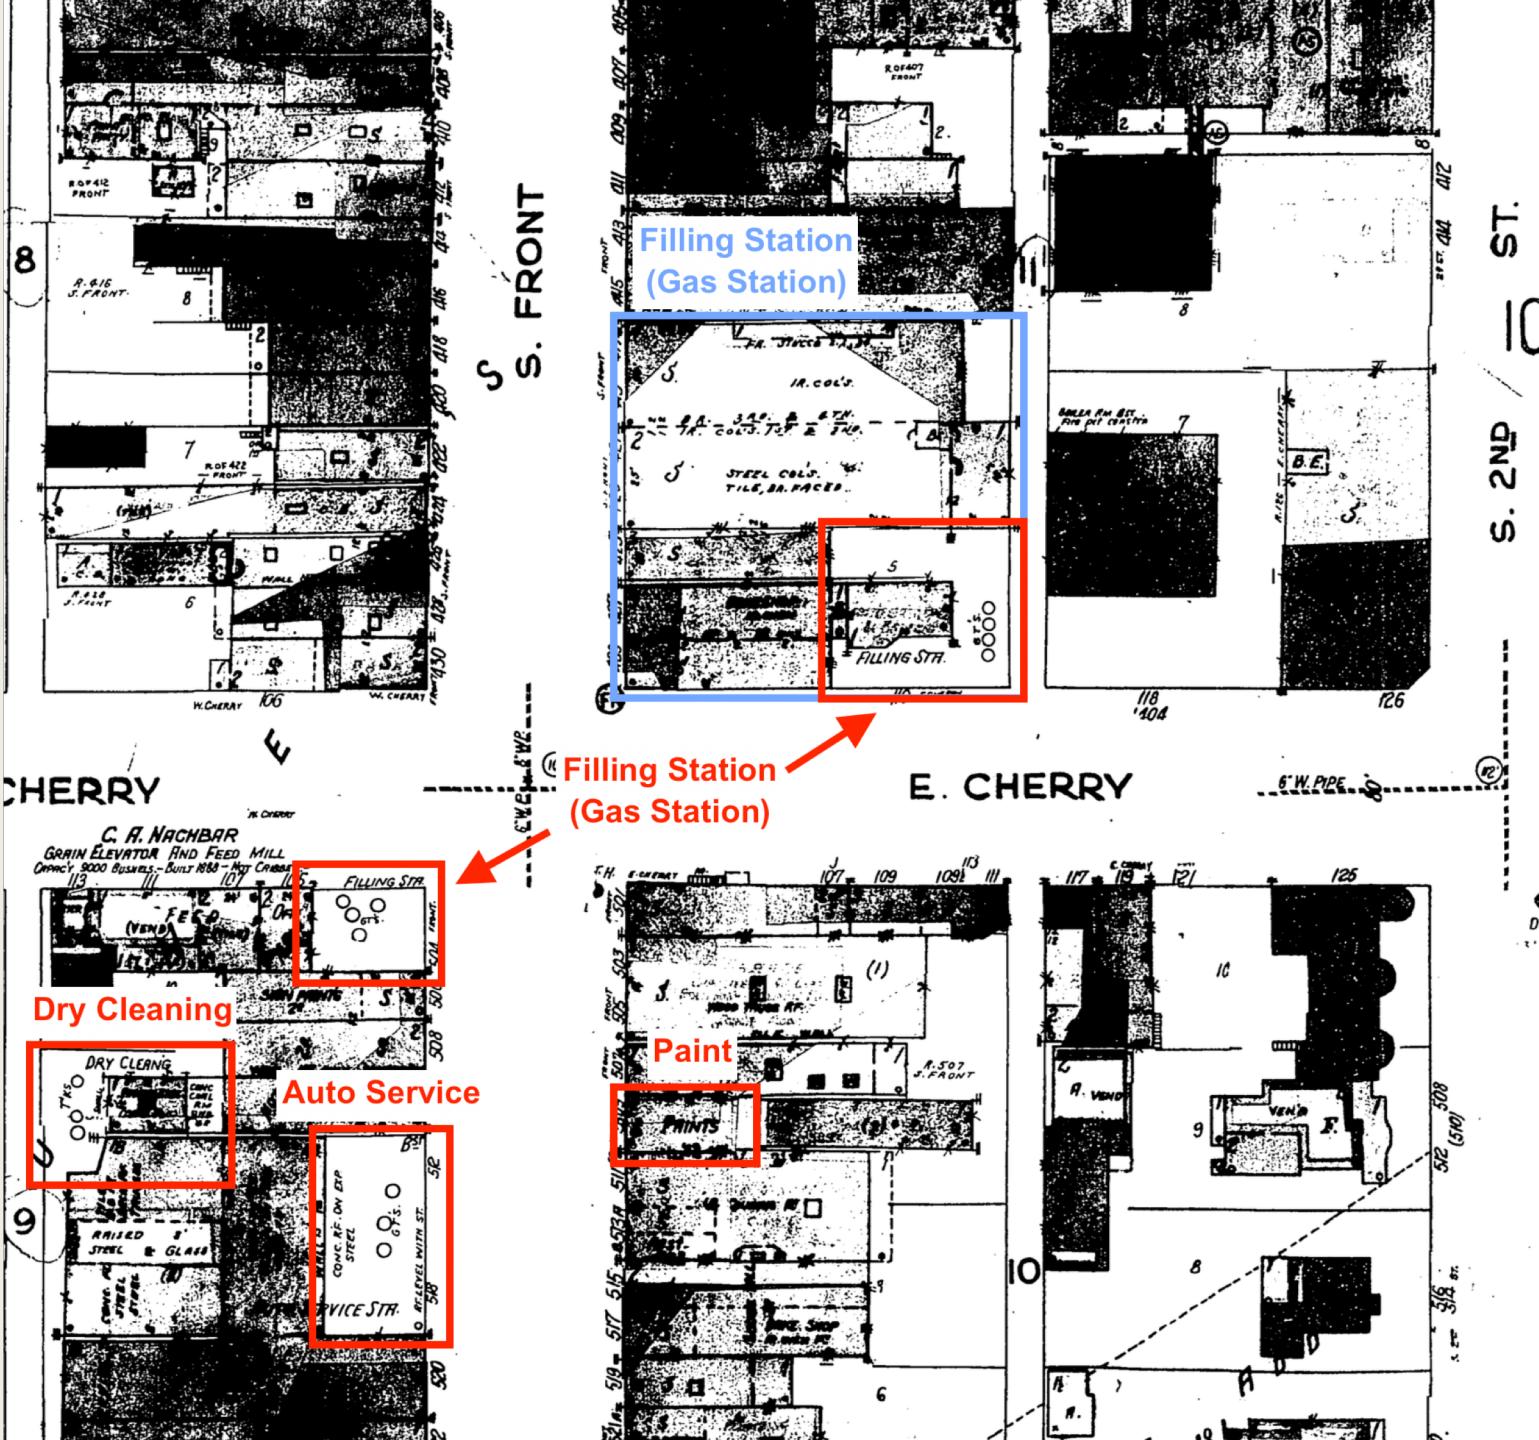
# 1948

- Filling Station
  - 4 Gas Tanks on Site

- Filling Station
  - 4 Gas Tanks on Site
- Dry Cleaning
  - Waste, 3 Gas Tanks on Site
- Auto Service
  - Auto. Waste, fuels, oils, etc.
  - 3 Gas Tanks on Site
- Paint Shop

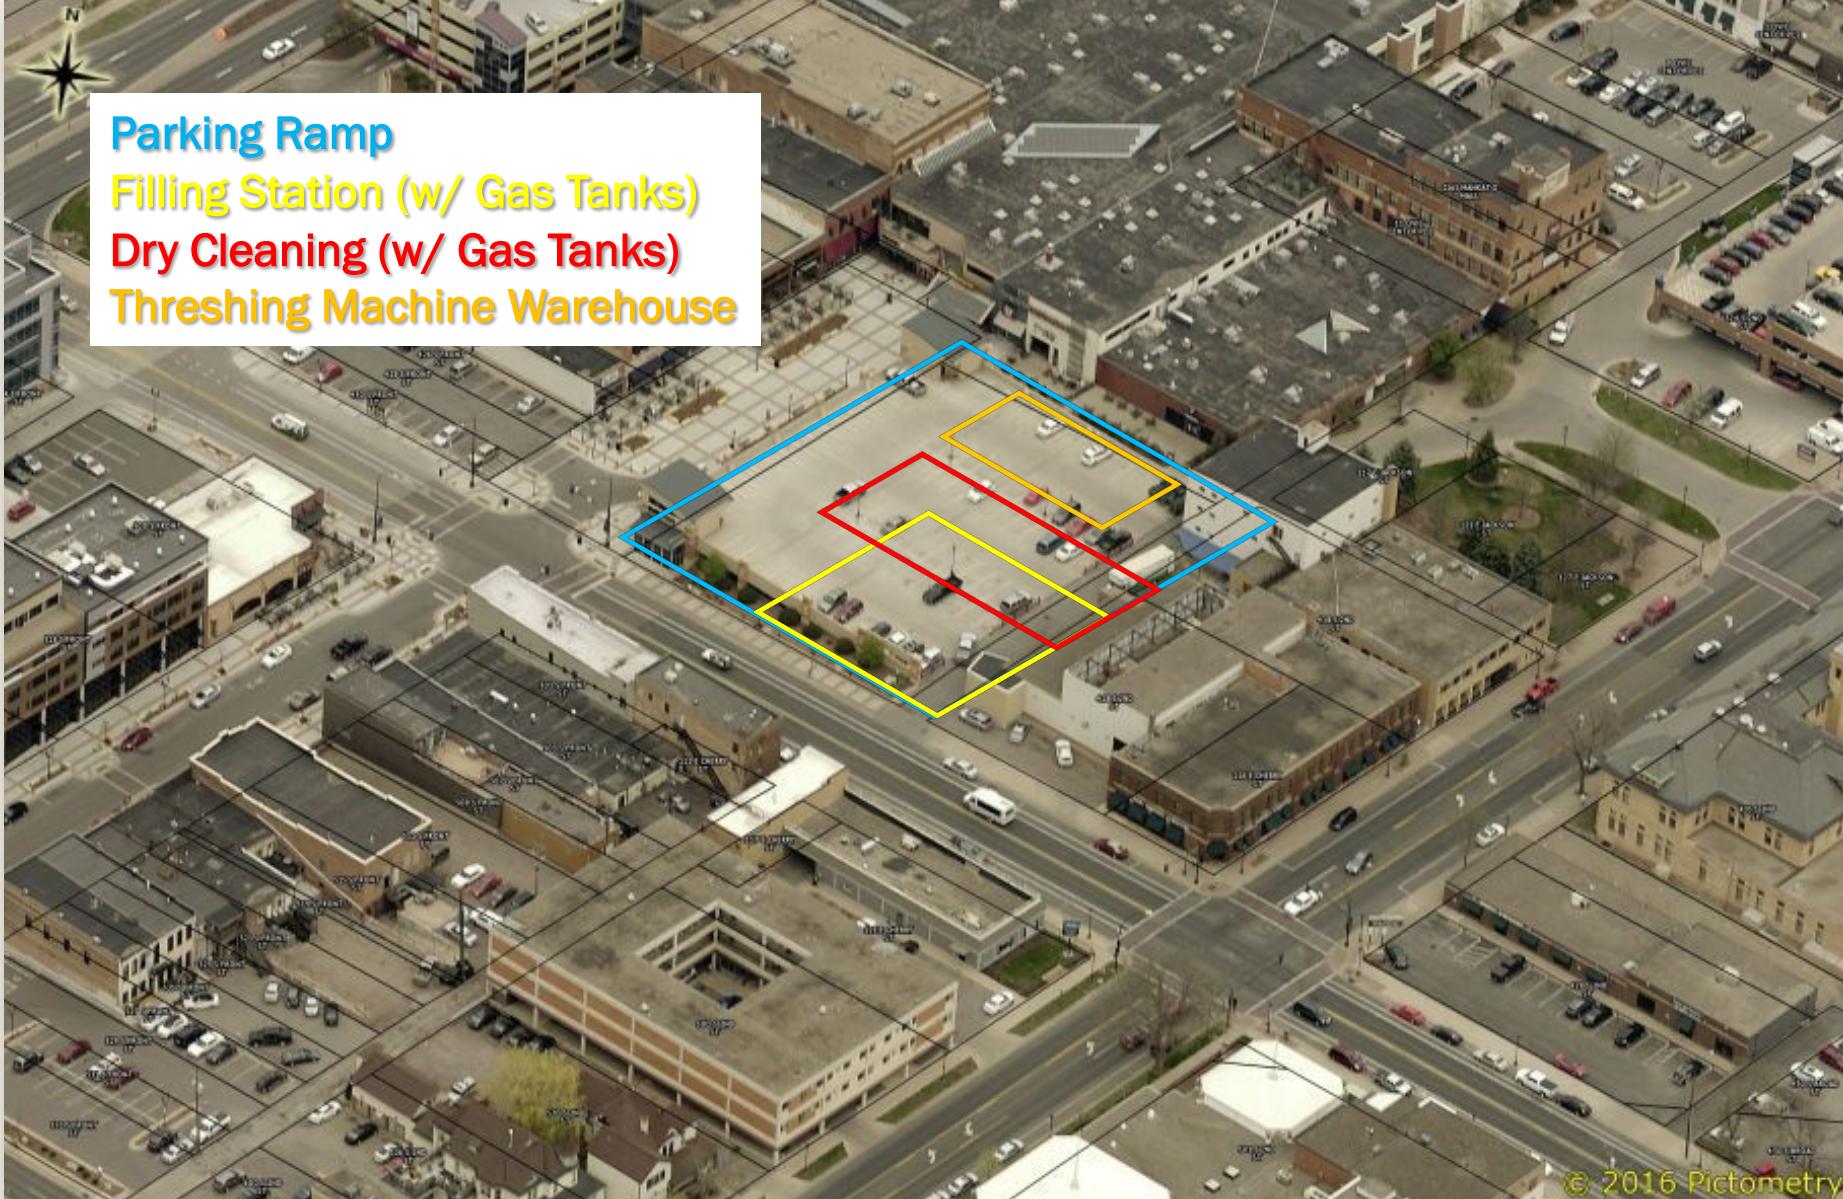
# REFERENCED TO PRESENT DAY

- Filling Station (1948)
  - *One on site, other bordering on SW corner, Gasoline Tanks*
- Dry Cleaning (1924)
  - *On Site, Gasoline Tanks*
- Threshing Machine Warehouse (1908)
  - *On Site*
  - *Other border sites should always be in consideration, but on site is very critical.*

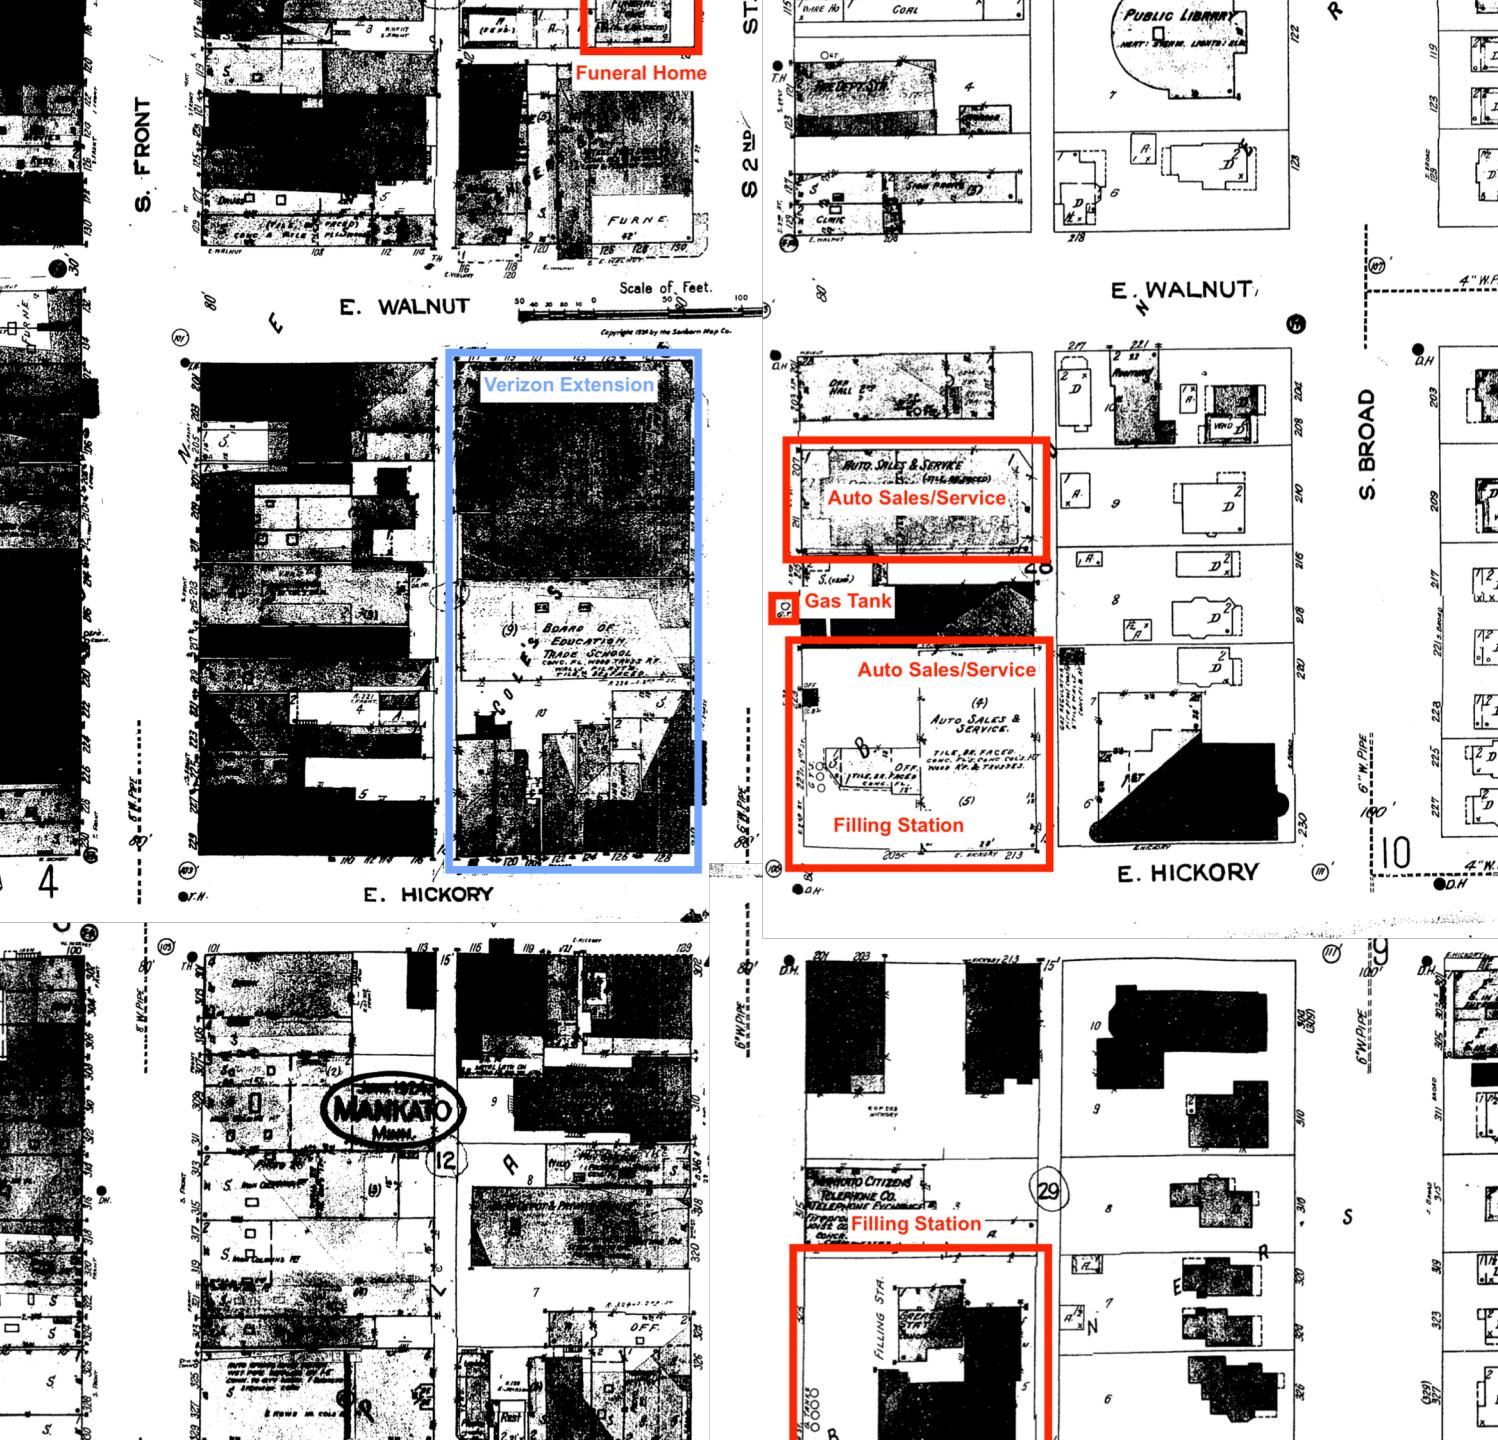
# 1948

- None
  - Due to obstruction, unable to see possible RECs

- Funeral Home
  - Use of toxic fluids, embalming
- 2 Filling Stations
  - Total of 8 Gas Tanks
- 2 Auto Sales/Service
  - Auto. Waste, fuels, oils, etc.
