Finland Air Force Base

Historical Photographic Analysis

Minnesota State University, Mankato

GEOG 480 – GISc and Environmental Hazards

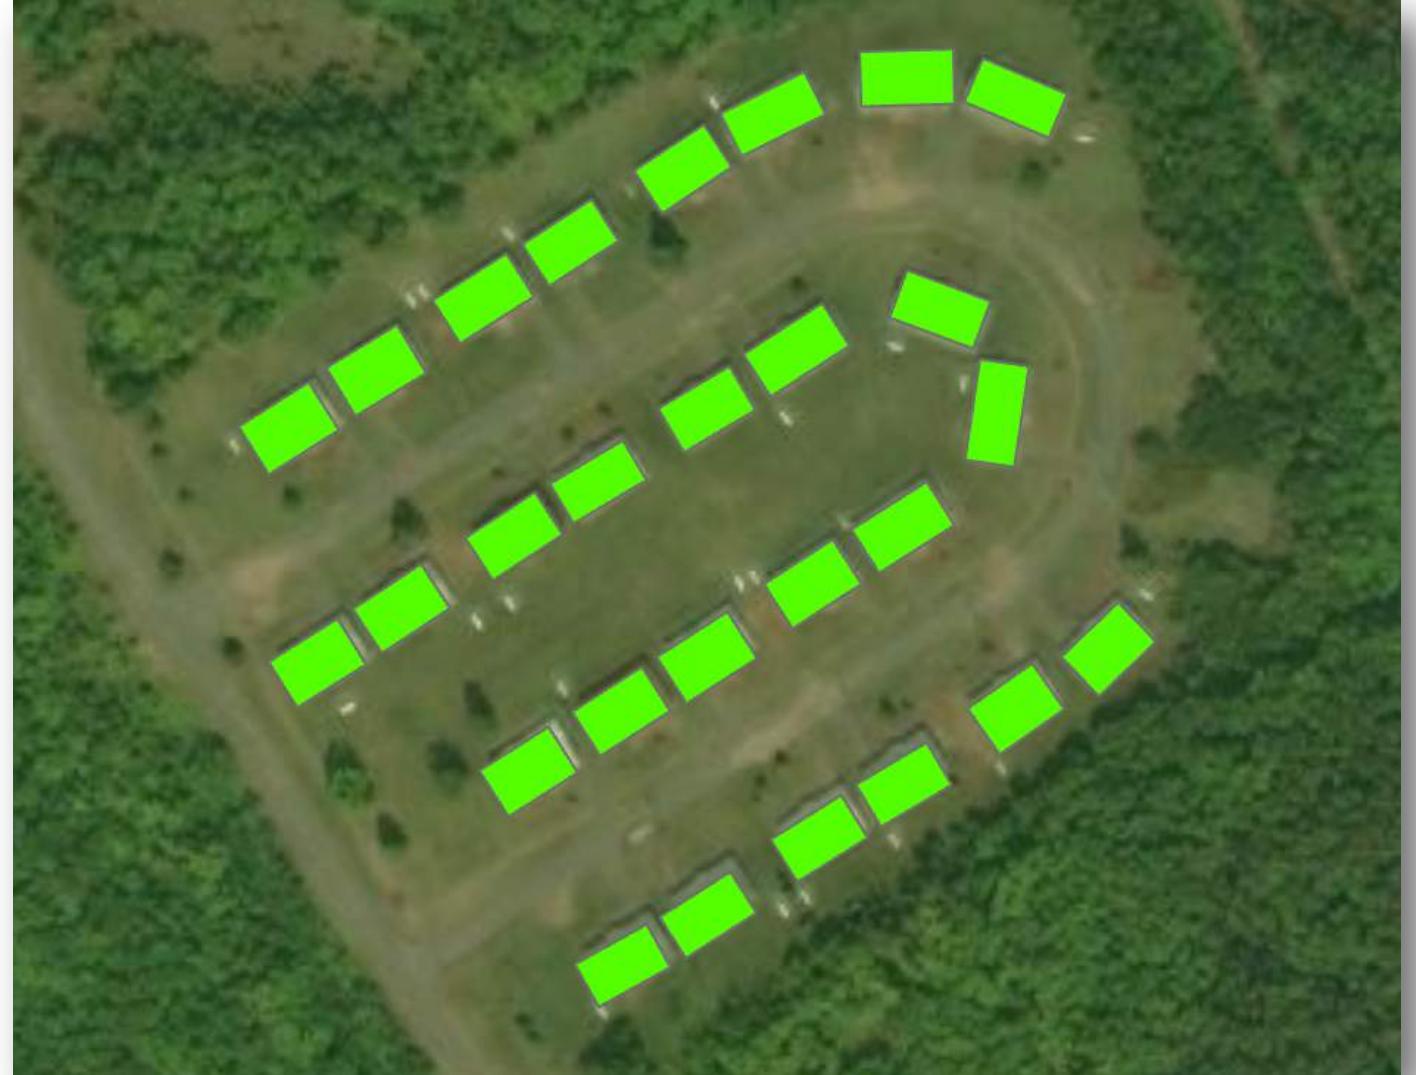
Issue for Present/Future

There appears to be natural gas tanks supplying energy to all the eastern most households.

Should be kept in mind for the future, as to not have any other issues like previously.

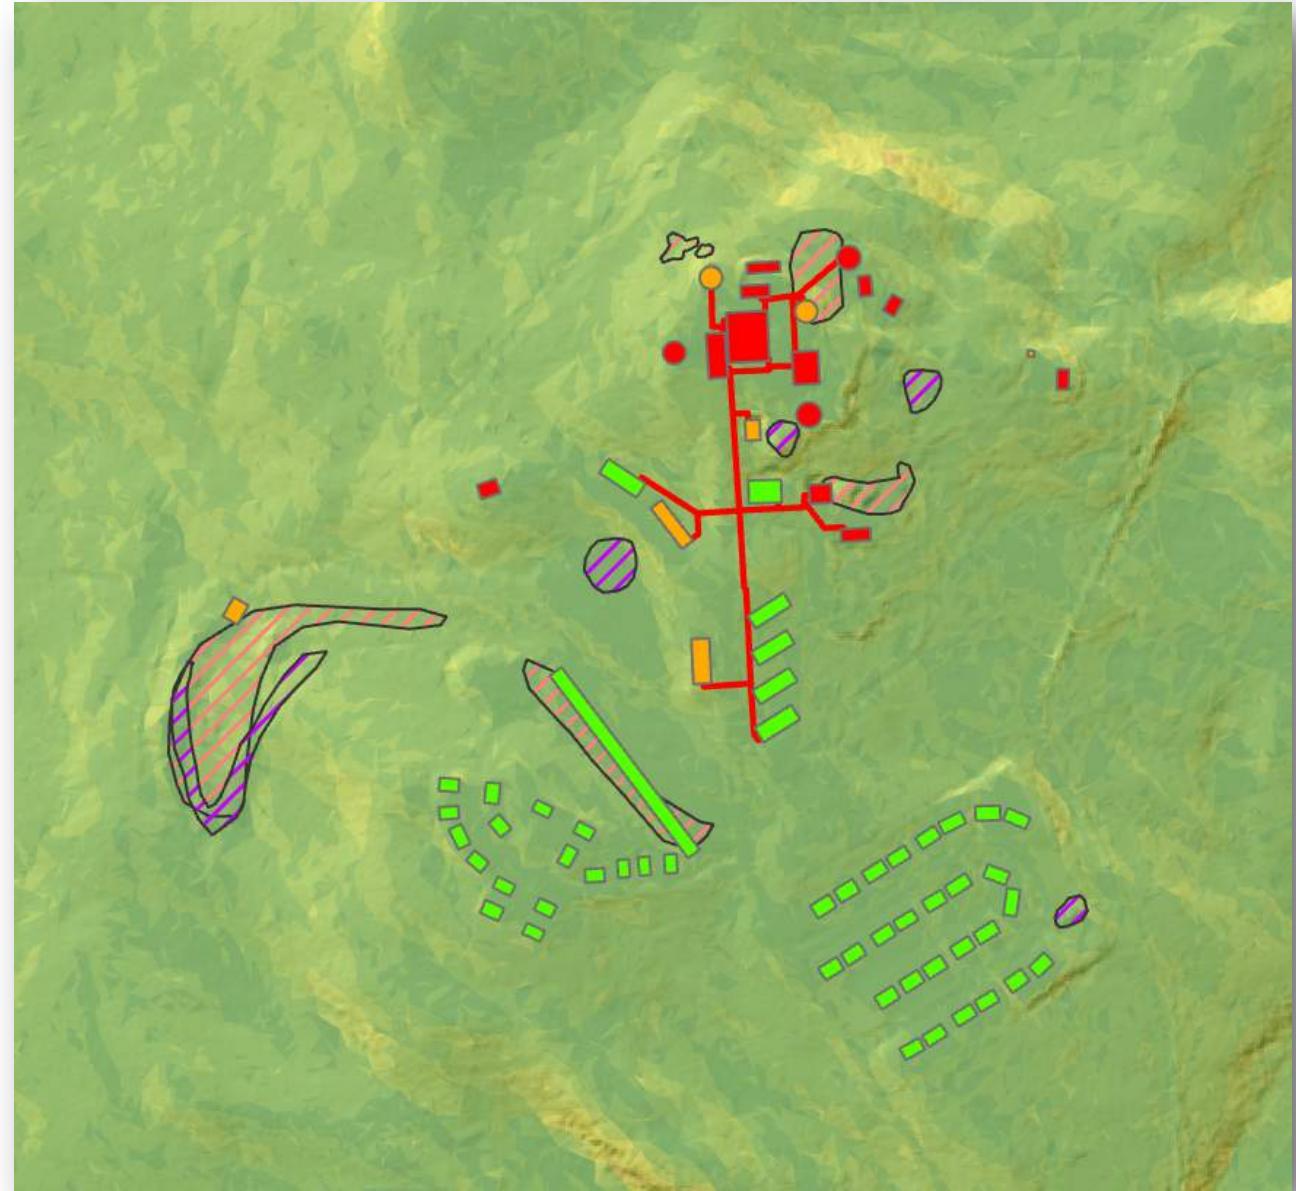
Elevation in Relation to Hazards

The red raster are aspects facing NW, N or NE. With the base being located at a peak in elevation, and with the concentration of concern being next the slopes, this aspect map confirms it could have impacts downhill.

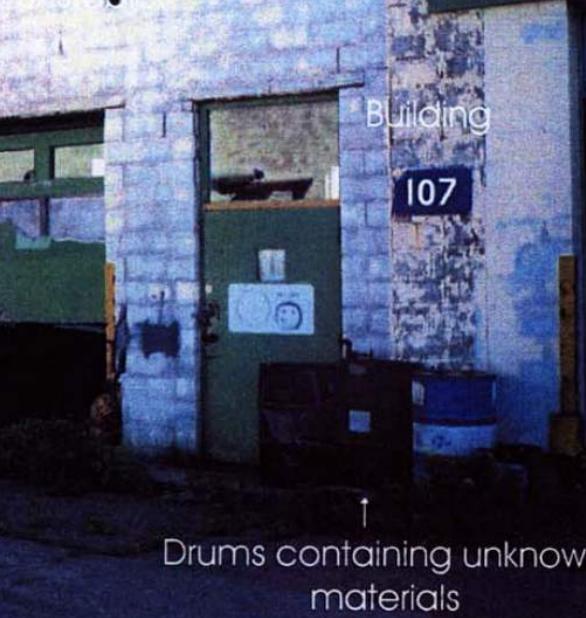
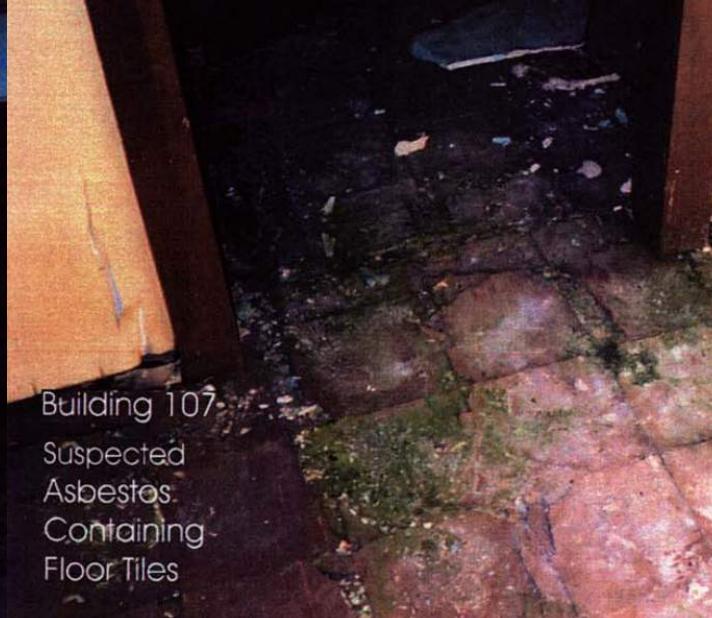
Figure 13 Solid Waste Pile (6/9/03)
