Wardak Watershed and Irrigation Survey Project

Chaki Wardak District Report

March 2011

CERP Project Number 20100204152503

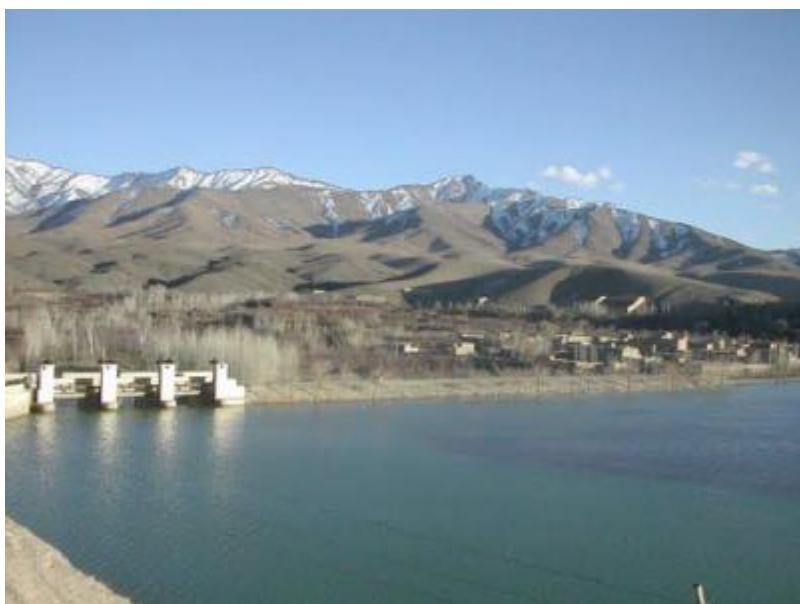
Figure 1. The Chak Dam

A major feature on the river is the Chak Dam. Much has been written about the dam elsewhere and no attempt was made to survey it. It is reported to be very silted up.

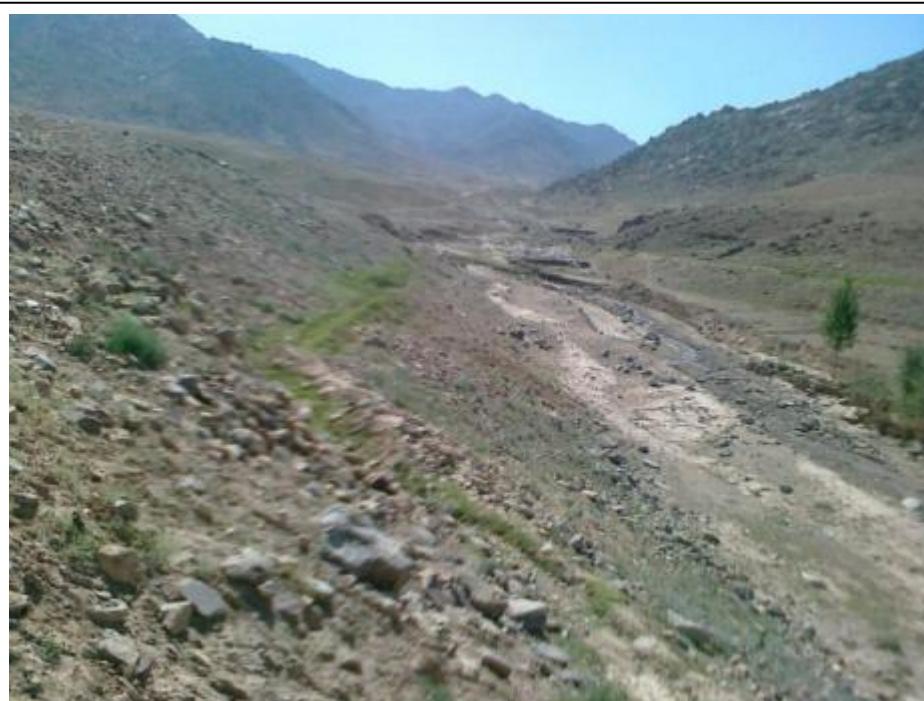
The water comes from a karez and a spring. The karez originates further up (0.8km) the main Baksmand valley and is only 100m from mother well to exit. The karez was cleaned in 2008, but it seems that it was recently flooded by the main river and the shafts are damaged. No work has been undertaken above the mother well to mitigate flooding and improve infiltration into groundwater. Although the flow is said to have decreased, when the photographs were taken in October there was a good stream in the karez channel. The distribution channels are haphazard and could be improved by directing them out of the potential flood zone and stabilising with willows, Russian olives or other native species. Some 120 jeribs are irrigated from the Karez. The spring also needs some attention.

Figure 3. Urdu karez channel showing erosion, flooding and the potential for establishing a deeper channel to prevent water loss from evaporation and protecting it from future flood damage. There is also potential for terracing and planting on the sides of the valley.

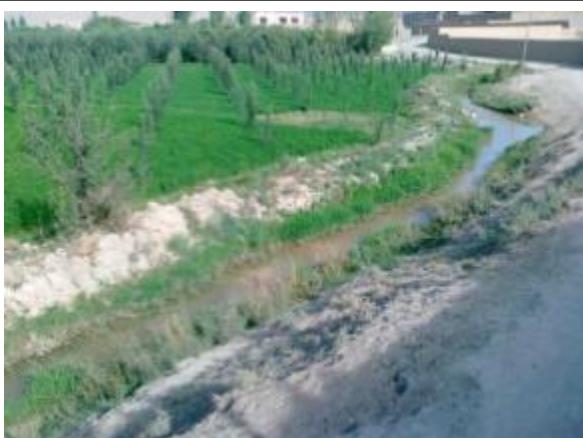
According to the villagers, the irrigation system is in relatively good condition (see Figure 4 below) in spite of the recent floods, but our survey team thought that work was needed. Water is mainly by the Sayed Canal off the Chak River, but a properly constructed off-take would allow better water regulation. The canal is long and serves some 18 villages, comprising 1,200 households. General improvements to the canal system are requested to clear blockages and prevent leaks. There are several inconsistencies in the data collected for the canal and it is suggested that the team return to check their readings. For example, although the canal is supposedly 3,000 m long, the altitude of the discharge end is higher than the off-take from the main river and the GPS reading for the discharge is totally wrong. Also there is no record of how the canal is managed, how equitable is the distribution and how frequently water is supplied to each farm. Improvements to the canal would be worthwhile, but better data is needed.

Figure 4 Sayed Canal. Neat Orchards and a well-maintained canal characterise Nurkhel

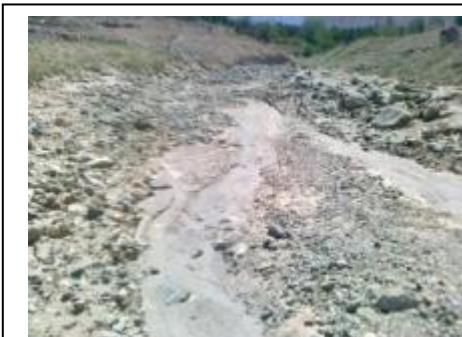
**Figure 6 The
Karez Channel
at Qurbanay**

Water is sourced from karezes which are said to be in poor condition and needing repair. There are four karezes in Qurbanay, of which two are private, and one in Sprinkalay. Small unlined reservoirs accumulate water on a daily basis. The older (20 years) reservoir at Sprinkalay holds 3,375 m³ and the newer one at Qurbanay (8 years) holds 6,000 m³. It takes 6 hours to fill the former and 13 hours to fill the latter. Sprinkalay reservoir is in better condition, but Qurbanay needs cleaning. Lining the reservoirs would reduce leaks. From photos of Qurbanay, some channels and the karez sources are subject to erosion and flooding, but some canals are in good condition and lined with trees. Unfortunately there are no photos of Sprinkalay. Little attempt has been made to improve groundwater infiltration above the mother wells and the potential for this needs further investigation.

The village elders from Sprinkalay say that the karez needs cleaning and they would like a tubewell and a larger reservoir. At Qurbanay, the reservoir and canal system are also mentioned as needing attention. Our survey team agreed that all karezes need attention, but the karez at Sprinkalay was cleaned quite recently. However, any sustainable long-term intervention here should focus on the Dersh Shalay watershed as a whole and include the other villages: Nurkhel, Moqamkhell, Mahekam Khell, and Dersh Shalay / Darsheelay itself. The Google Map (Figure 6) shows large areas where water harvesting with terracing, check dams etc. and where flood prevention works could be carried out. Moqamkhell, Qurbanay and Sprinkalay all spoke of flooding being a problem. Work would benefit the karezes and springs lower down. Control of grazing would be a prerequisite to any afforestation and this would involve active cooperation between all villages in the watershed.
