# Dome Inspection and Metrology

Alan M. Watson

2026 February 19

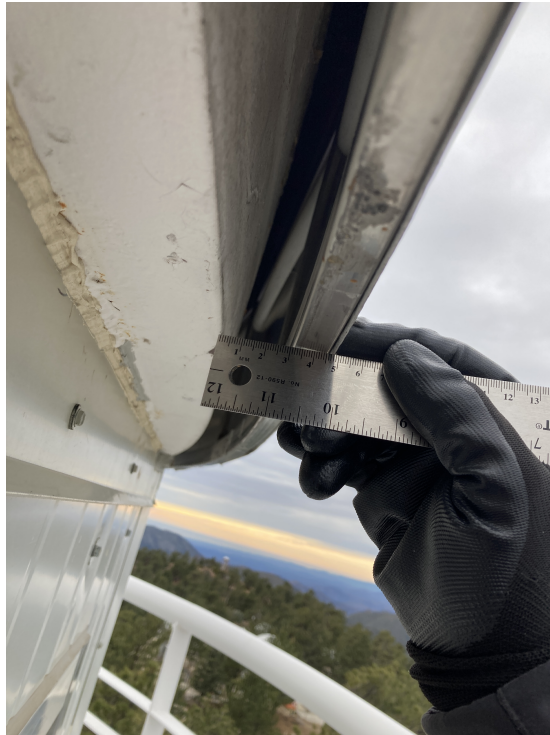
We measured the distance  $D$  between the outer radius of the beam on the building and the inner radius of the dome at the center of 14 of the 16 sizes to the building. We were not able to measure this at two positions over the door. See Figure 2. The dome was positioned with the slit to the north. The results are shown in Figure 3 along with a sinusoidal model (fit by eye). We repeated the measurement twice ( $D1$  and  $D2$ ) to confirm that the point at 292.5 degrees, is correct. The figure suggests that the dome is displaced with respect to the building by about 15 mm, being furthest from the building at an azimuth of about 300 degrees (WNW) and closest at about 120 degrees (ESE). At its

Figure 2: Measuring the distance  $D$  between the outer radius of the building beam and inner radius of the dome.
