# **Dome Inspection and Metrology**

Alan M. Watson

10 March 2026

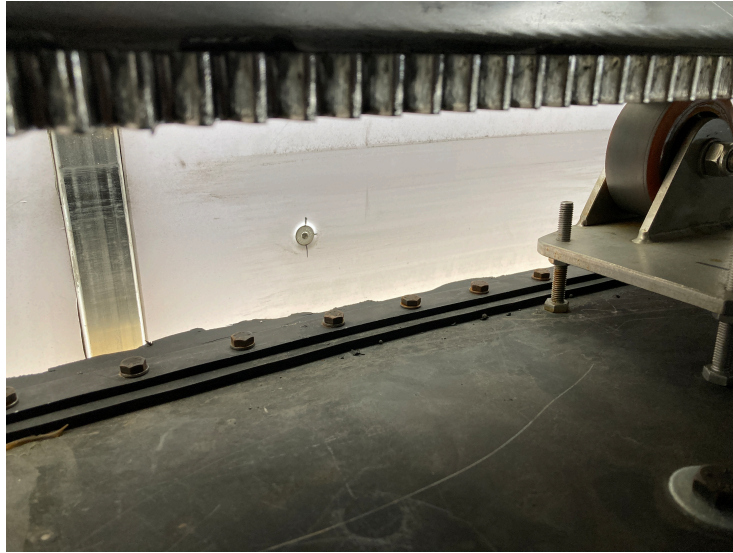
In the first week of December 2025, the neoprene seal between the building and the dome was damaged. It appears to have been torn at the point that it is fixed by steel strips to the interface plates attached to the building. It fell between the dome and building on the SW side and prevented movement. On-site staff removed the damaged seal between azimuths of about 150 and 330 degrees and fixed the ends of the undamaged seal so that the dome could turn. See Figure 1.

Figure 1: The damaged seal.

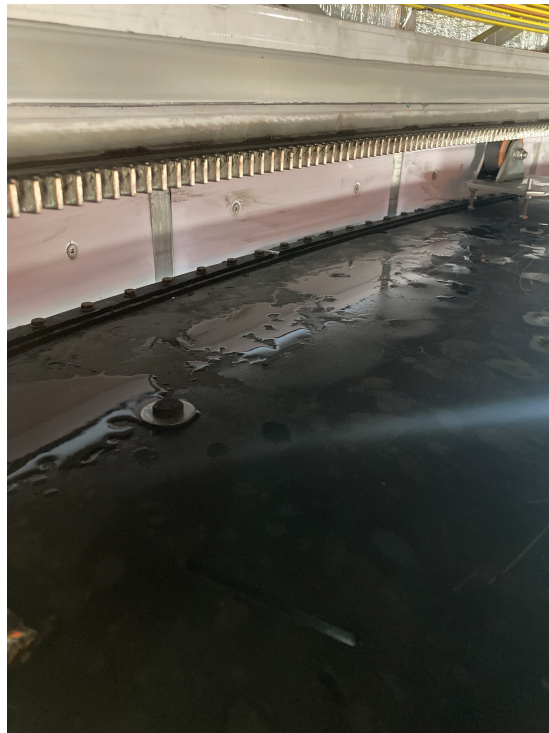
Unsurprisingly, water is now able to penetrate the enclosure and reach the interface plate. See Figure 2.

Figure 2: Water on the interface plate.

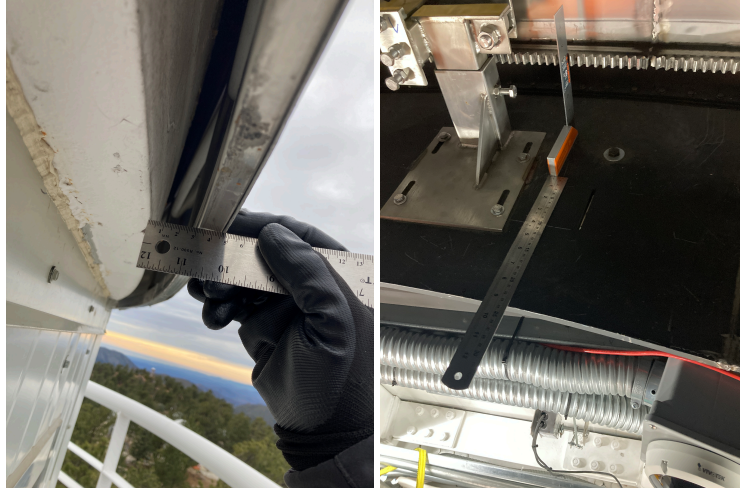
Figure 3: Left: Measuring the distance  $D$  between the outer radius of the building beam and inner radius of the dome. Right: Measuring the distance  $G$  from the inner radius of the interface plates to the bottom of the teeth in the drive track.

We measured the distance  $D$  between the outer radius of the beam on the building and the inner radius of the dome at the center of 14 of the 16 sides of the building. See Figure 3. We were not able to measure this at two positions over the door. The dome was positioned with the slit to the north. We repeated the measurement twice ( $D1$  and  $D2$ ) to confirm that the apparently anomalous point at 292.5 degrees is correct.

We also measured the distance  $G$  from the inner radius of the interface plates to the bottom of the teeth in the drive track. See Figure 3. (More precisely, we measured this distance minus the length of one side of the set-square, but since we are interested only in differences this is irrelevant.) We obtained measurements with the dome shutter at azimuths of 0, 90, 180, and 270 degrees. We measured this at each one of the 10 radial supports.

- The dome appears to be decentered with respect to both the building (measurement  $D$ ) and the interface plate (measurement  $G$ ). The displacements are estimated to be 15 and 11 mm, respectively, at azimuths of 300 and 285 degrees. These are in fairly good agreement.
- After subtracting a model that corresponds to a nominal recentering of the dome, there are still significant residuals in the radial measurements  $D'$  and  $G'$ . These may be caused by local deformations of the dome by the radial supports.

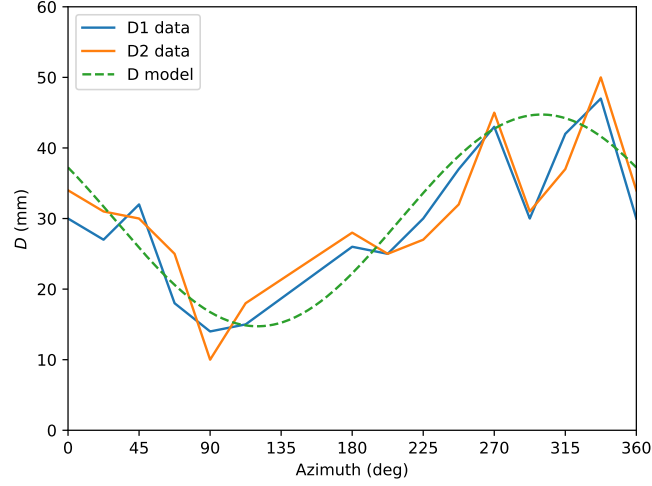
Figure 4 suggests that the dome is displaced with respect to the building by about 15 mm, being furthest from the building at an azimuth of about 300 degrees (WNW) and closest at about 120 degrees (ESE). At its widest point, the gap is almost 50 mm, but at its narrowest point it is about 15 mm. Figure 5 suggests that the dome is displaced with respect to the interface plate by about 11 mm, being furthest from the building at an azimuth of about 285 degrees (between W and WNW) and closest at about 105 degrees (between E and ESE). These two estimated displacements are similar but not identical; it is possible that the interface plate is not perfectly centered

Figure 4: The distance  $D$  between the outer radius of the building beam and inner radius of the dome as a function of azimuth. The plot shows two sets of measurements ( $D1$  and  $D2$ ) and an approximate sinusoidal model with a half-amplitude of 15 mm and a maximum at 300 deg.

on the building. Nevertheless, we can conclude that the dome is displaced by 10–15 mm towards W or WNW with respect to both the building and the interface plate.

It seems the first thing to do is to correct this consequence of the installation and recenter the dome. As part of this process, we might also consider if the radial supports are locally deforming the dome out of a circular shape and, if necessary and possible, correct this.

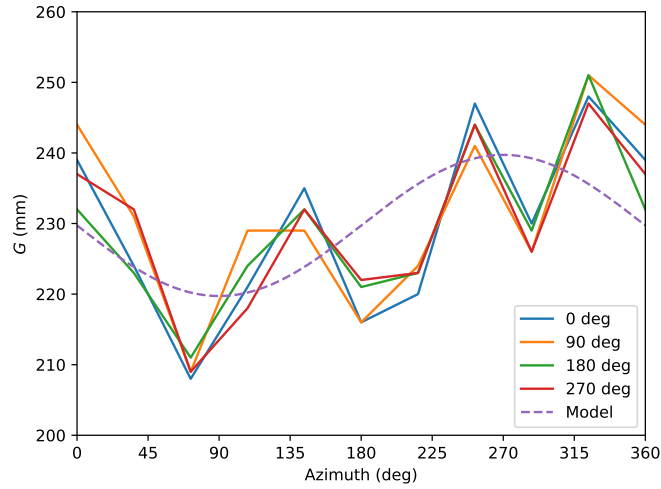
Figure 5: The distance  $G$  between from the inner radius of the interface plates to the bottom of the teeth in the drive track as a function of azimuth and for the dome shutter at azimuths of 0, 90, 180, and 270 deg. The plot also shows approximate sinusoidal model with a half-amplitude of 11 mm and a maximum of 285 deg.

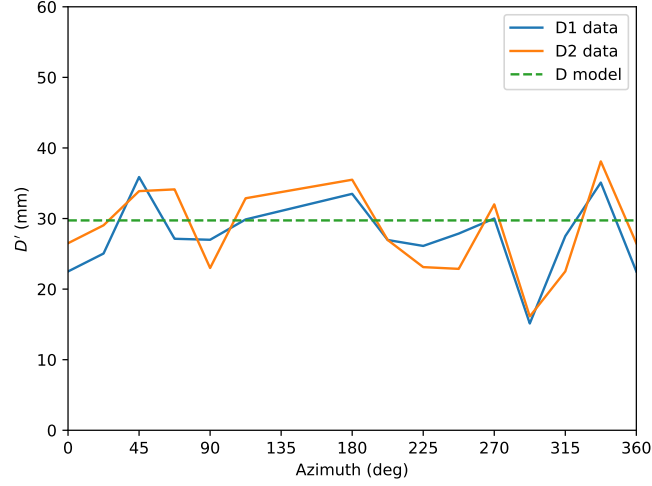
Figure 6: The estimated distance  $D'$  between the outer radius of the building beam and inner radius of the dome as a function of azimuth after displacing the dome by 15 mm at an azimuth of 120 degrees. The model assumes the dome moves rigidly.

Figure 6 shows  $D'$ , the value of  $D$  after displacing the dome by 15 mm at an azimuth of 120 degrees, assuming the dome moves rigidly. The P-V is reduced from 40 mm to 23 mm. Figure 7 shows  $G'$ , the value of  $G$  after displacing the dome by 11 mm at an azimuth of 105 degrees, assuming the dome moves rigidly. The P-V is reduced from 43 to 27 mm.

Even after modeling the displacement of the dome to better center it, there are still notable variations in  $D'$  and  $G'$ . For example, in Figure 6 the measurement at 292.5 deg is approximately 15 mm smaller than the general trend (i.e., the dome is 15 mm closer to the building than the general trend). A similar deviation is seen in Figure 7, in which the measurement at 288 deg is approximately 10 mm smaller than the general trend. The similarity between these and other residuals suggests that they are real.

One possibility is that these residuals reflect variations in the radial position of the radial supports; that is that the radial supports are forcing the dome outwards at some positions (the high residuals, e.g., at about 135 and 340 degrees) and allowing it to move inwards at other positions (the low residuals, e.g., at about 280 degrees). If this is the case, the dome may be undergoing repeated deformations, which could damage it and the radial supports and cause additional load on the motors.

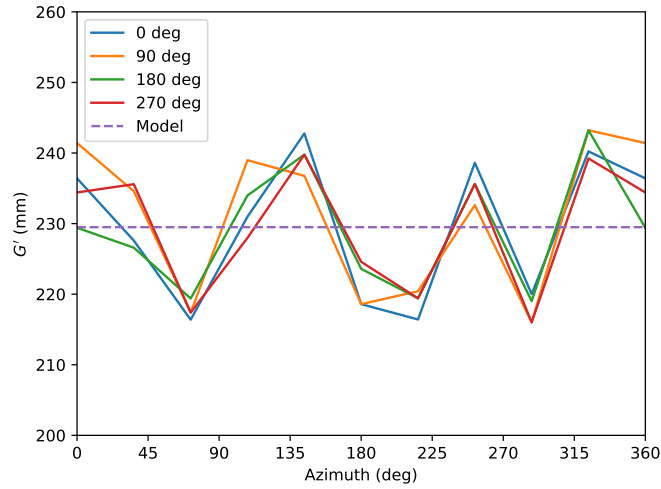
Figure 7: The estimated distance  $G'$  between from the inner radius of the interface plates to the bottom of the teeth in the drive track as a function of azimuth and for the dome shutter at azimuths of 0, 90, 180, and 270 deg after displacing the dome by 11 mm at an azimuth of 105 degrees. The model assumes the dome moves rigidly.
