HAZARDOUS MATERIALS ASSESSMENT REPORT

Client: Cape Cod Australia Pty. Limited

Location: 42 Lyton Street, Blacktown NSW

Our reference: HM04800416

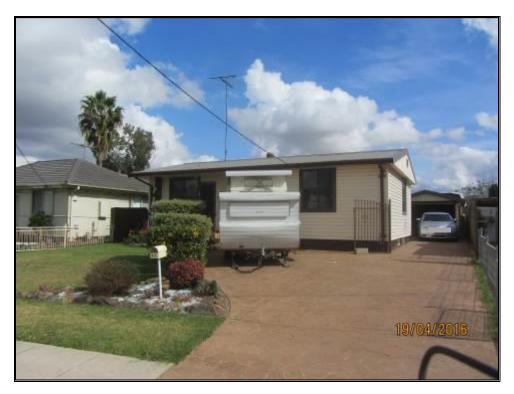
Front eastern elevation of the residence
