HAZARDOUS MATERIALS ASSESSMENT REPORT

Client: Cape Cod Australia Pty. Limited

Location: 1A Holly Street, Castle Cove NSW

Date of assessment: 4th September 2015

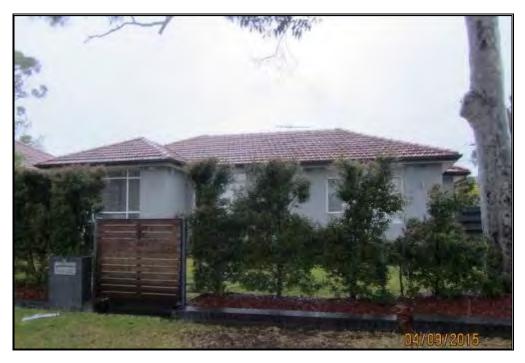
Front northern elevation of the residence
