# HAZARDOUS MATERIALS ASSESSMENT REPORT

Client: Cape Cod Australia Pty. Limited

Location: 217A Burns Bay Rd, Lane Cove.

Our reference: HM05221016

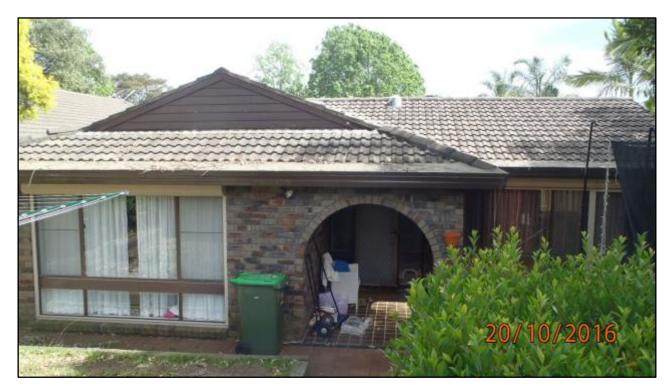
Front south eastern elevation of the residence
