HAZARDOUS MATERIALS ASSESSMENT REPORT

Client: Cape Cod Australia Pty. Limited

Location: 15 Eulabah Avenue, EARLWOOD.

Our reference: HM04900516

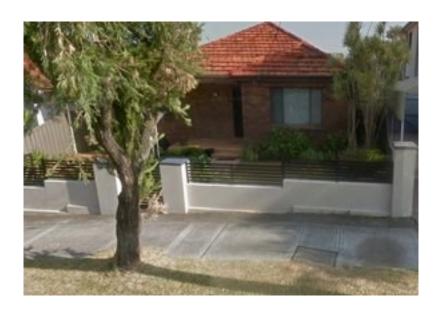
Front southern elevation of the residence
