HAZARDOUS MATERIALS ASSESSMENT REPORT

Client: Cape Cod Australia Pty. Limited

Location: 31 Knowles Avenue, North Bondi.

Our reference: HM05291216

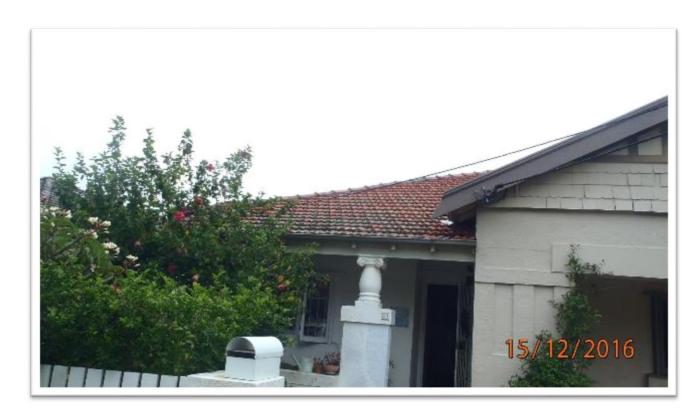
Front eastern elevation of the residence
