HAZARDOUS MATERIALS ASSESSMENT REPORT

Client: Cape Cod Australia Pty. Limited

Location: 4 Ray Avenue Vaucluse, NSW

Our reference: HM 03060514

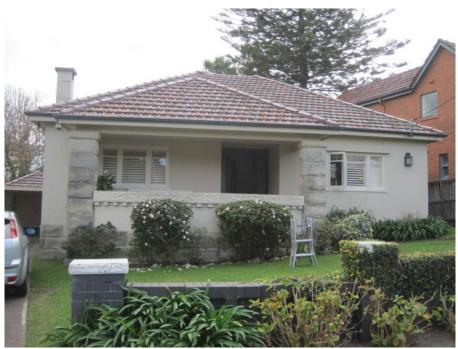
Front elevation of 4 Ray Av. Vaucluse
