HAZARDOUS MATERIALS ASSESSMENT REPORT

Client: Cape Cod Australia Pty. Limited

Location: 174 North Liverpool Road, Green Valley

Our reference: HM05140916

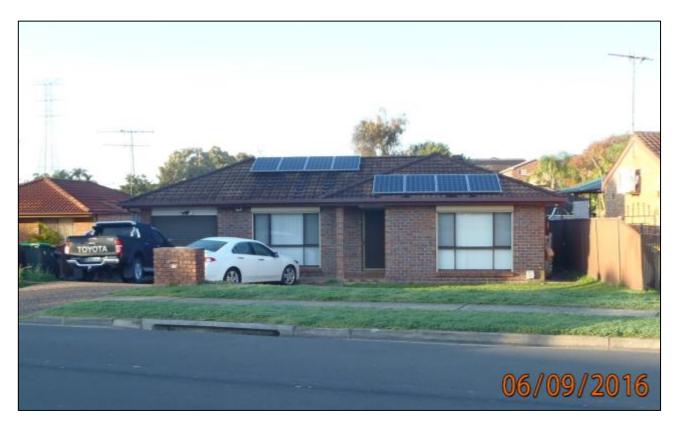
Front northern elevation of the residence
