HAZARDOUS MATERIALS ASSESSMENT REPORT

Client: Cape Cod Australia Pty. Limited

Location: 108 Gardeners Road, Kingsford NSW

Our reference: HM04560116

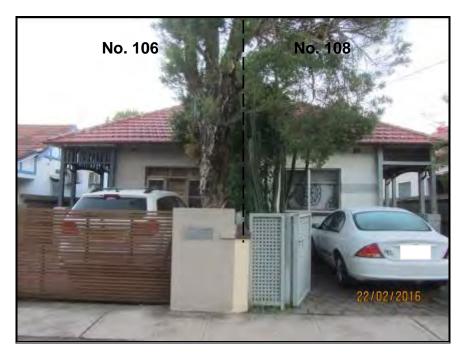
Front southern elevation of the adjoining properties: No.106 & No.108 Gardeners Road, Kingsford
