HAZARDOUS MATERIALS ASSESSMENT REPORT

Client: Cape Cod Australia Pty. Limited

Location: 44 Alfred Street, BRONTE.

Our reference: HM04970716

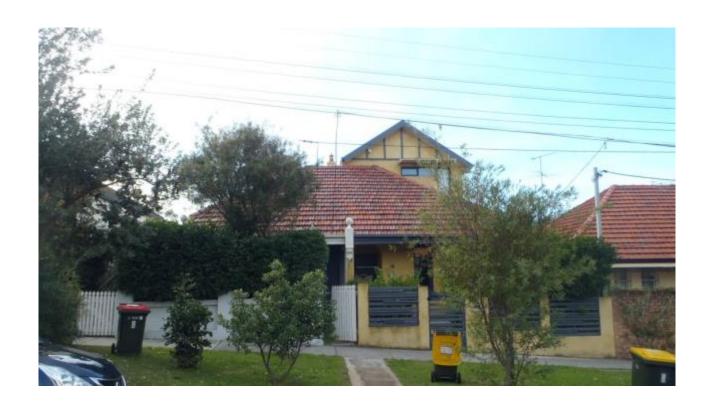
Front western elevation of the residence
