HAZARDOUS MATERIALS ASSESSMENT REPORT

Client: Cape Cod Australia Pty. Limited

Location: 1 Justus Street, North Bondi NSW

Date of assessment: 2nd June 2015

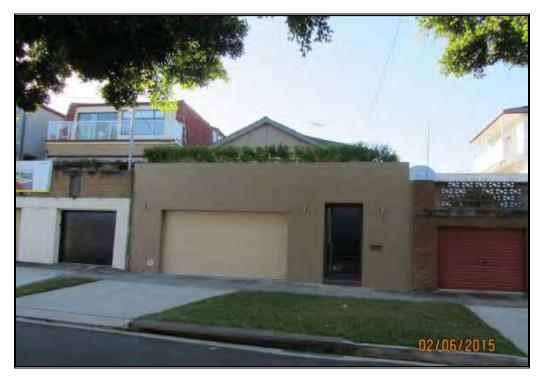
Front western elevation of the residence
