HAZARDOUS MATERIALS ASSESSMENT REPORT

Location: 24 Gammell Street, Rydalmere NSW

Date of assessment: 9th January 2015

Our reference: HM03591214

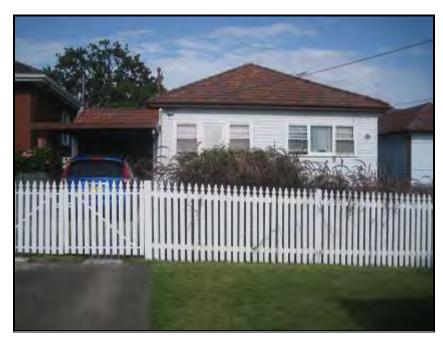
Front eastern elevation of the residence
