# **HAZARDOUS MATERIALS ASSESSMENT REPORT**

Client: Cape Cod Australia Pty. Limited

Location: 21 Morgan St, Thornleigh.

Our reference: HM06131017

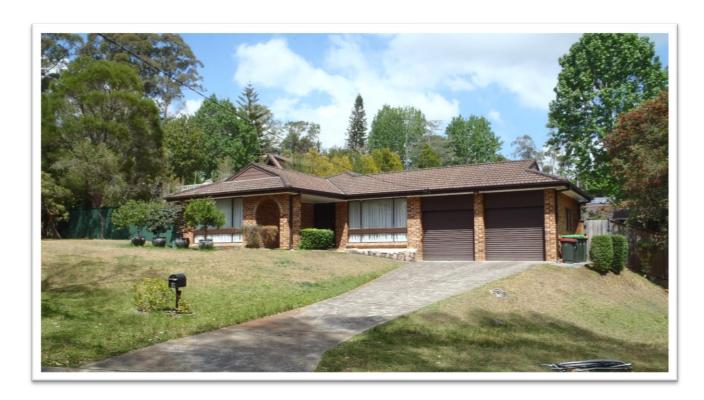
Front eastern elevation of the residence
