# HAZARDOUS MATERIALS ASSESSMENT REPORT

Client: Cape Cod Australia Pty. Limited

Location: 360 Avoca Street, Kingsford.

Our reference: HM05120816

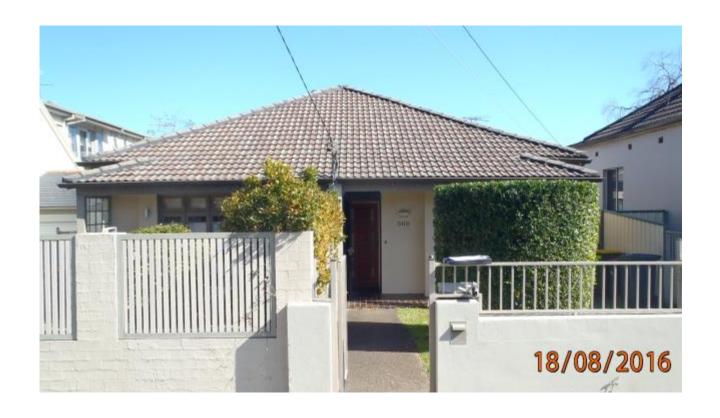
#### Front eastern elevation of the residence
