HAZARDOUS MATERIALS ASSESSMENT REPORT

Client: Cape Cod Australia Pty. Limited

Location: 34 Heydon Street, Enfield.

Our reference: HM05560217

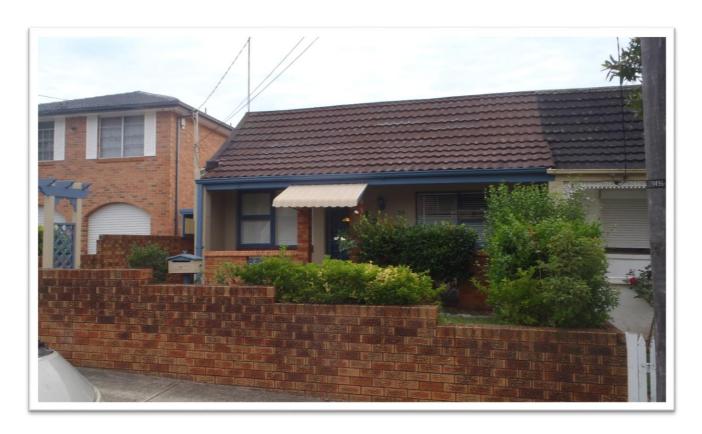
Front western elevation of the residence
