HAZARDOUS MATERIALS ASSESSMENT REPORT

Client: Cape Cod Australia Pty. Limited

Location: 40 Kulgoa Avenue, Ryde.

Our reference: HM05351116

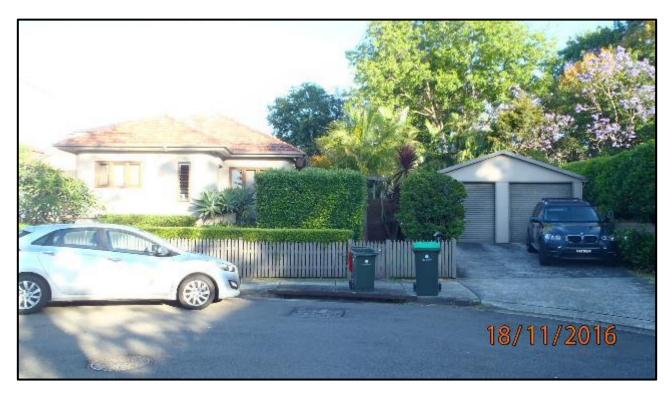
Front south-eastern elevation of the residence
