# **HAZARDOUS MATERIALS ASSESSMENT REPORT**

Client: Cape Cod Australia Pty. Limited

Location: 72 Simpson Street, Bondi Beach.

Date of assessment: 1st June 2017

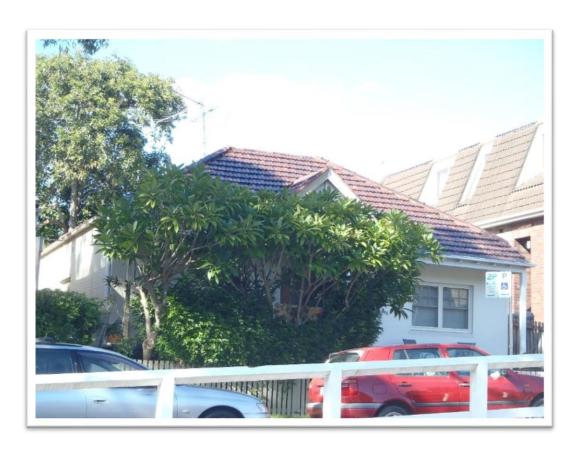
Front north-west elevation of the residence
