HAZARDOUS MATERIALS ASSESSMENT REPORT

Client: Cape Cod Australia Pty. Limited

Location: 44 Sackville Street, Maroubra.

Our reference: HM05371216

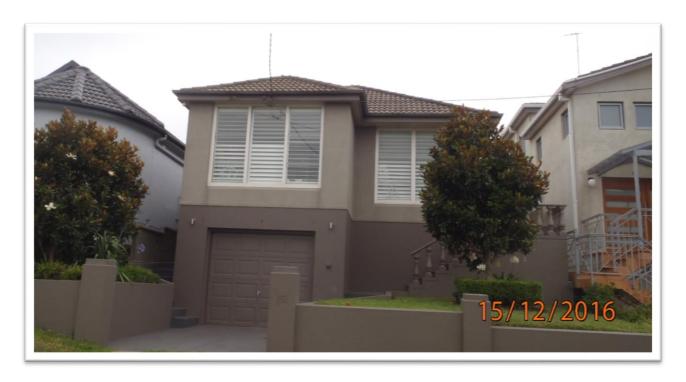
Front south western elevation of the residence
