HAZARDOUS MATERIALS ASSESSMENT REPORT

Client: Cape Cod Australia Pty. Limited

Location: 26 Ivey Street, Lindfield.

Our reference: HM05341116

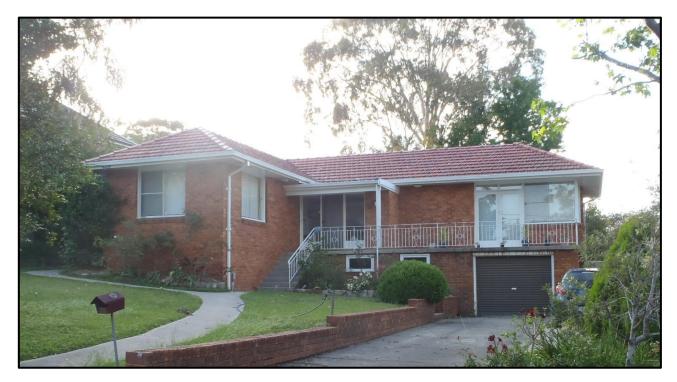
Front northern elevation of the residence
