HAZARDOUS MATERIALS ASSESSMENT REPORT

Client: Cape Cod Australia Pty. Limited

Location: 44 Becky Avenue, North Rocks.

Our reference: HM05400117

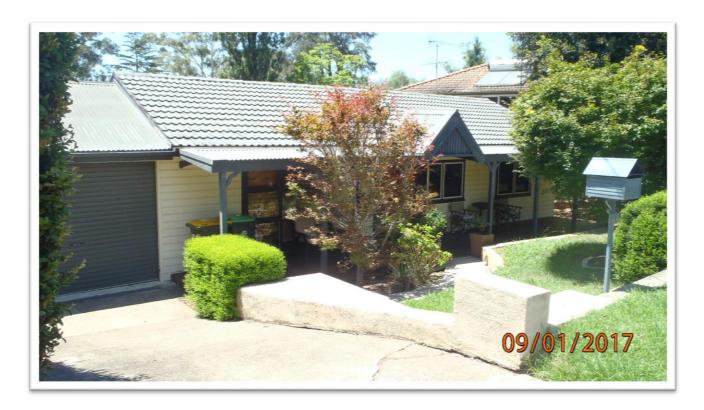
Front western elevation of the residence
