# HAZARDOUS MATERIALS ASSESSMENT REPORT

Client: Cape Cod Australia Pty. Limited

Location: 43 Drummond Road, Beaumont Hills

Our reference: HM04471215

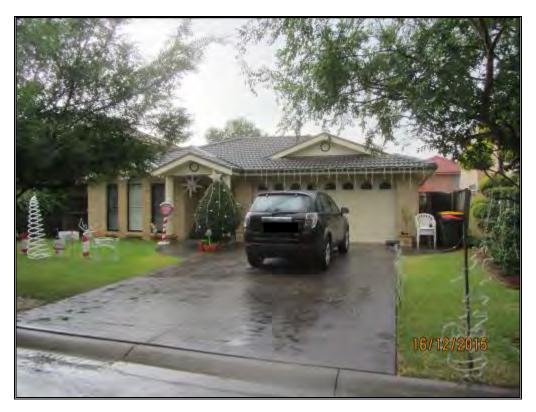
Front eastern elevation of the residence
