HAZARDOUS MATERIALS ASSESSMENT REPORT

Client: Cape Cod Australia Pty. Limited

Location: 38 Woodriff Street, PENRITH.

Date of assessment: 14th June 2016

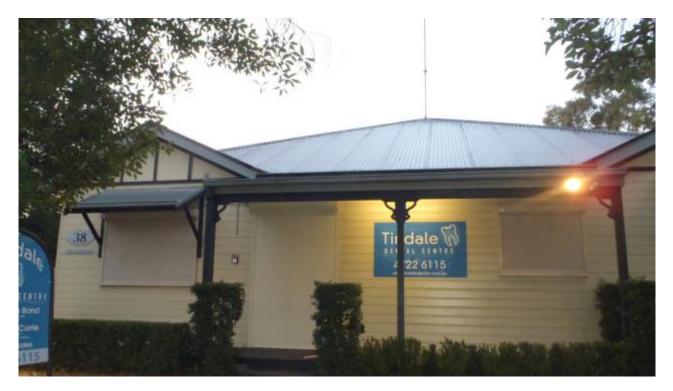
Front north western elevation of the residence
