# **HAZARDOUS MATERIALS ASSESSMENT REPORT**

Client: Cape Cod Australia Pty. Limited

Our reference: HM05540217

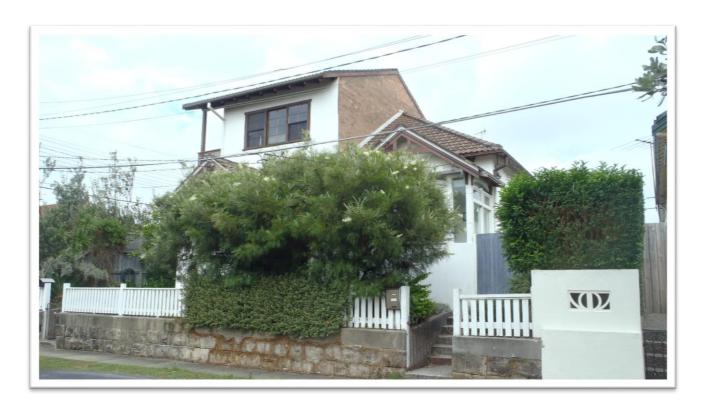
Front eastern elevation of the residence
