# **HAZARDOUS MATERIALS ASSESSMENT REPORT**

Client: Cape Cod Australia Pty. Limited

Location: 11 Lawson Street, Ermington NSW

Our reference: HM04130715

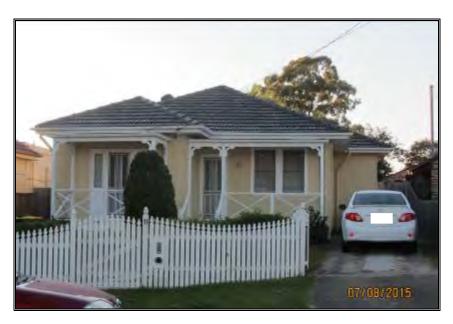
Front western elevation of the residence
